Remove 350 lf of 6" pipe / Install 350 lf of 8" pipe
from MH 5744-742 to MH 5744-736
See site pictures / Contractor should review the site

Television Inspection Master Report

US Manhole: 5744-742CO
DS Manhole: 5744-737 2920 S RUTAN CT

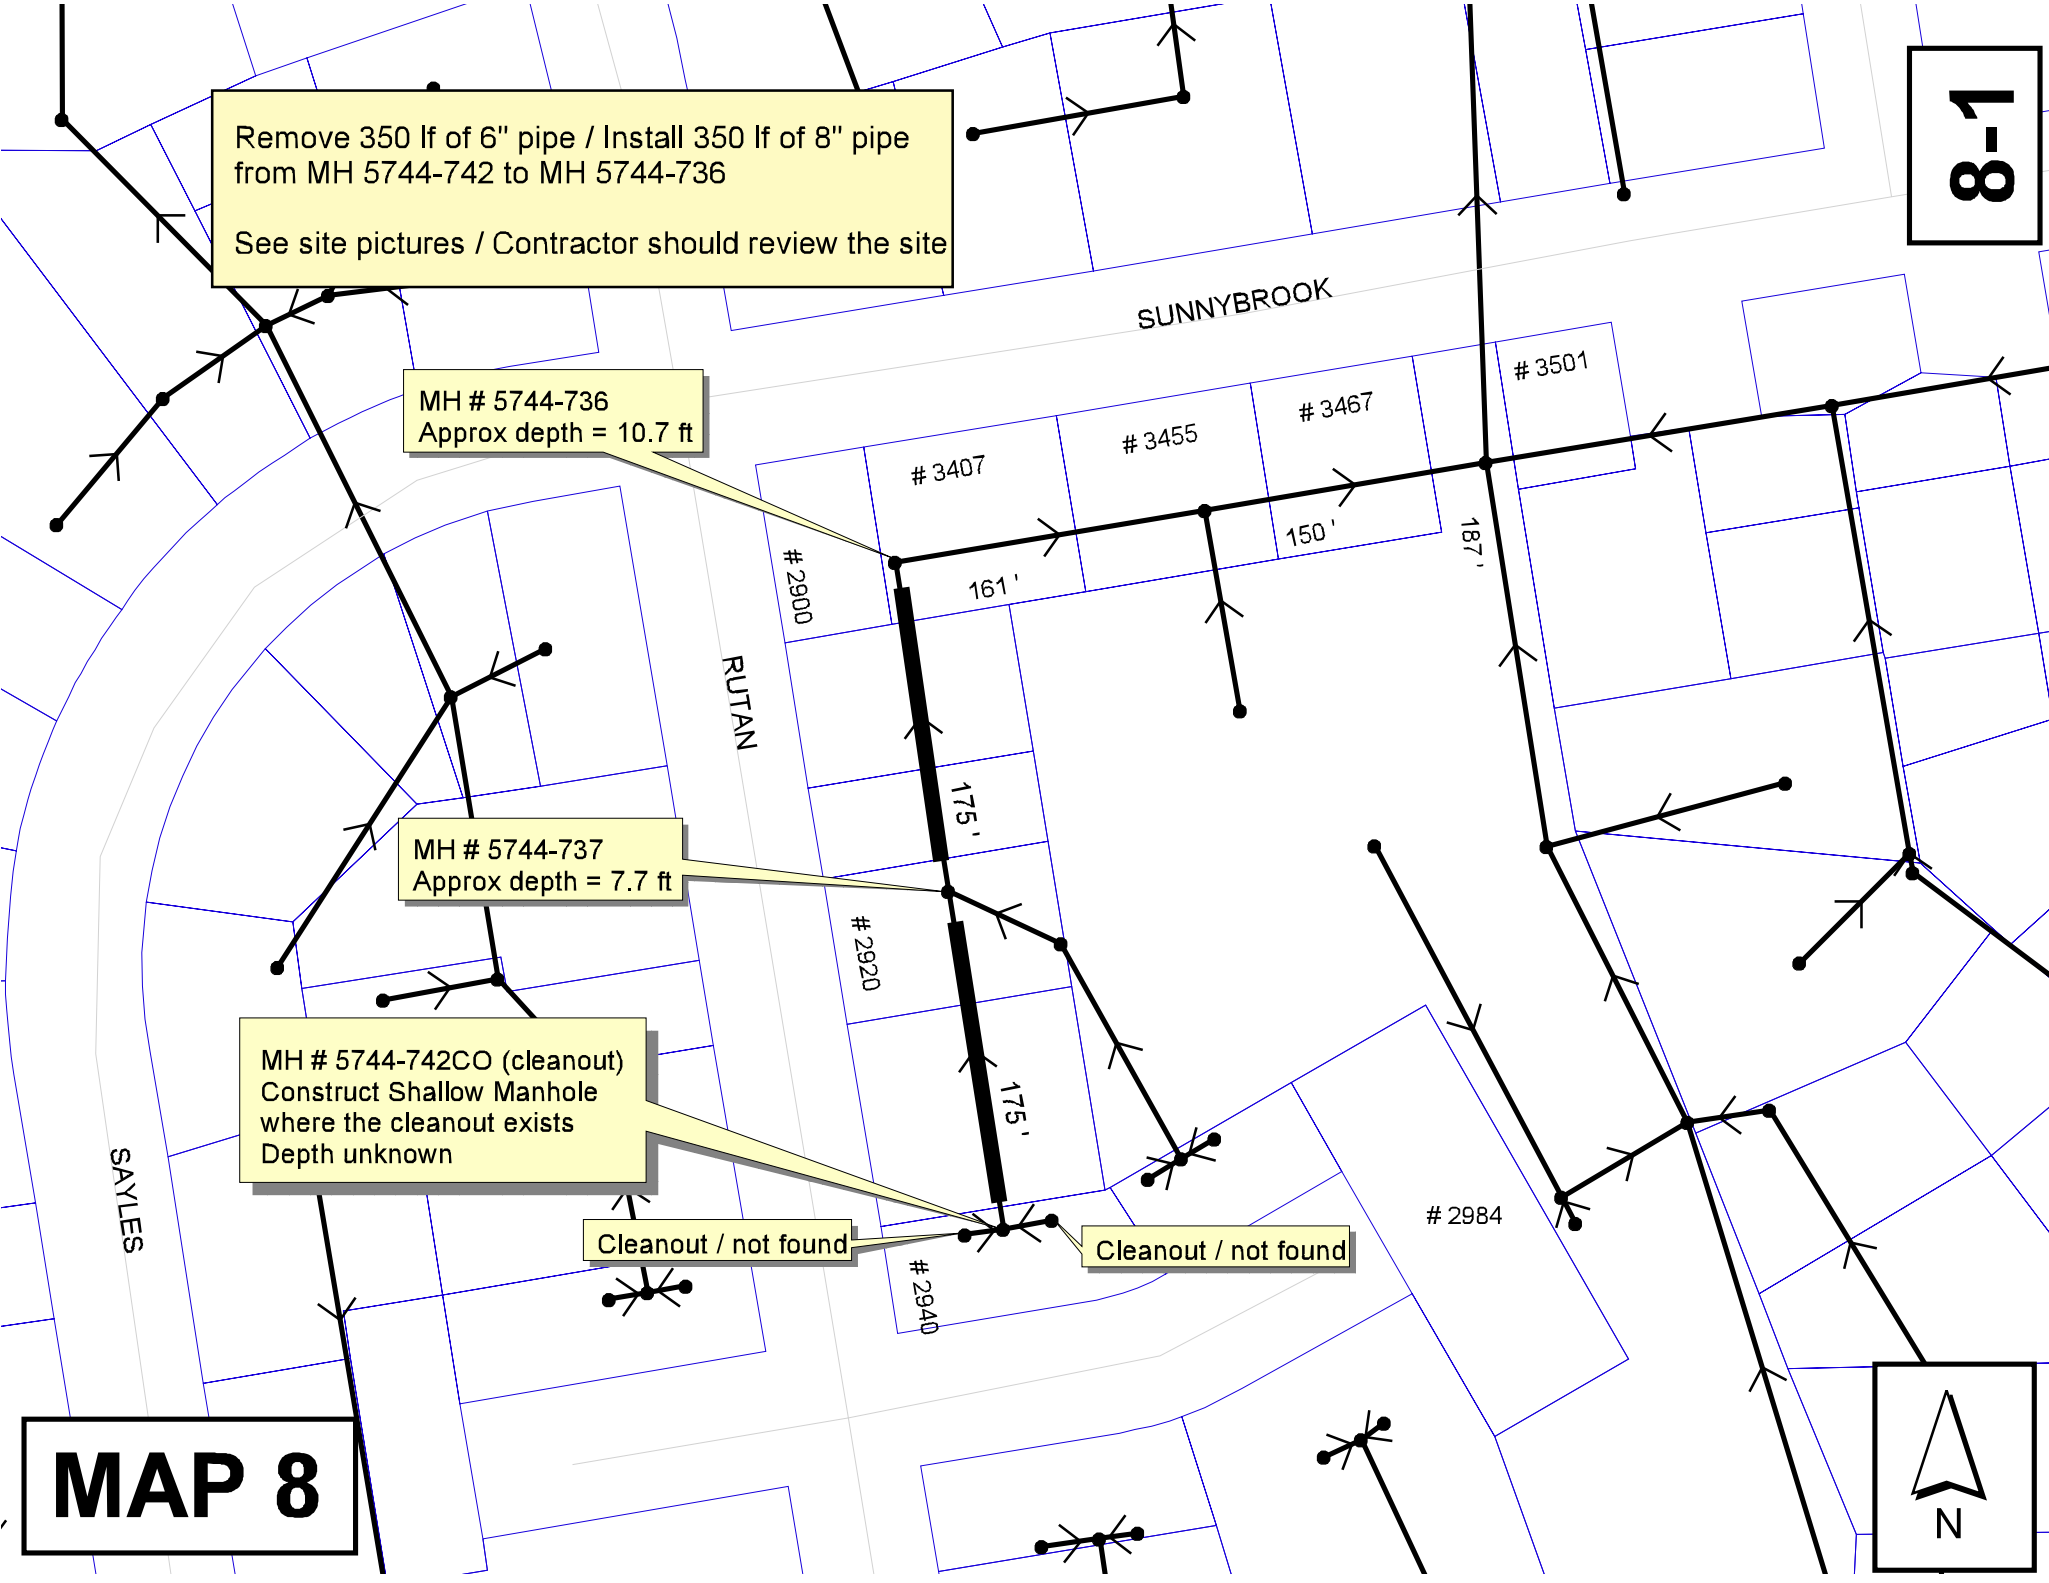
MH # 5744-736
Approx depth = 10.7 ft

MH # 5744-737
Approx depth = 7.7 ft

MH # 5744-742CO (cleanout)
Construct Shallow Manhole
where the cleanout exists
Depth unknown

Cleanout / not found

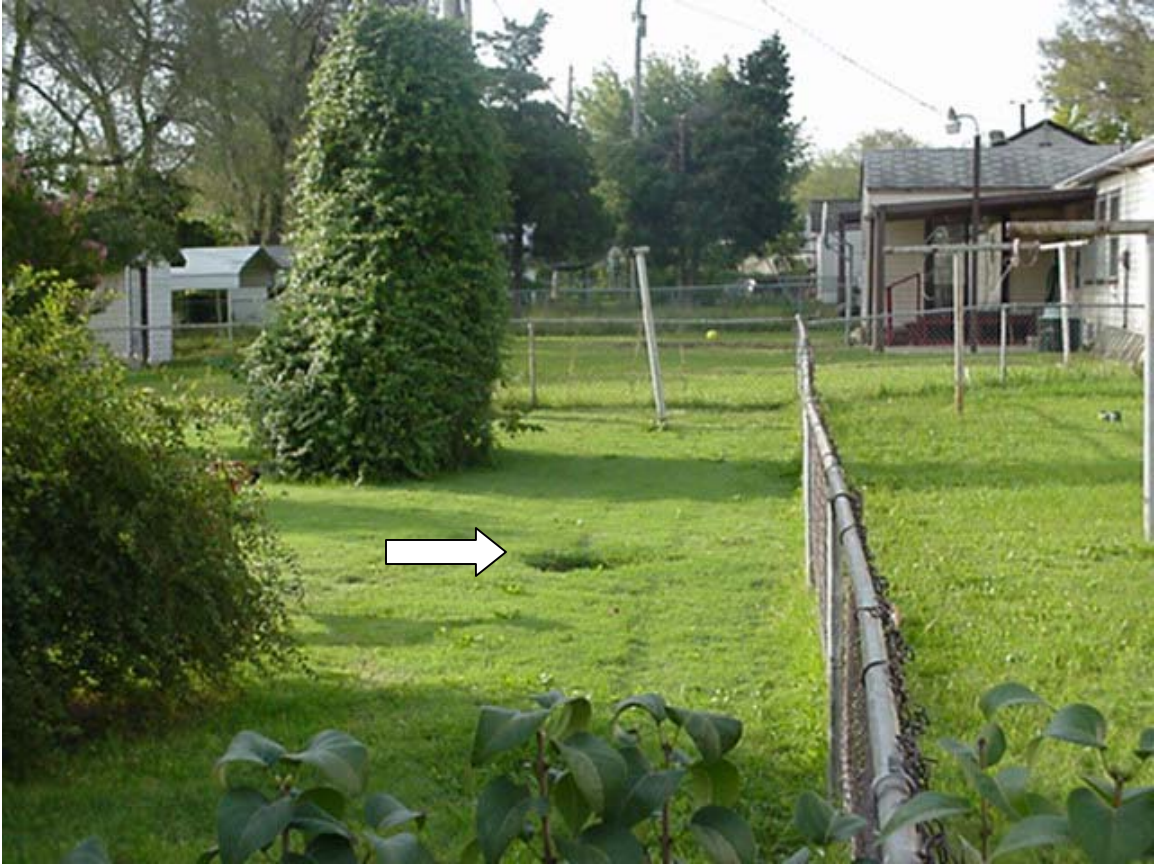
Standing north of MH 5744-736, looking south.
MH 5744-736 has the arrow pointing to it.

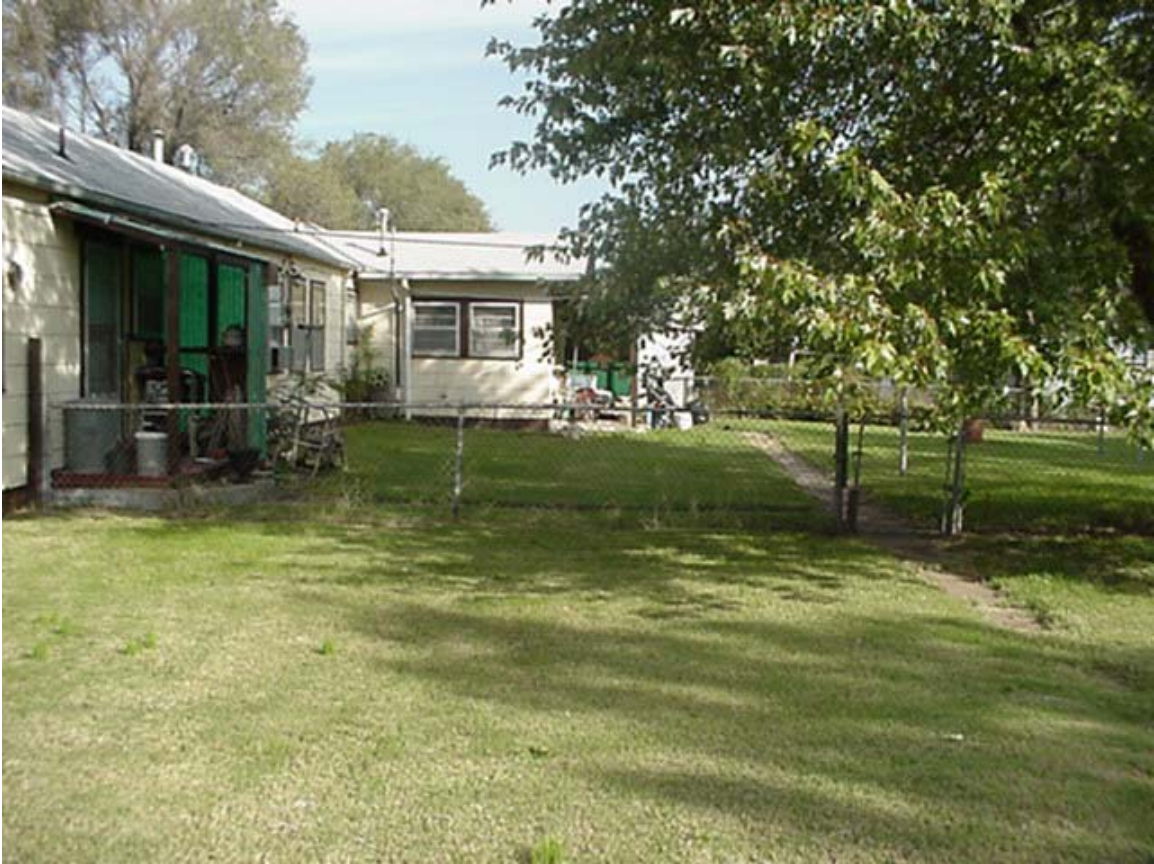
Standing north of 5744-742CO (cleanout), looking north.

Cleanout 5744-742CO is located on the north side of a small shed. 2940 S. Rutan

The line goes under a building as shown in the picture.

Contractor may want to swing the new line further east to avoid the building, and construct manhole 5744-742 up to approx 25 ft further east at 2940 S. Rutan.

(see easement sheet) Any relocation must be approved by the field engineer and will not change the contract amount. Any proposed relocation will include the extension of services and replacement of sidewalk.
