SITE 3

Television Inspection Master Report

US Manhole: 5746-427
DS Manhole: 5746-426

556 BELMONT ST
702 BELMONT ST

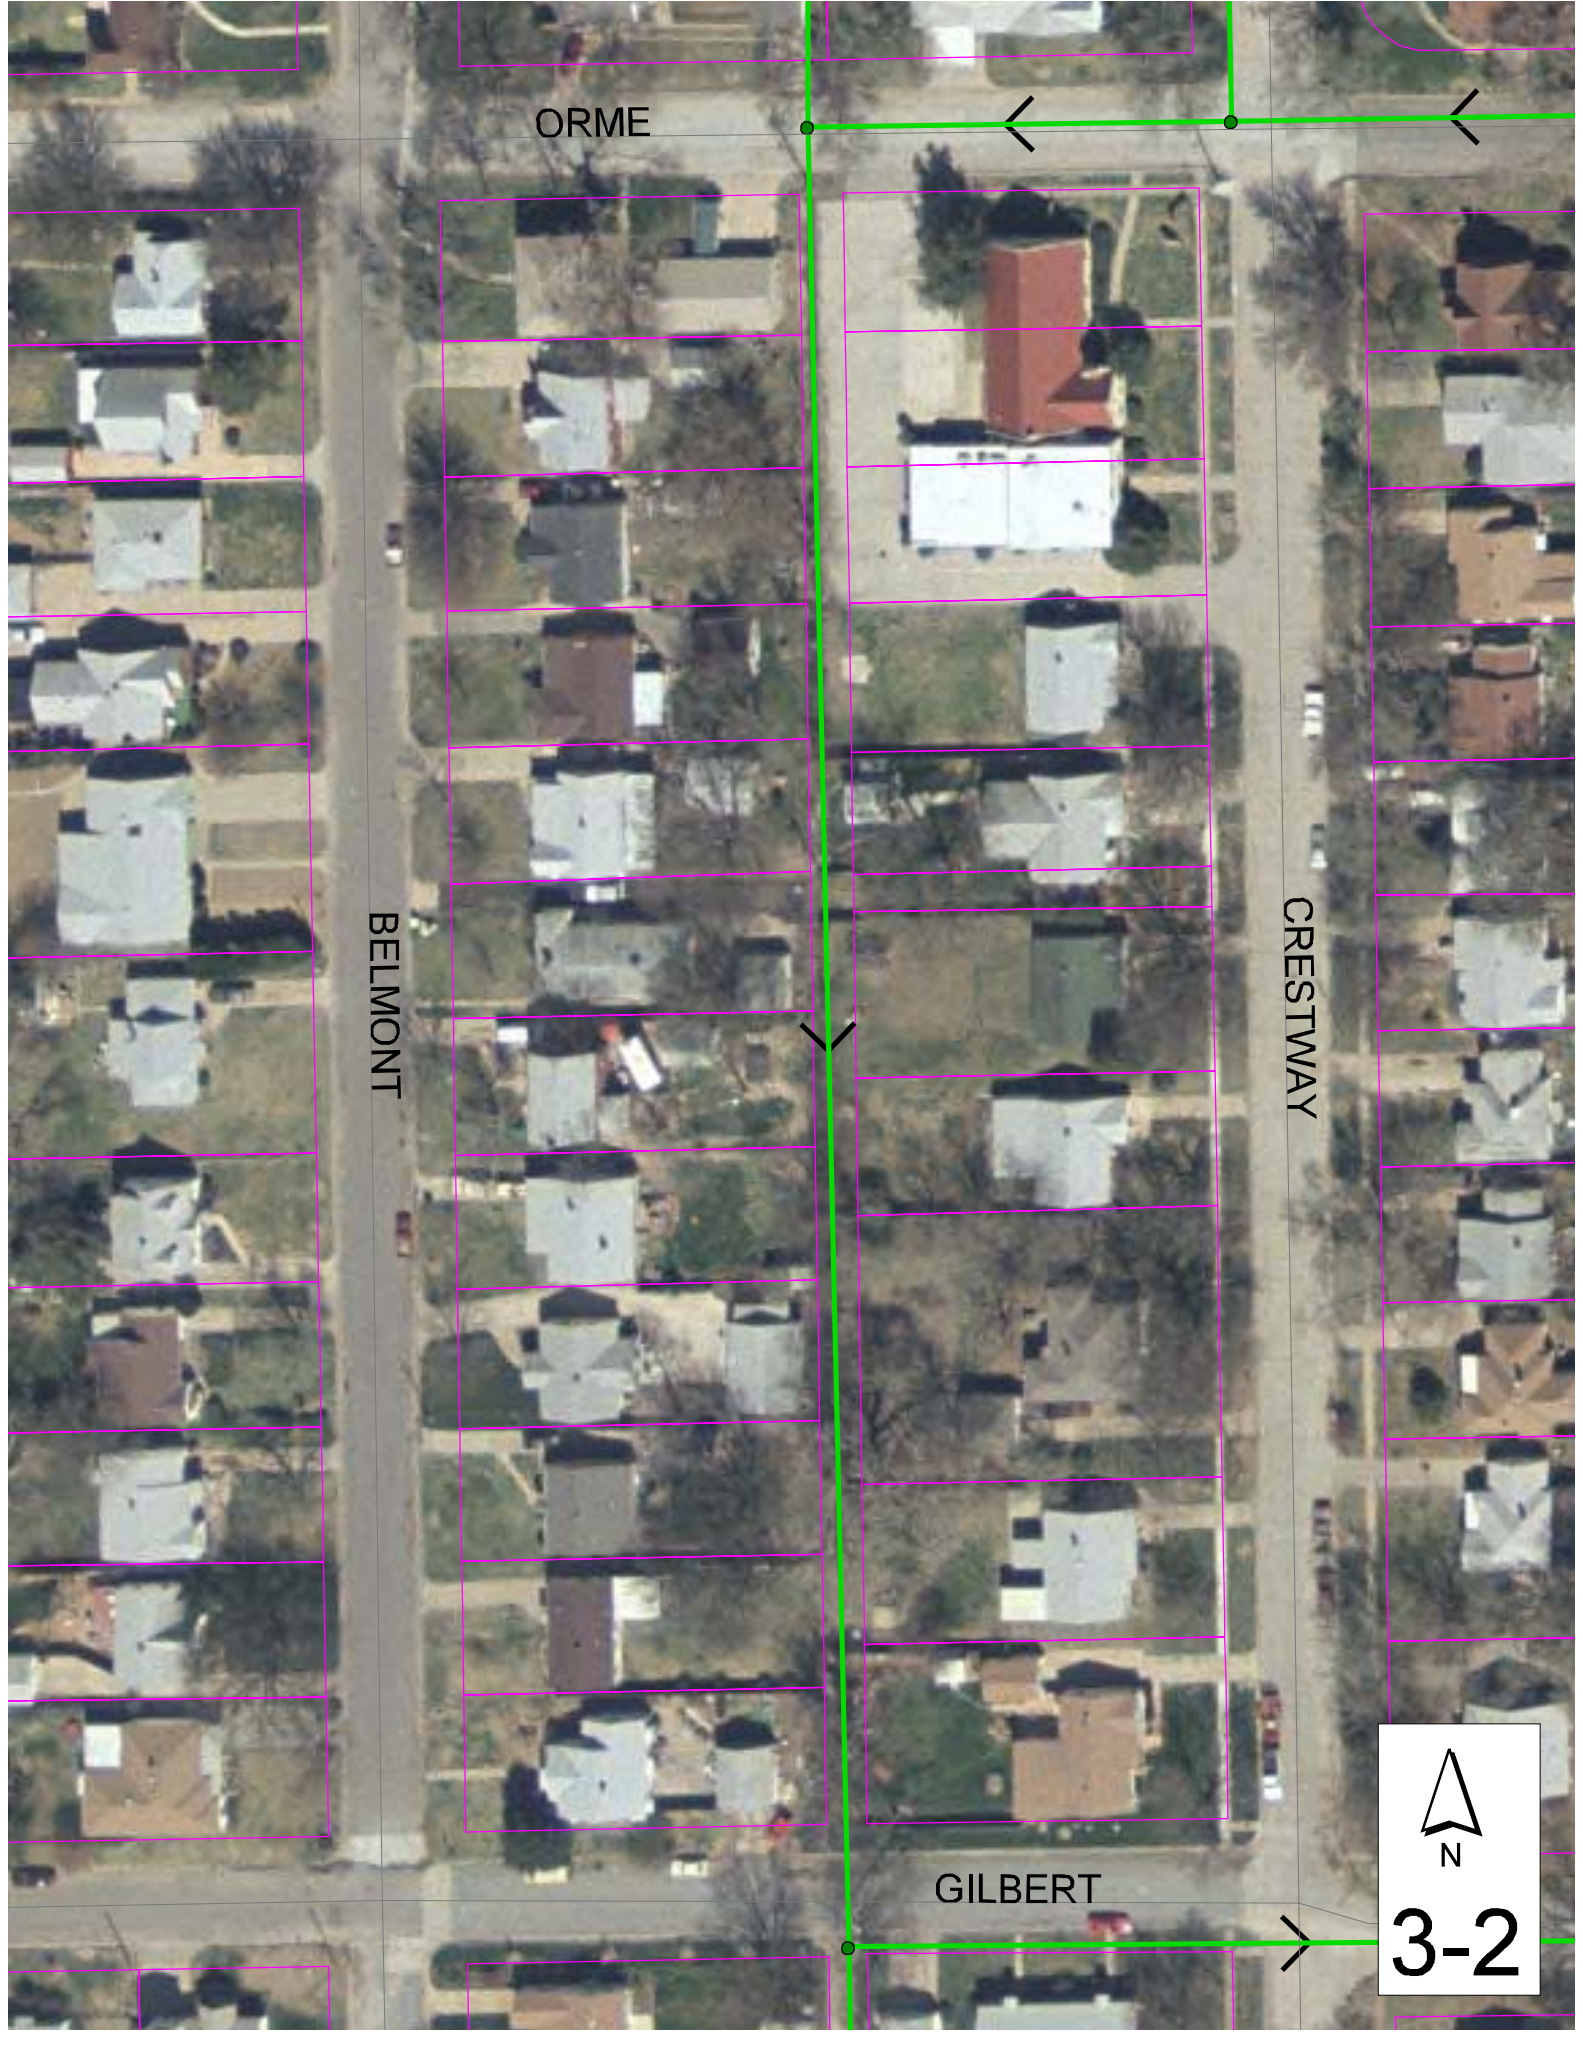
MH # 5746-427
Replace Manhole Frame & Cover
Rework Manhole Bench & Invert
Approx depth = 10.7 ft

MH # 5746-041
Construct Standard Manhole over existing
sanitary sewer line at approx. mid-block.

MH # 5746-426
Replace Manhole Frame & Cover
Rework Manhole Bench & Invert
Approx depth = 7.5 ft

Remove and replace 21 lf of Concrete Pavement

Remove and replace 671 lf of 10" pipe
from MH 5746-427 to MH 5746-426

Pipe Reaming or Pipe Bursting will be
allowed. Choosing either option will not
change the contract amount.

Remove and replace 31 lf of Asphalt Pavement
Remove and replace 4 lf of Concrete Approach (S)
