SITE 7

Television Inspection Master Report

US Manhole: 5749-022
DS Manhole: 5749-015

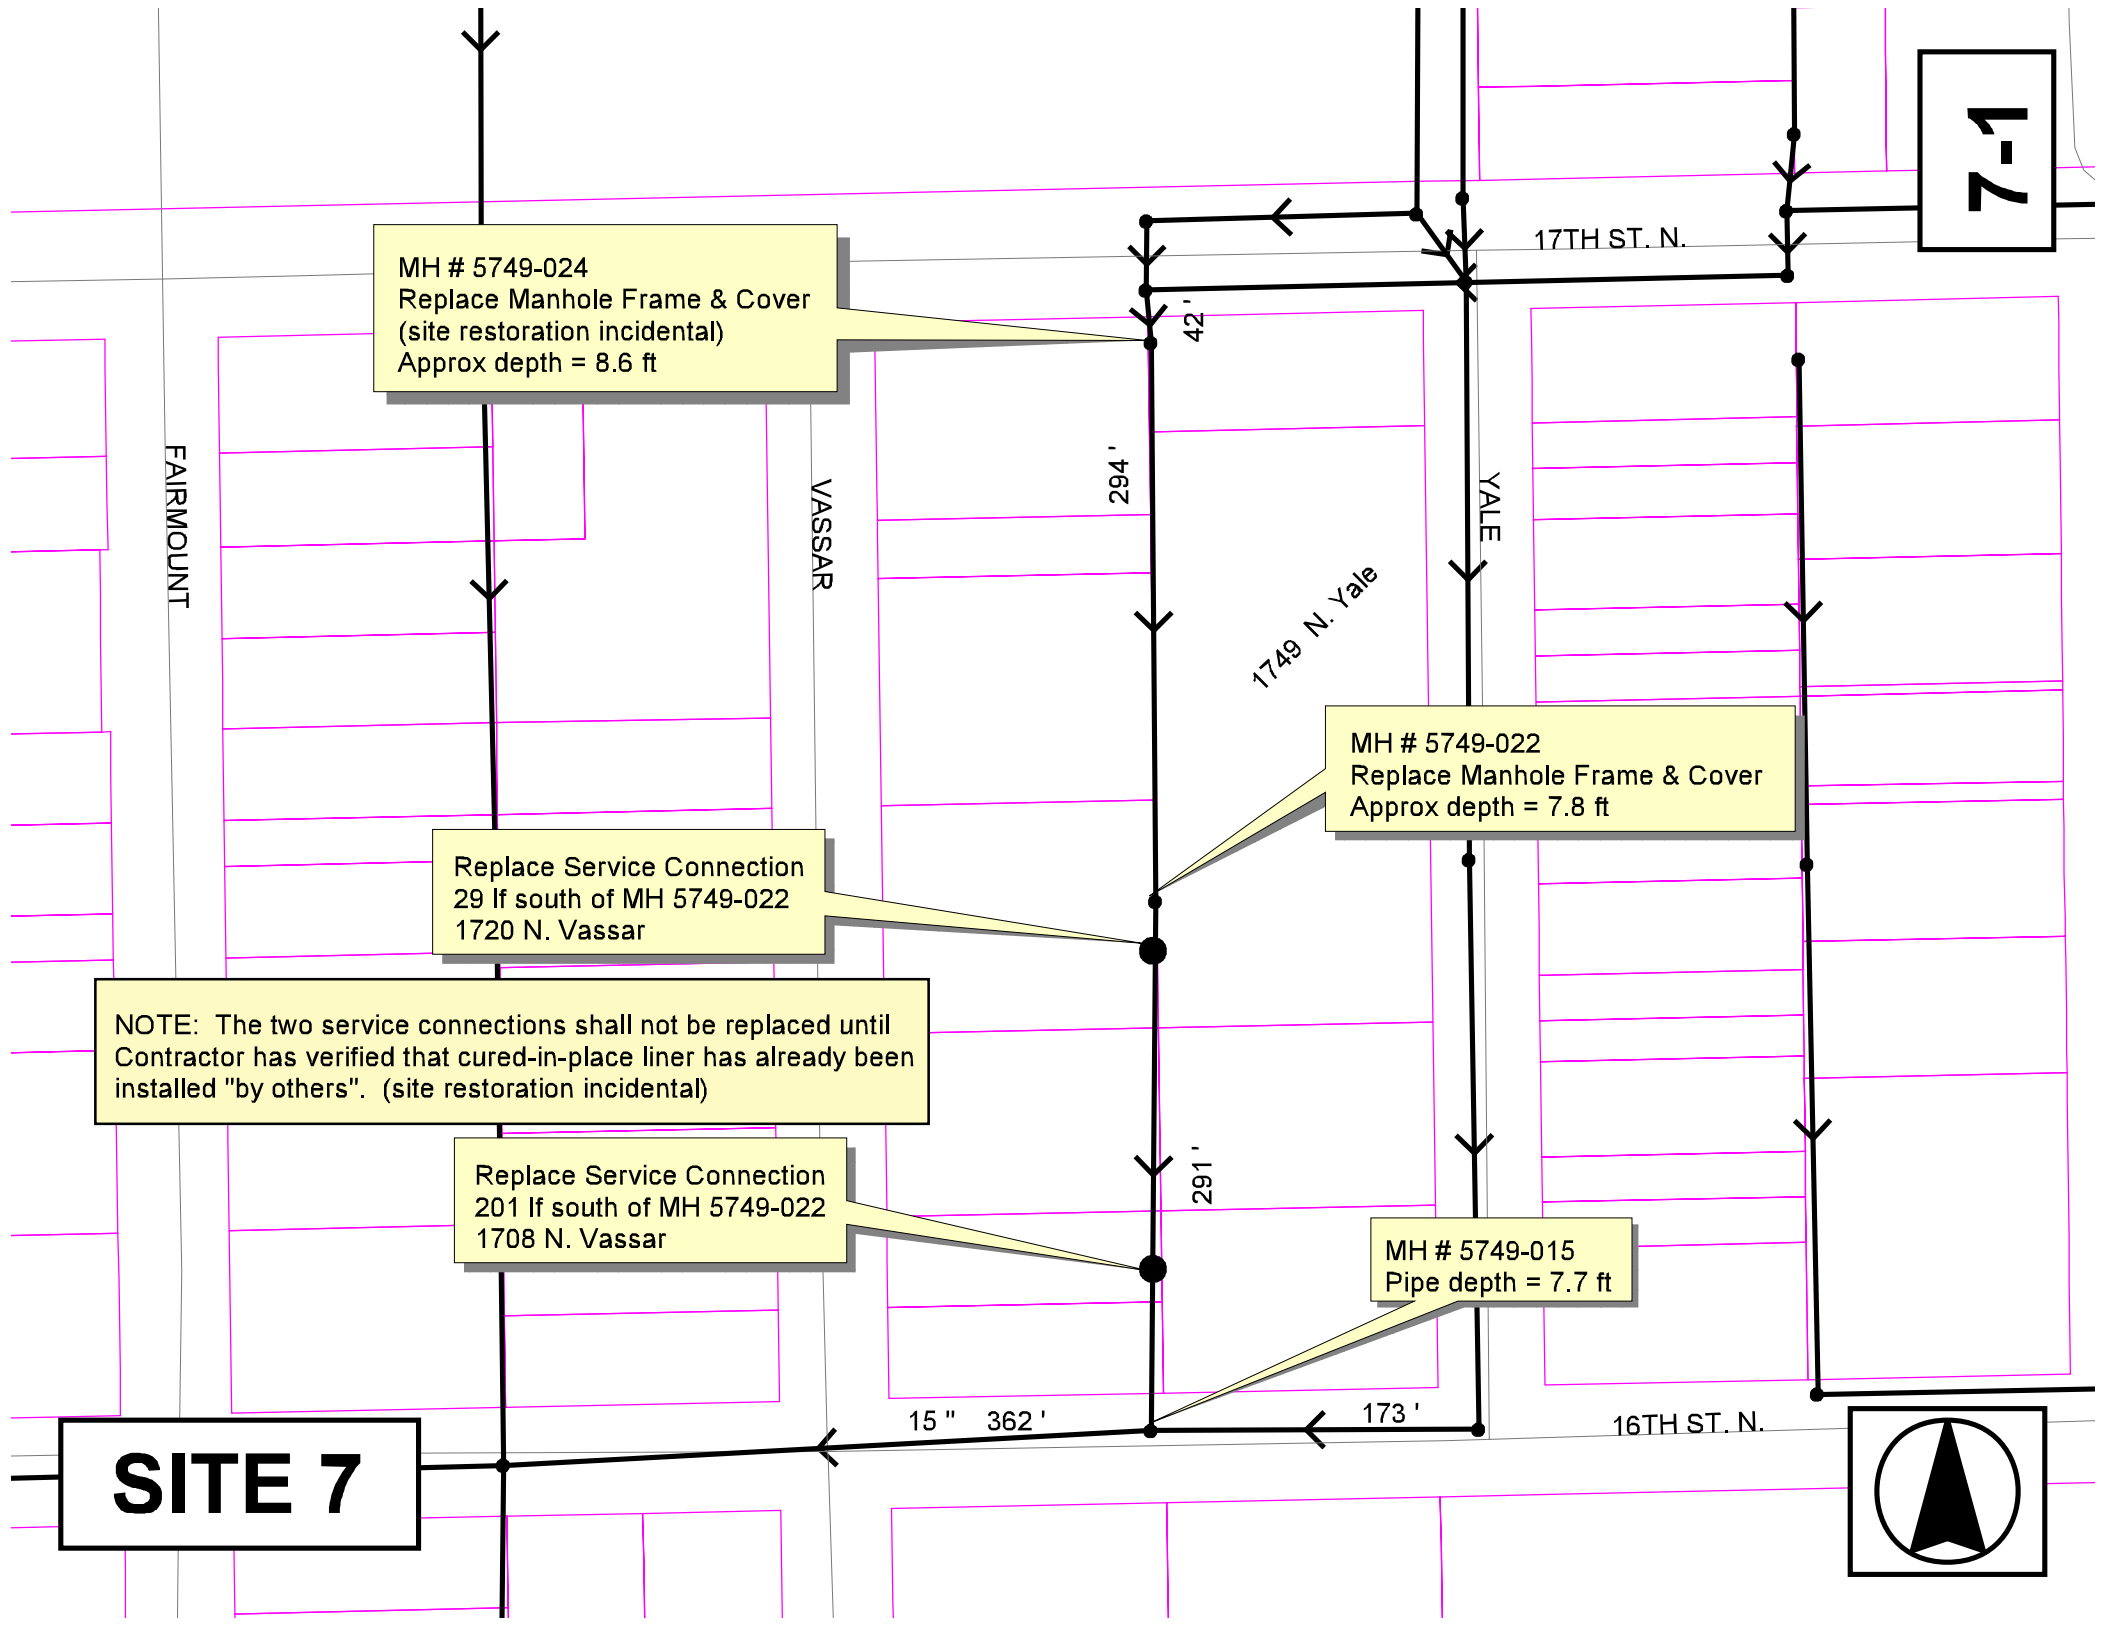
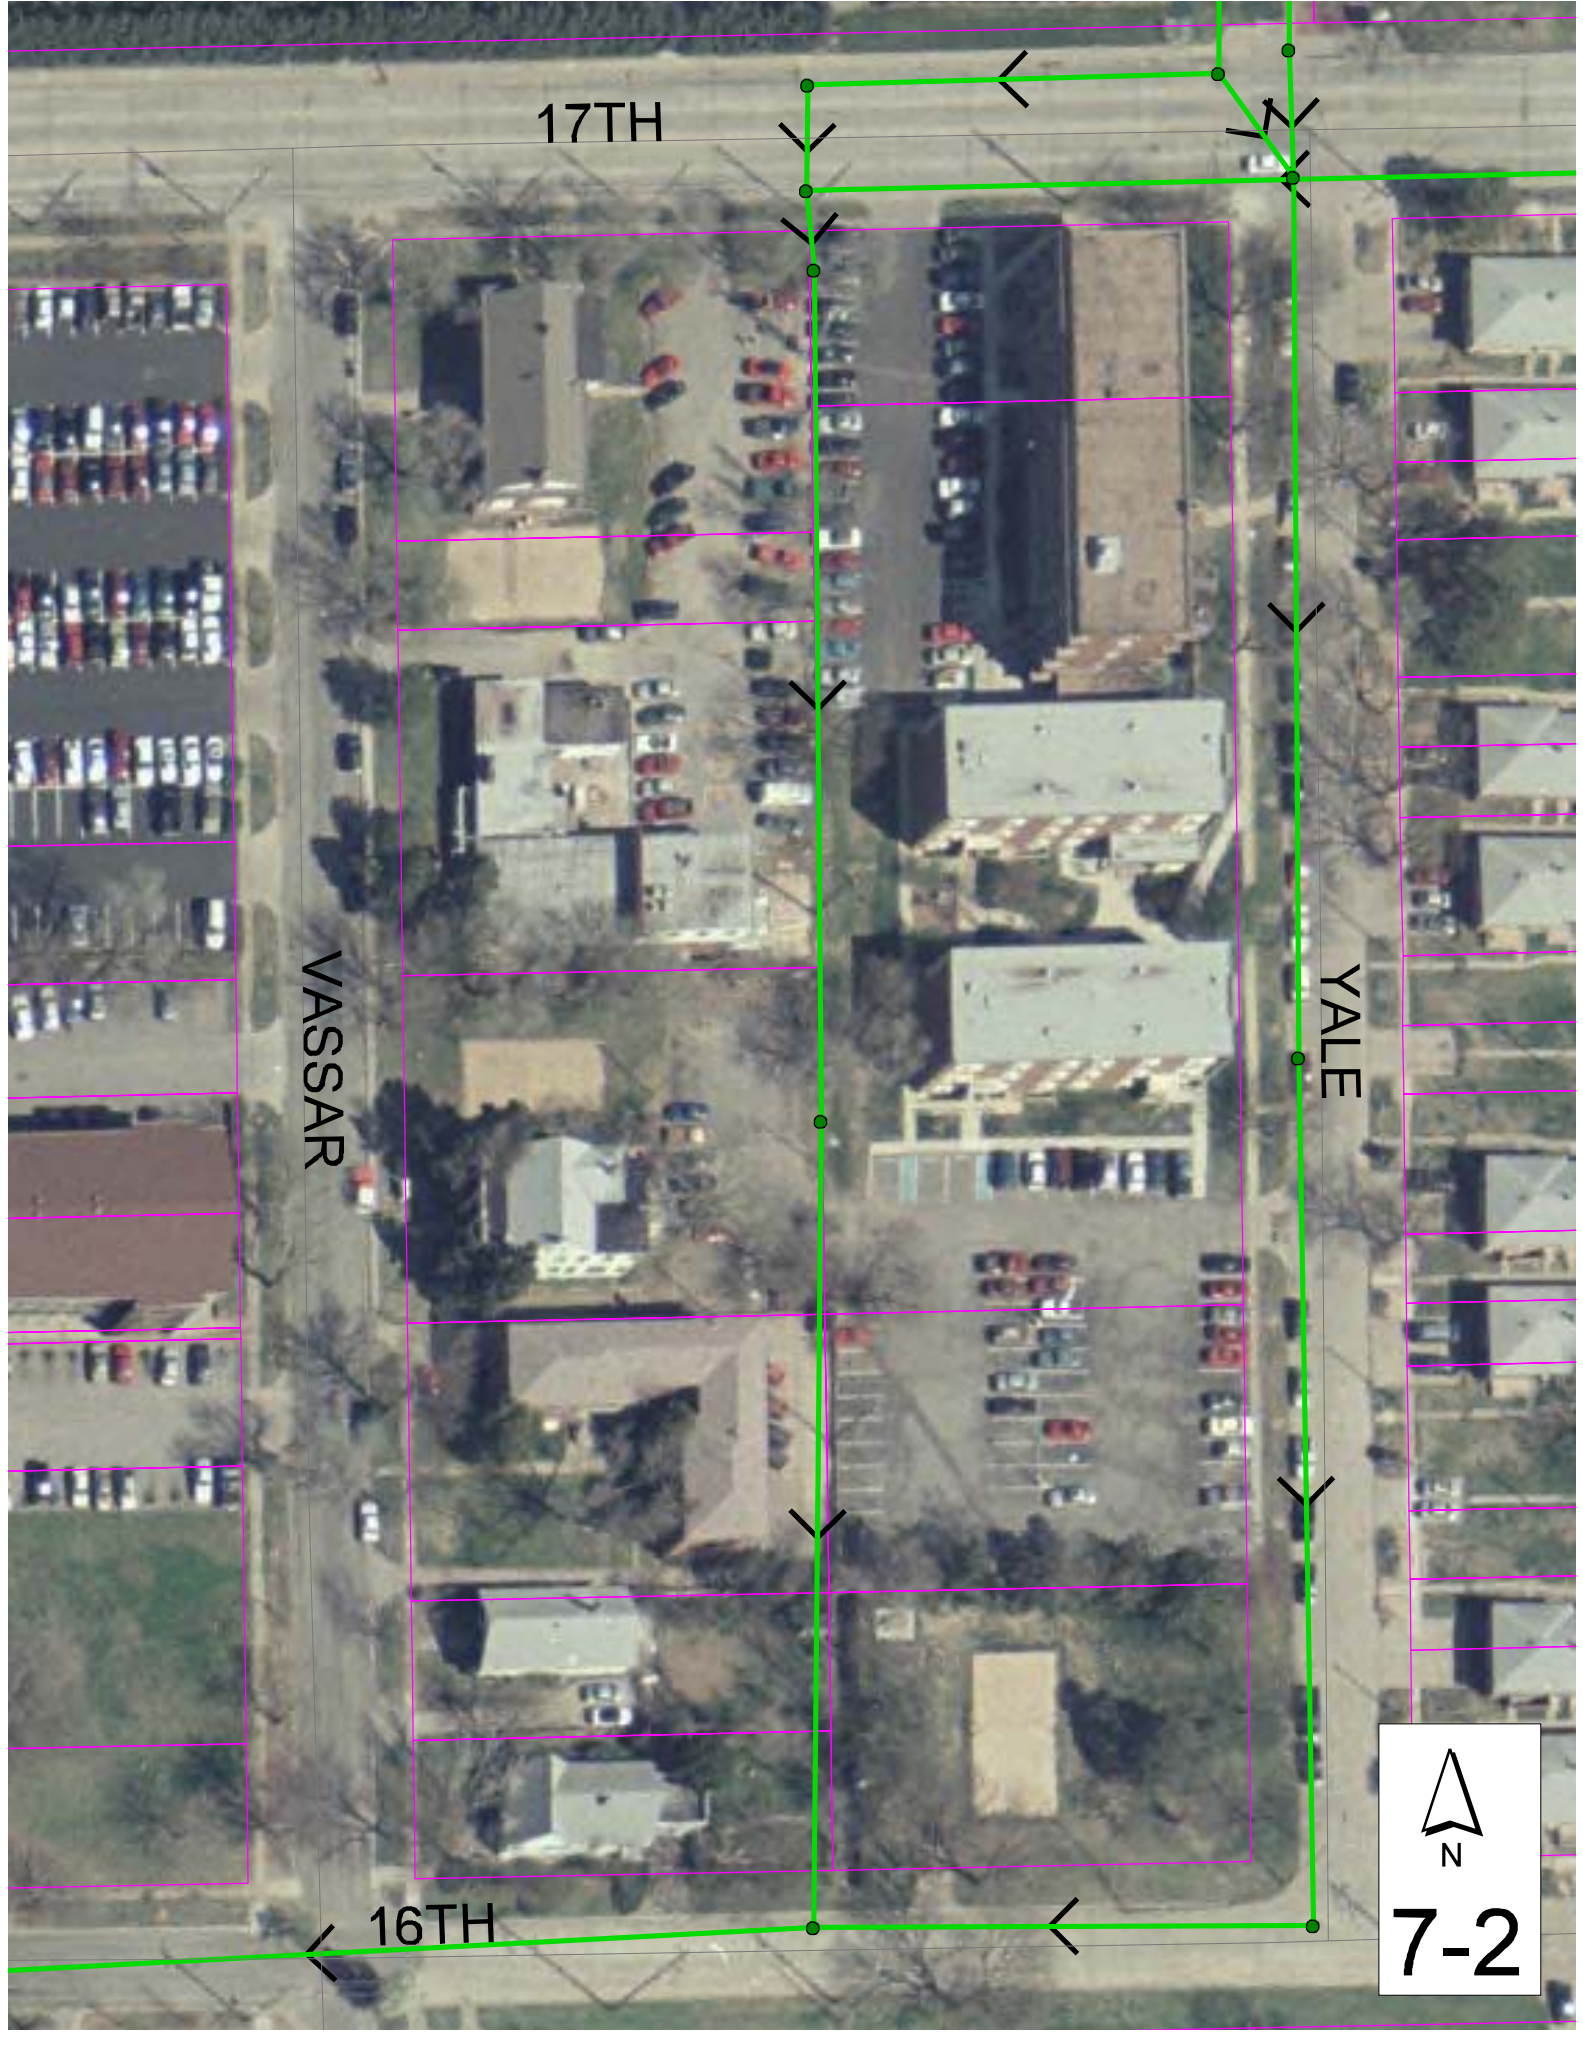
MH # 5749-024
Replace Manhole Frame & Cover
(site restoration incidental)
Approx depth = 8.6 ft

Replace Service Connection
29 If south of MH 5749-022
1720 N. Vassar

Replace Service Connection
201 If south of MH 5749-022
1708 N. Vassar

MH # 5749-022
Replace Manhole Frame & Cover
Approx depth = 7.8 ft

NOTE: The two service connections shall not be replaced until Contractor has verified that cured-in-place liner has already been installed "by others". (site restoration incidental)

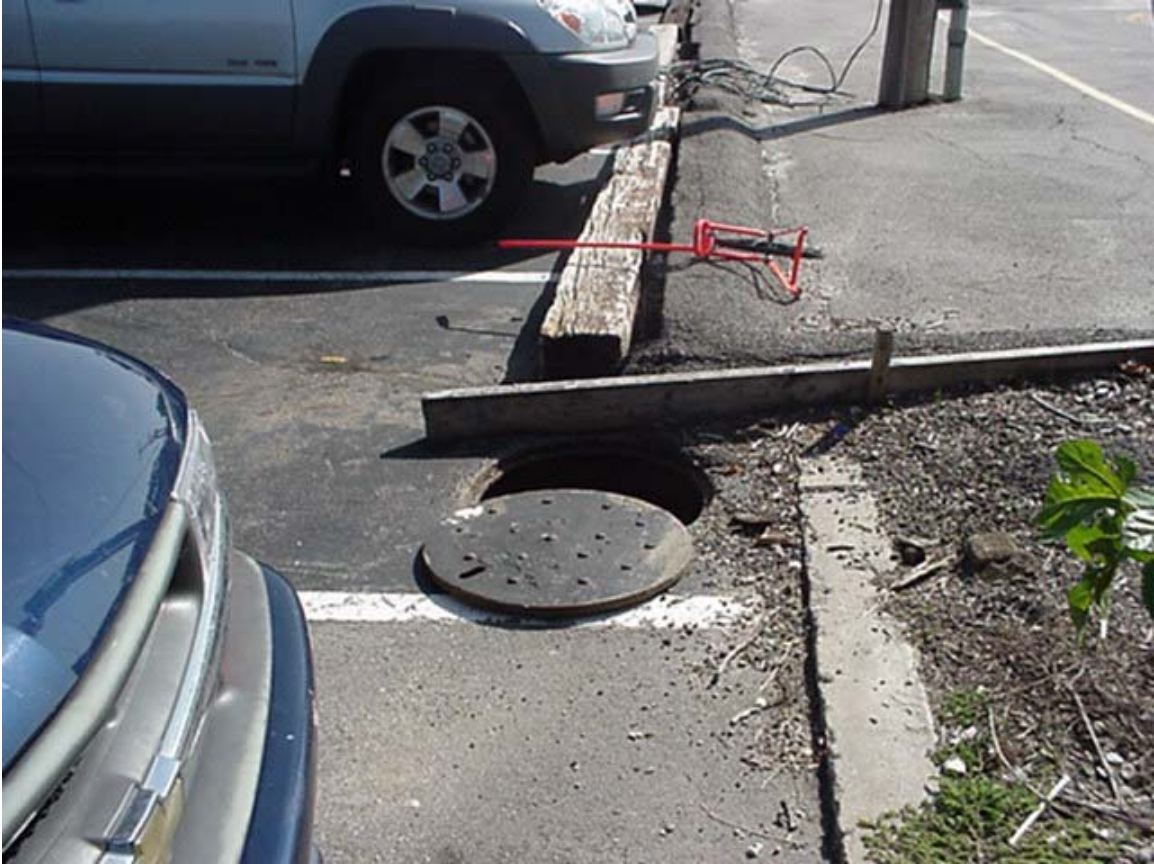
I'm looking south at MH 5749-024. The manhole needs a new Frame & Cover.
All site restoration, including asphalt removal and replacement, shall be incidental to the manhole work.

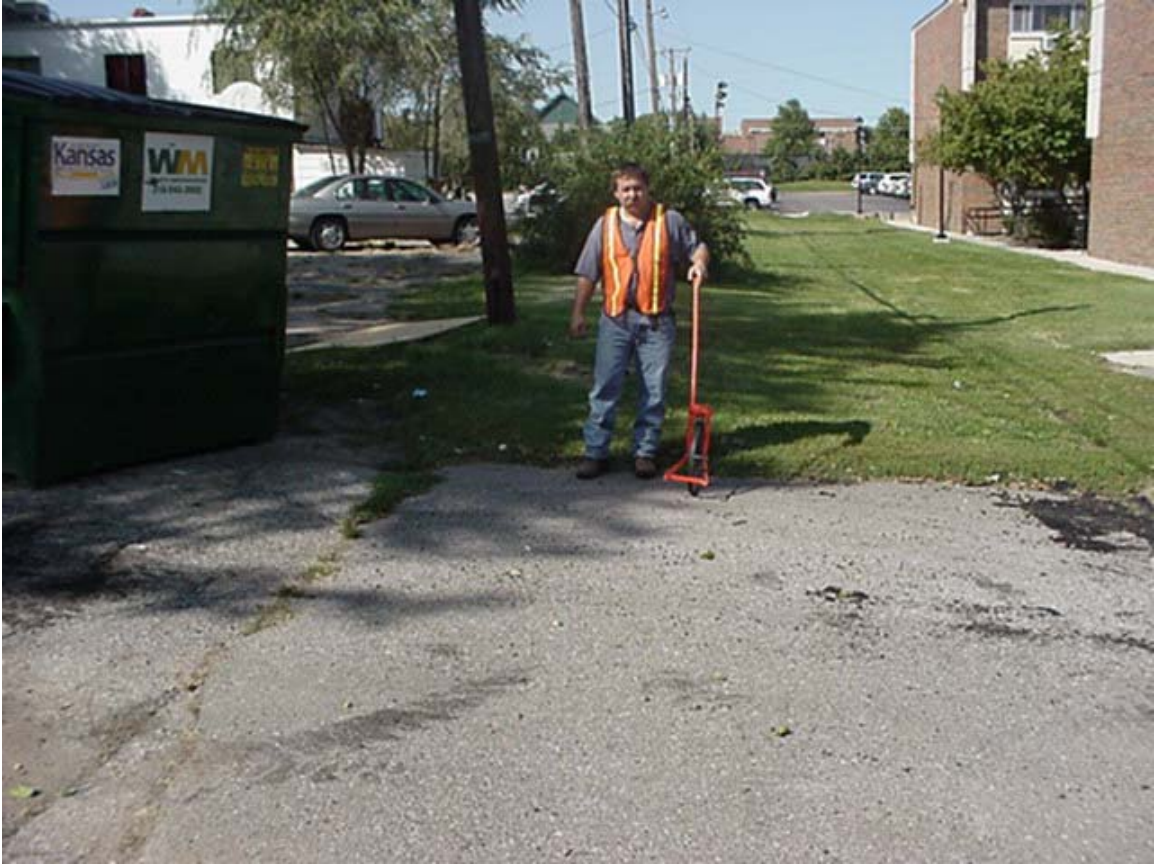
The west service connection at 29 1/2 south of MH 5749-022 measures out to be the north edge of an asphalt drive. Any asphalt removal and replacement shall be incidental to the replacement of the service connection.

I'm looking north, toward Greg standing at the point of the service connection.

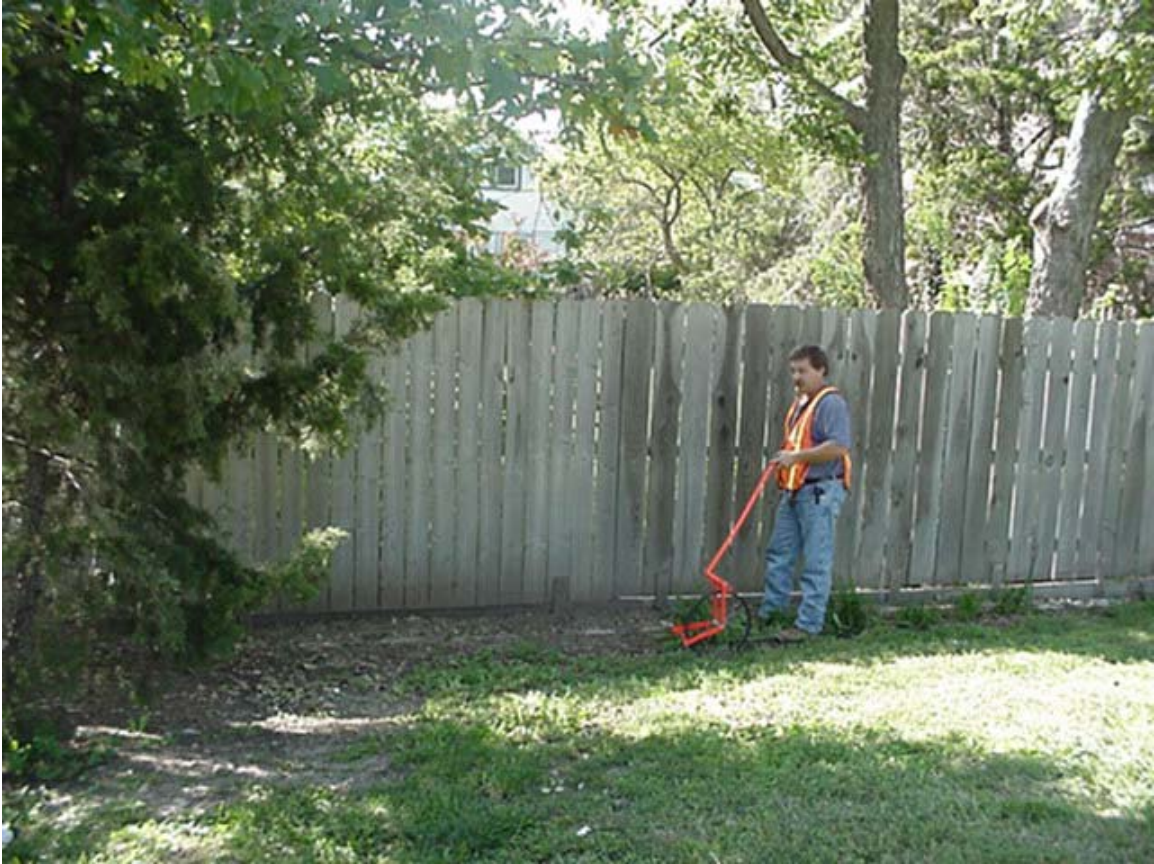
The service connection at 201 lf south of MH 5749-022 is in an open area, on the other side of this fence.
