# Television Inspection Master Report

US Manhole: 5446-114  
DS Manhole: 5446-108

413 S SYCAMORE ST  
417 S OAK ST

Date Insp: 2/20/2003

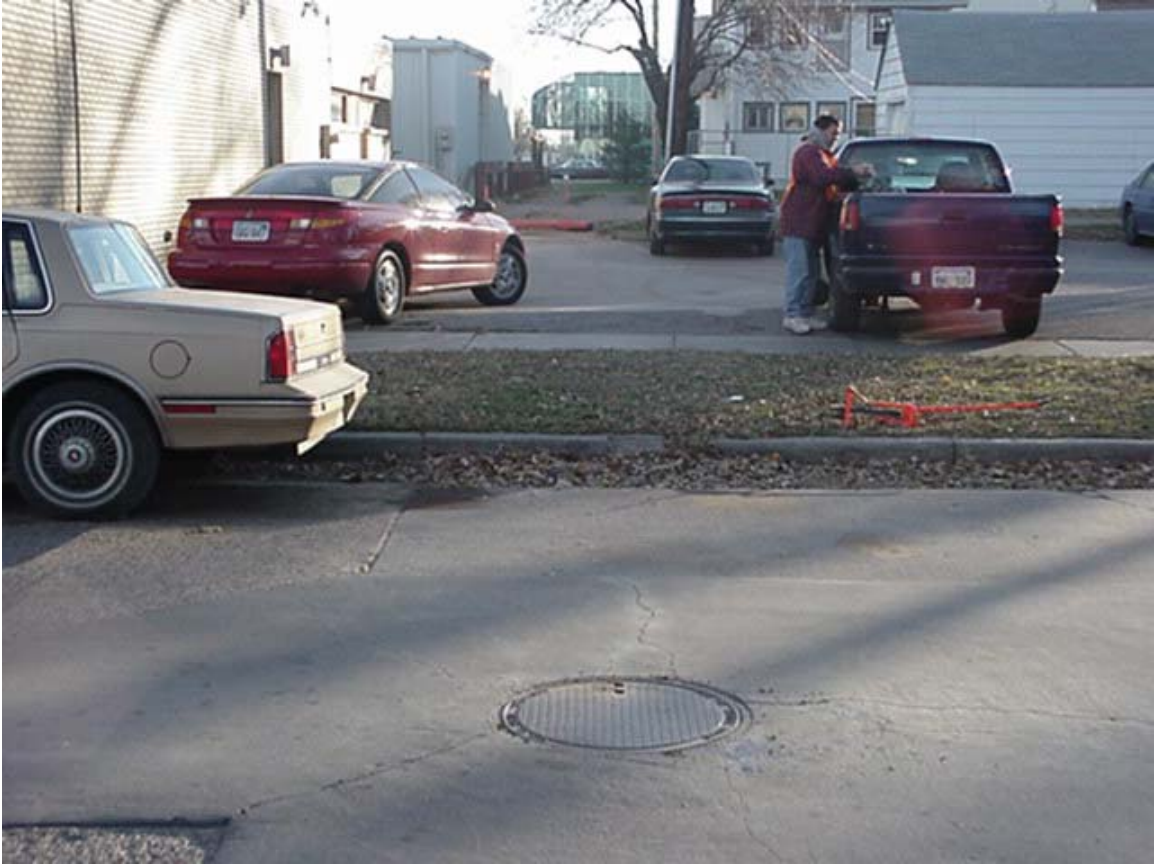
Standing in Oak Street, west of MH 5446-108, looking east
