**SITE 2**

# Television Inspection Master Report

US Manhole: 5947-093  
DS Manhole: 5947-090

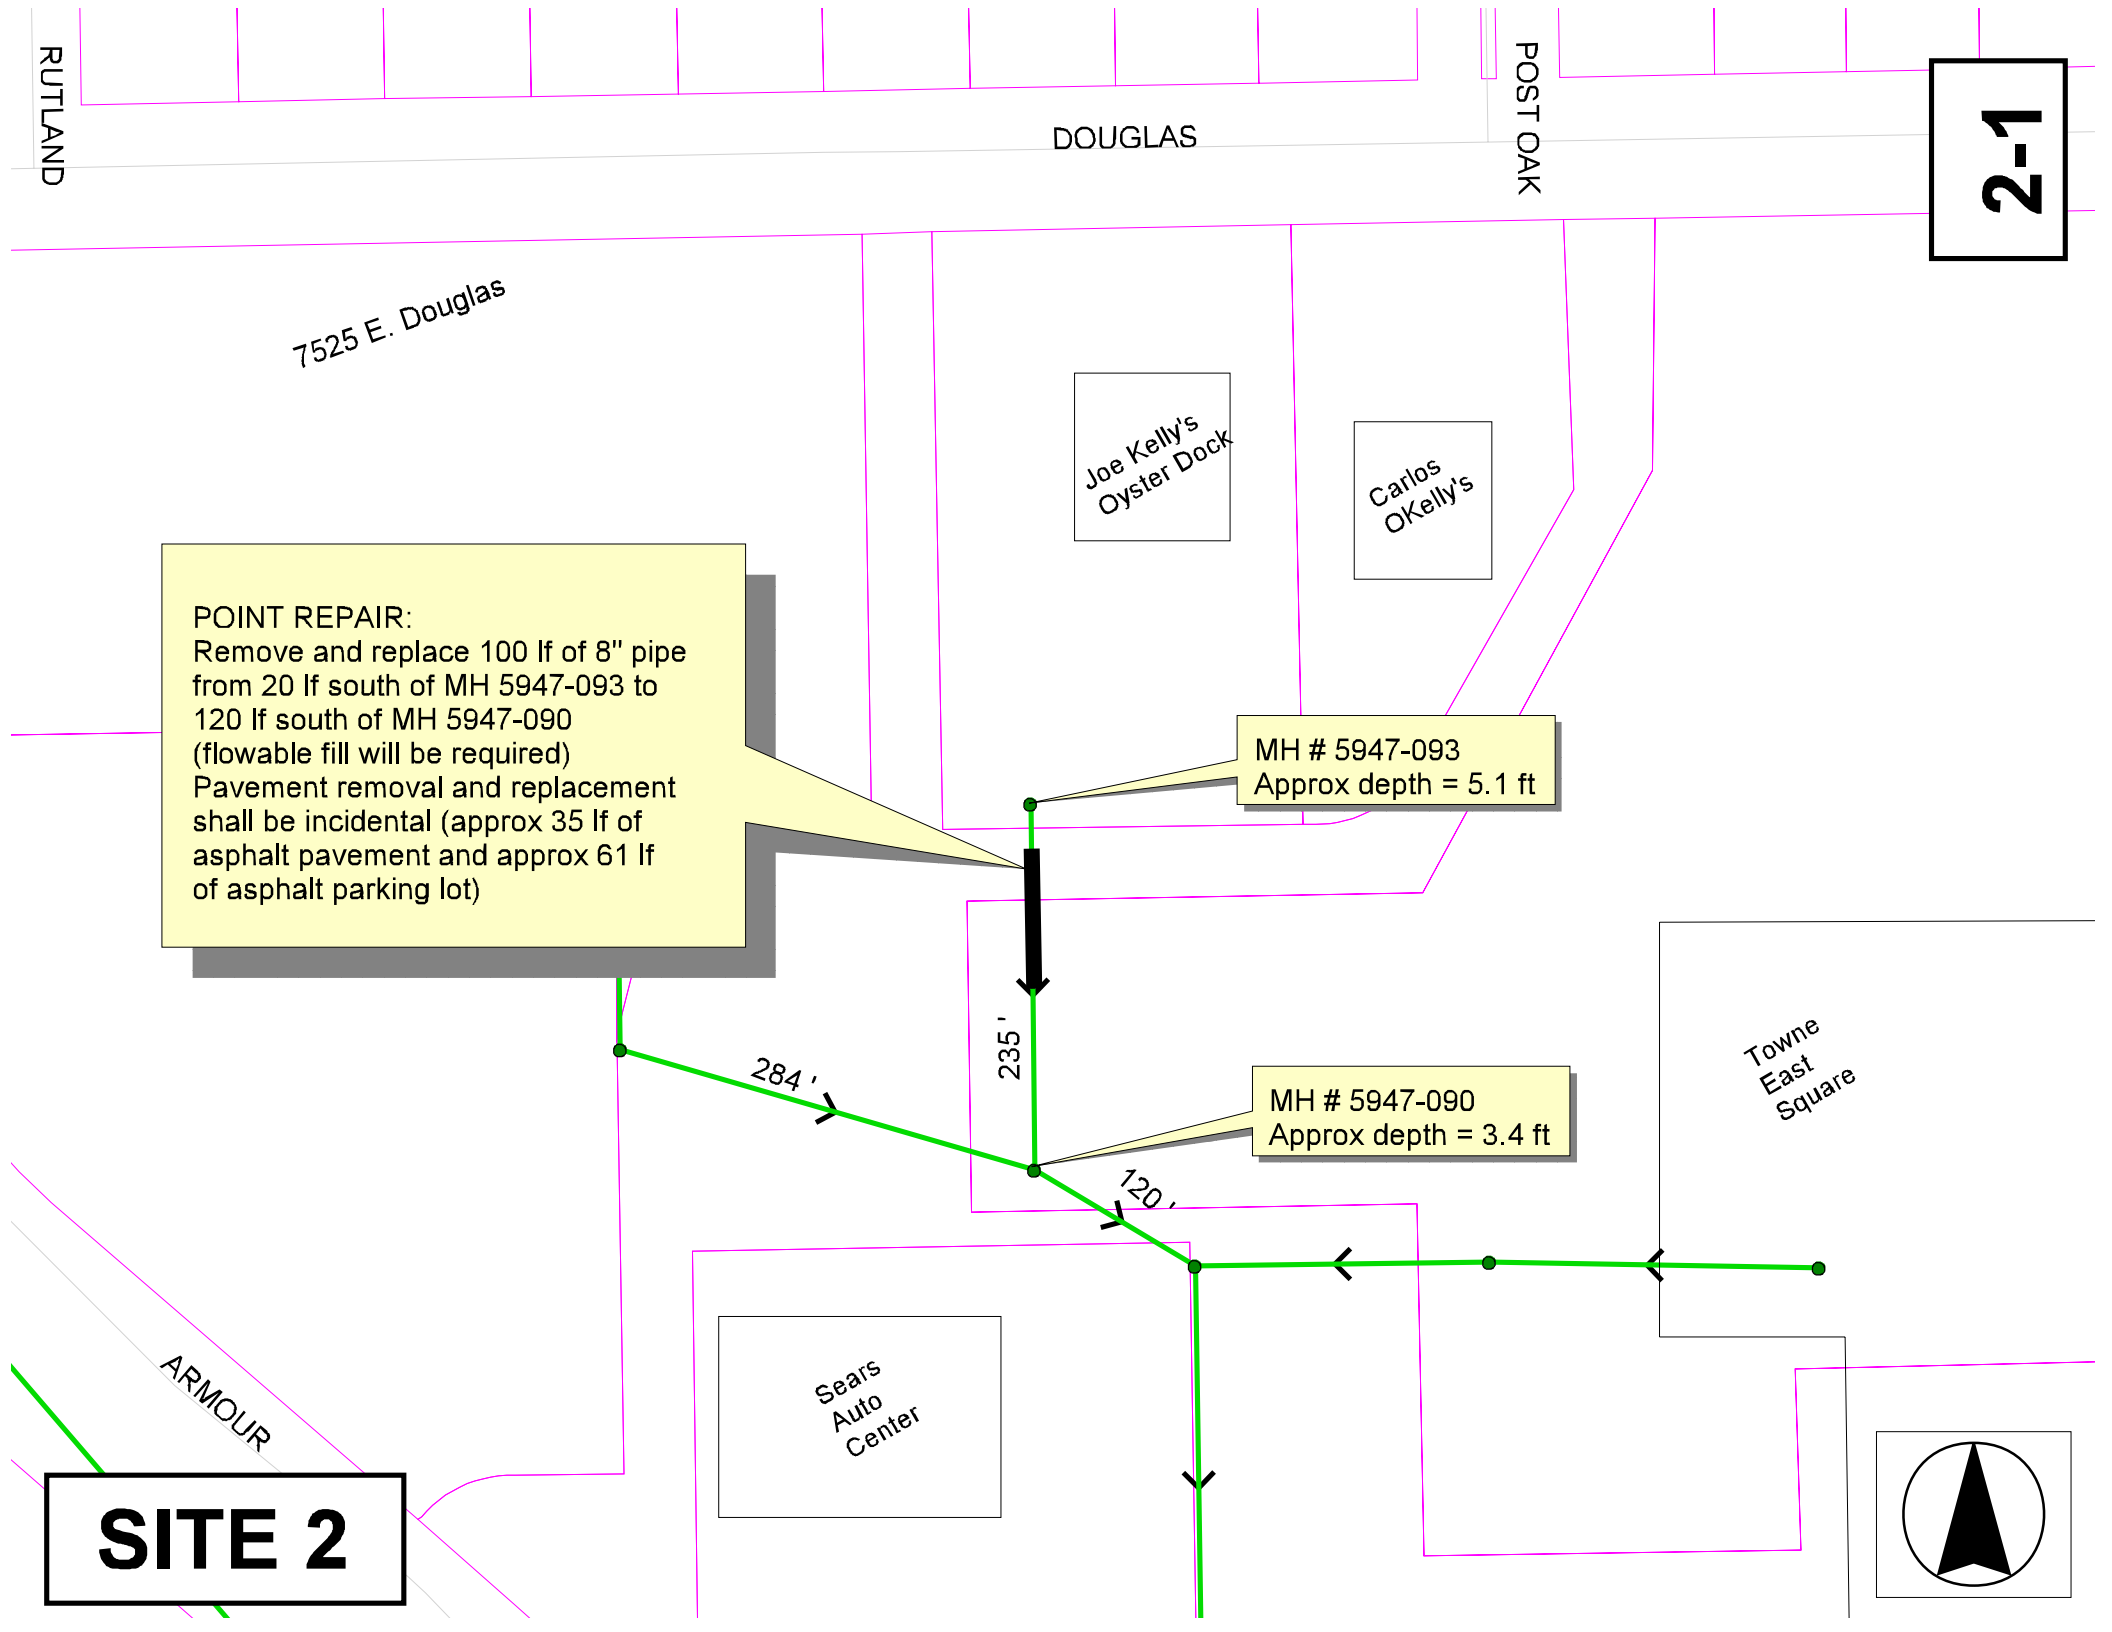
MH # 5947-093  
 Approx depth = 5.1 ft

MH # 5947-090  
 Approx depth = 3.4 ft

**POINT REPAIR:**  
 Remove and replace 100 lf of 8" pipe  
 from 20 lf south of MH 5947-093 to  
 120 lf south of MH 5947-090  
 (flowable fill will be required)  
 Pavement removal and replacement  
 shall be incidental (approx 35 lf of  
 asphalt pavement and approx 61 lf  
 of asphalt parking lot)

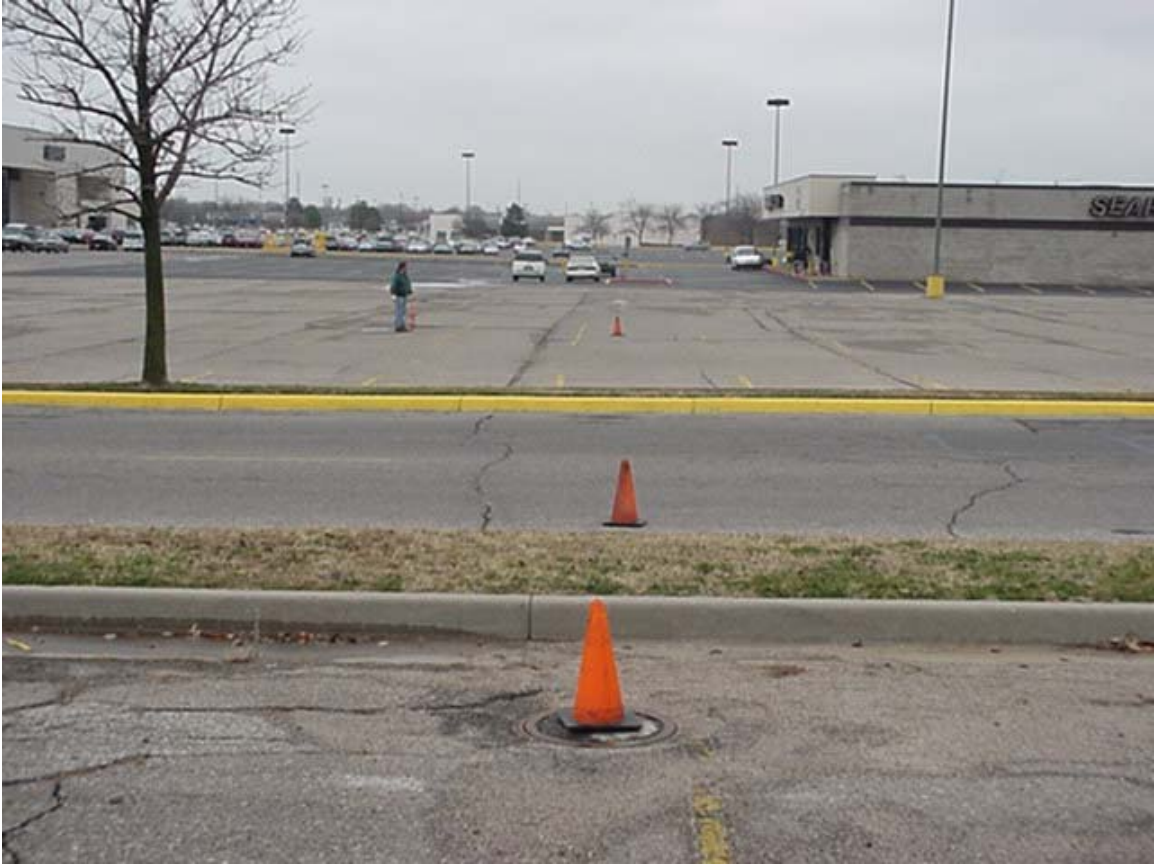
The 100' sag is a maintenance problem. Need to replace the pipe to correct the grade.

Standing north of MH 5947-093, looking south. The closest cone is sitting on MH 5947-093.

The second cone is sitting at 20 lf south of MH 5947-093 (begin repair).  
The third cone is sitting at 120 lf south of MH 5947-093 (end repair).

Flowable fill will be required due to the pipe depth.
