Television Inspection Master Report

US Manhole: 5747-139
DS Manhole: 5747-137

3833 E 2ND ST
216 N QUENTIN AVE

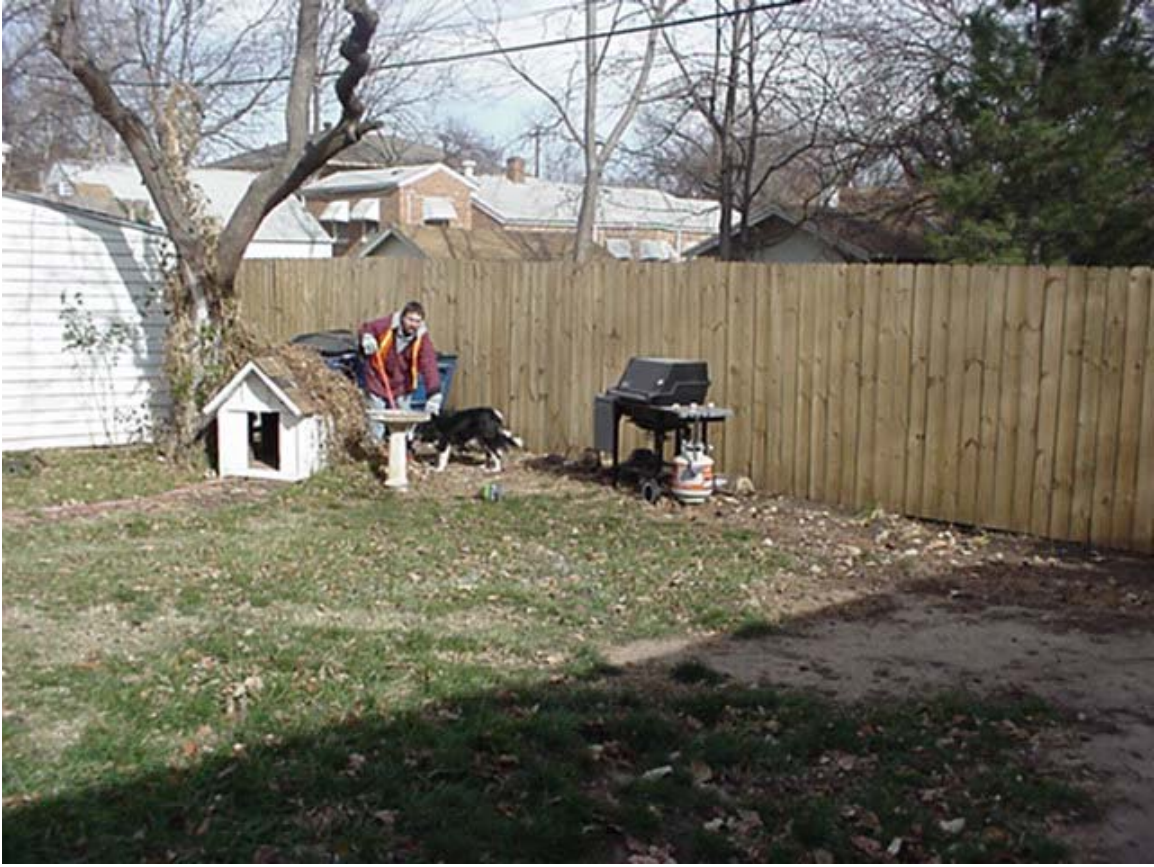
**POINT REPAIR NEEDS TO BE MADE AT 45' to 58' FEET S OF M.H. # 135
(see picture)**

In the back yard of 150 N. Quentin. The point repair would start where Greg is standing, and move south toward the cooker. Sewer line is located in this yard, and there is nothing in the way on the other side of the fence.
