Install 250 lf of 8" Cured-in-Place Liner

SITE 1

Television Inspection Master Report

US Manhole: 6048-246
DS Manhole: 6048-245

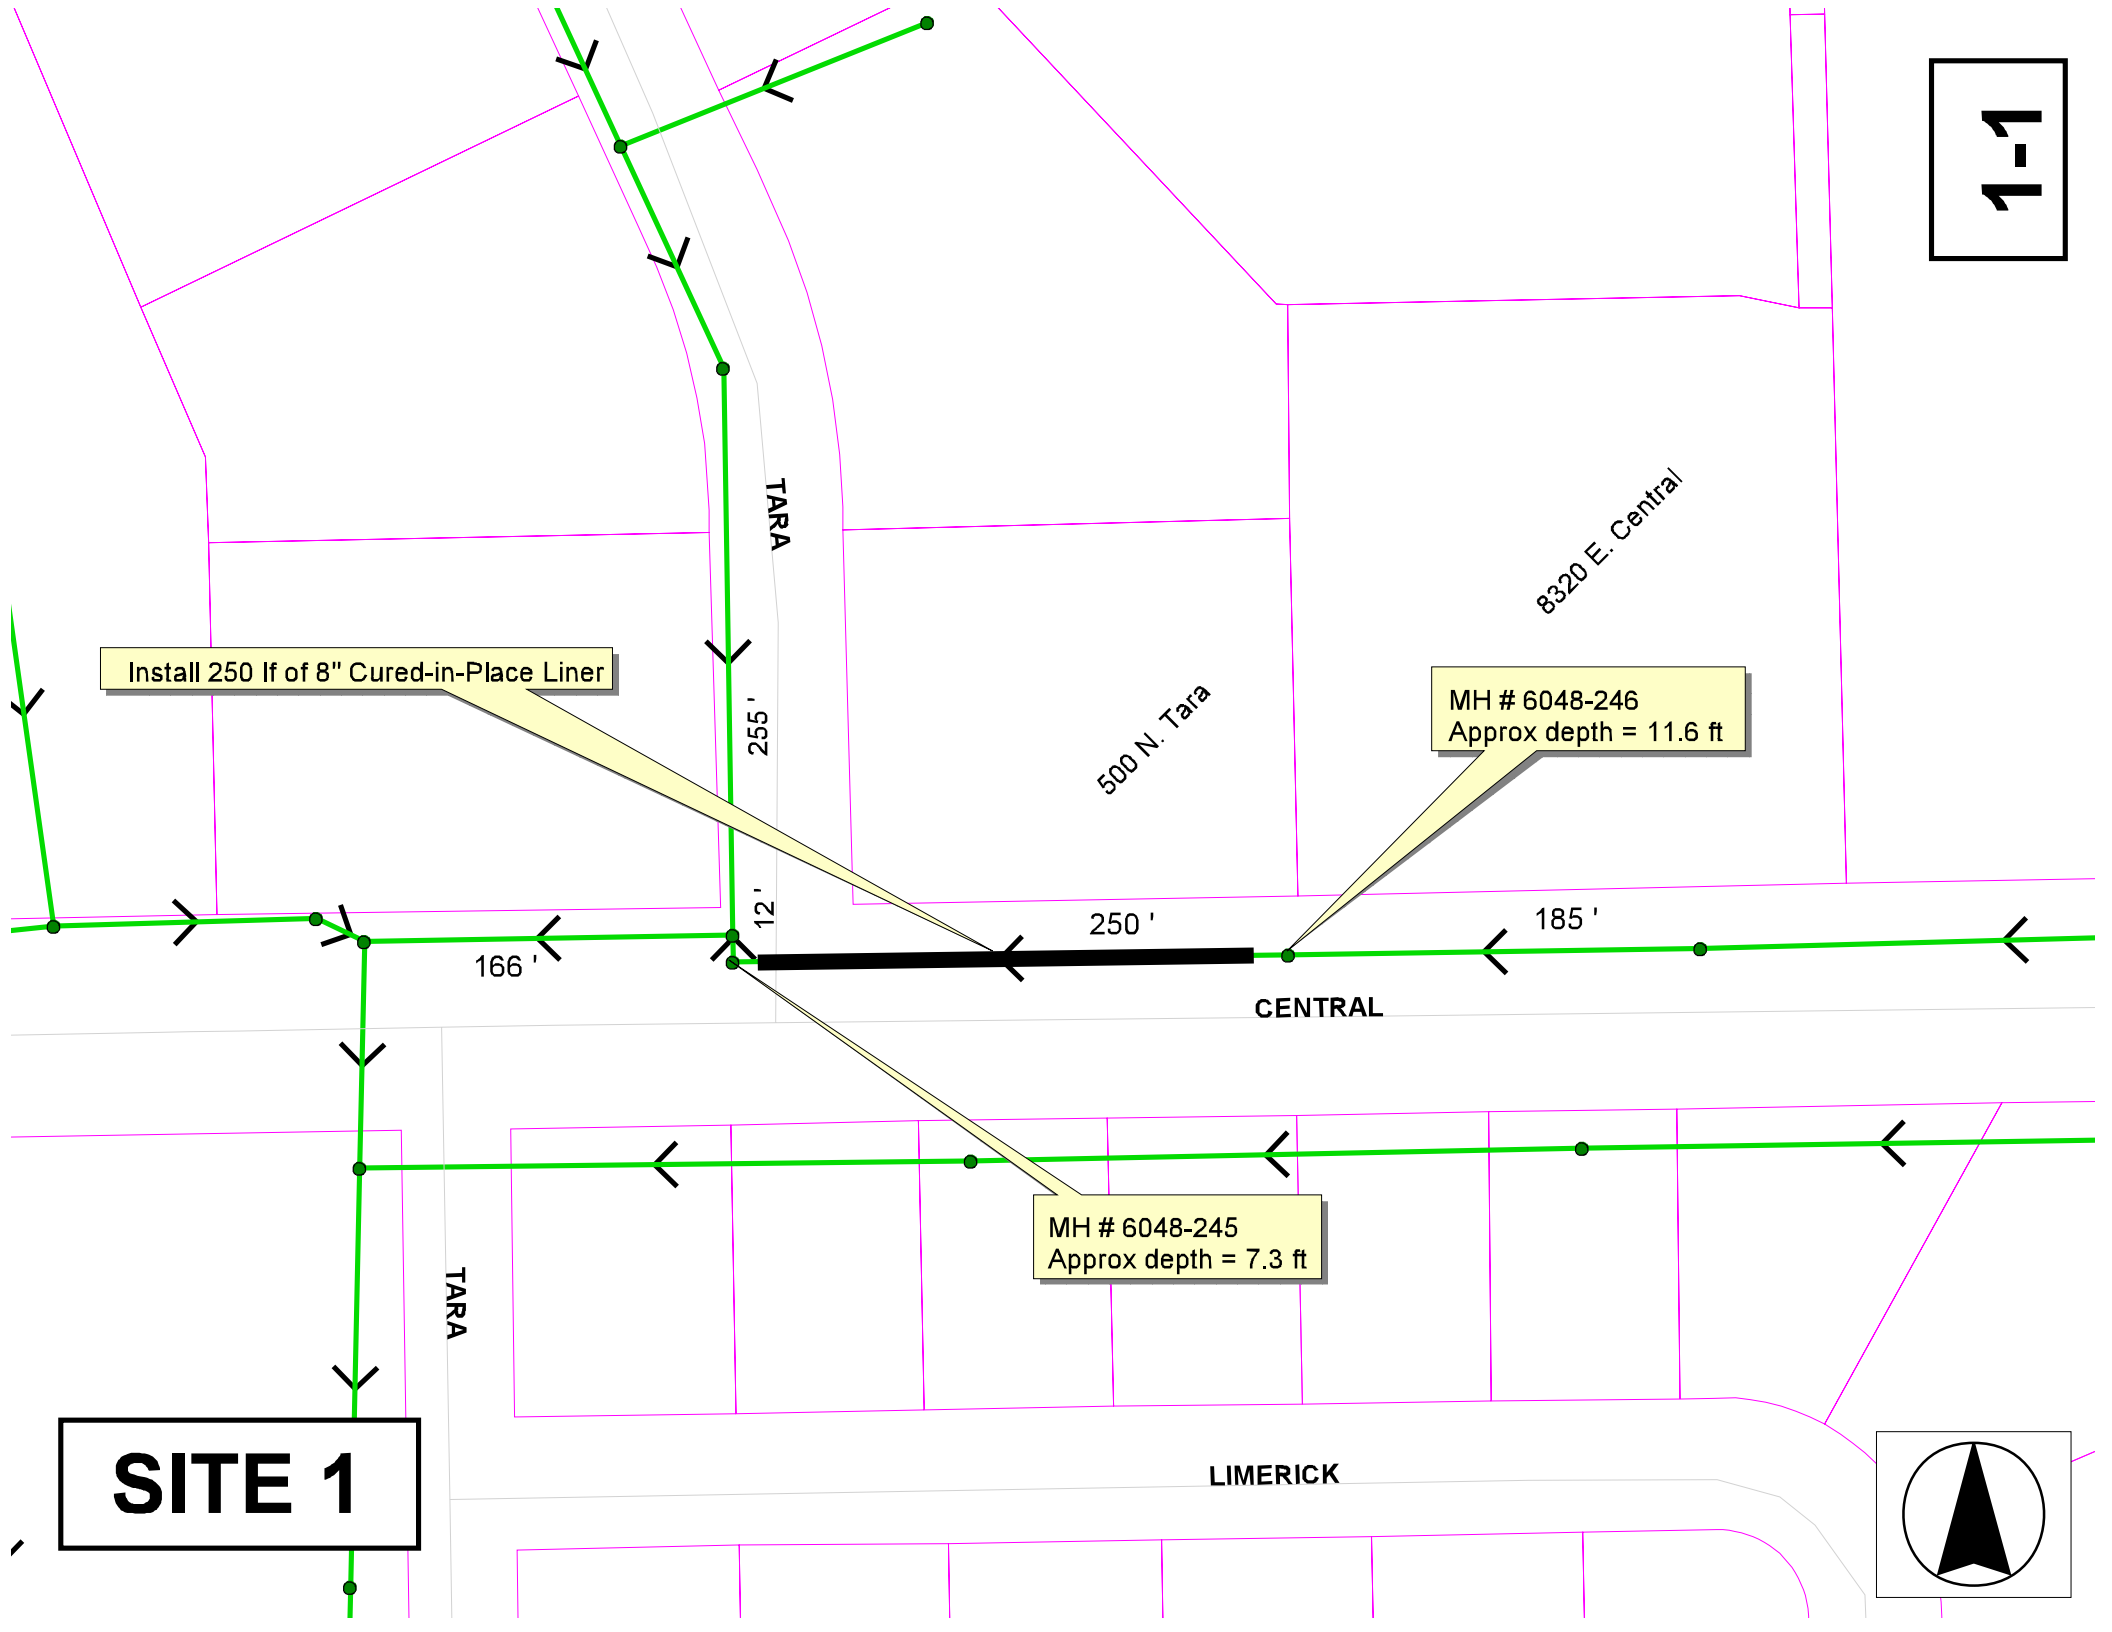
MH # 6048-246
Approx depth = 11.6 ft

MH # 6048-245
Approx depth = 7.3 ft
