Install 1572 lf of 15" Cured-in-Place Liner
from MH 6047-042 to MH 6047-039

SITE 5

Television Inspection Master Report

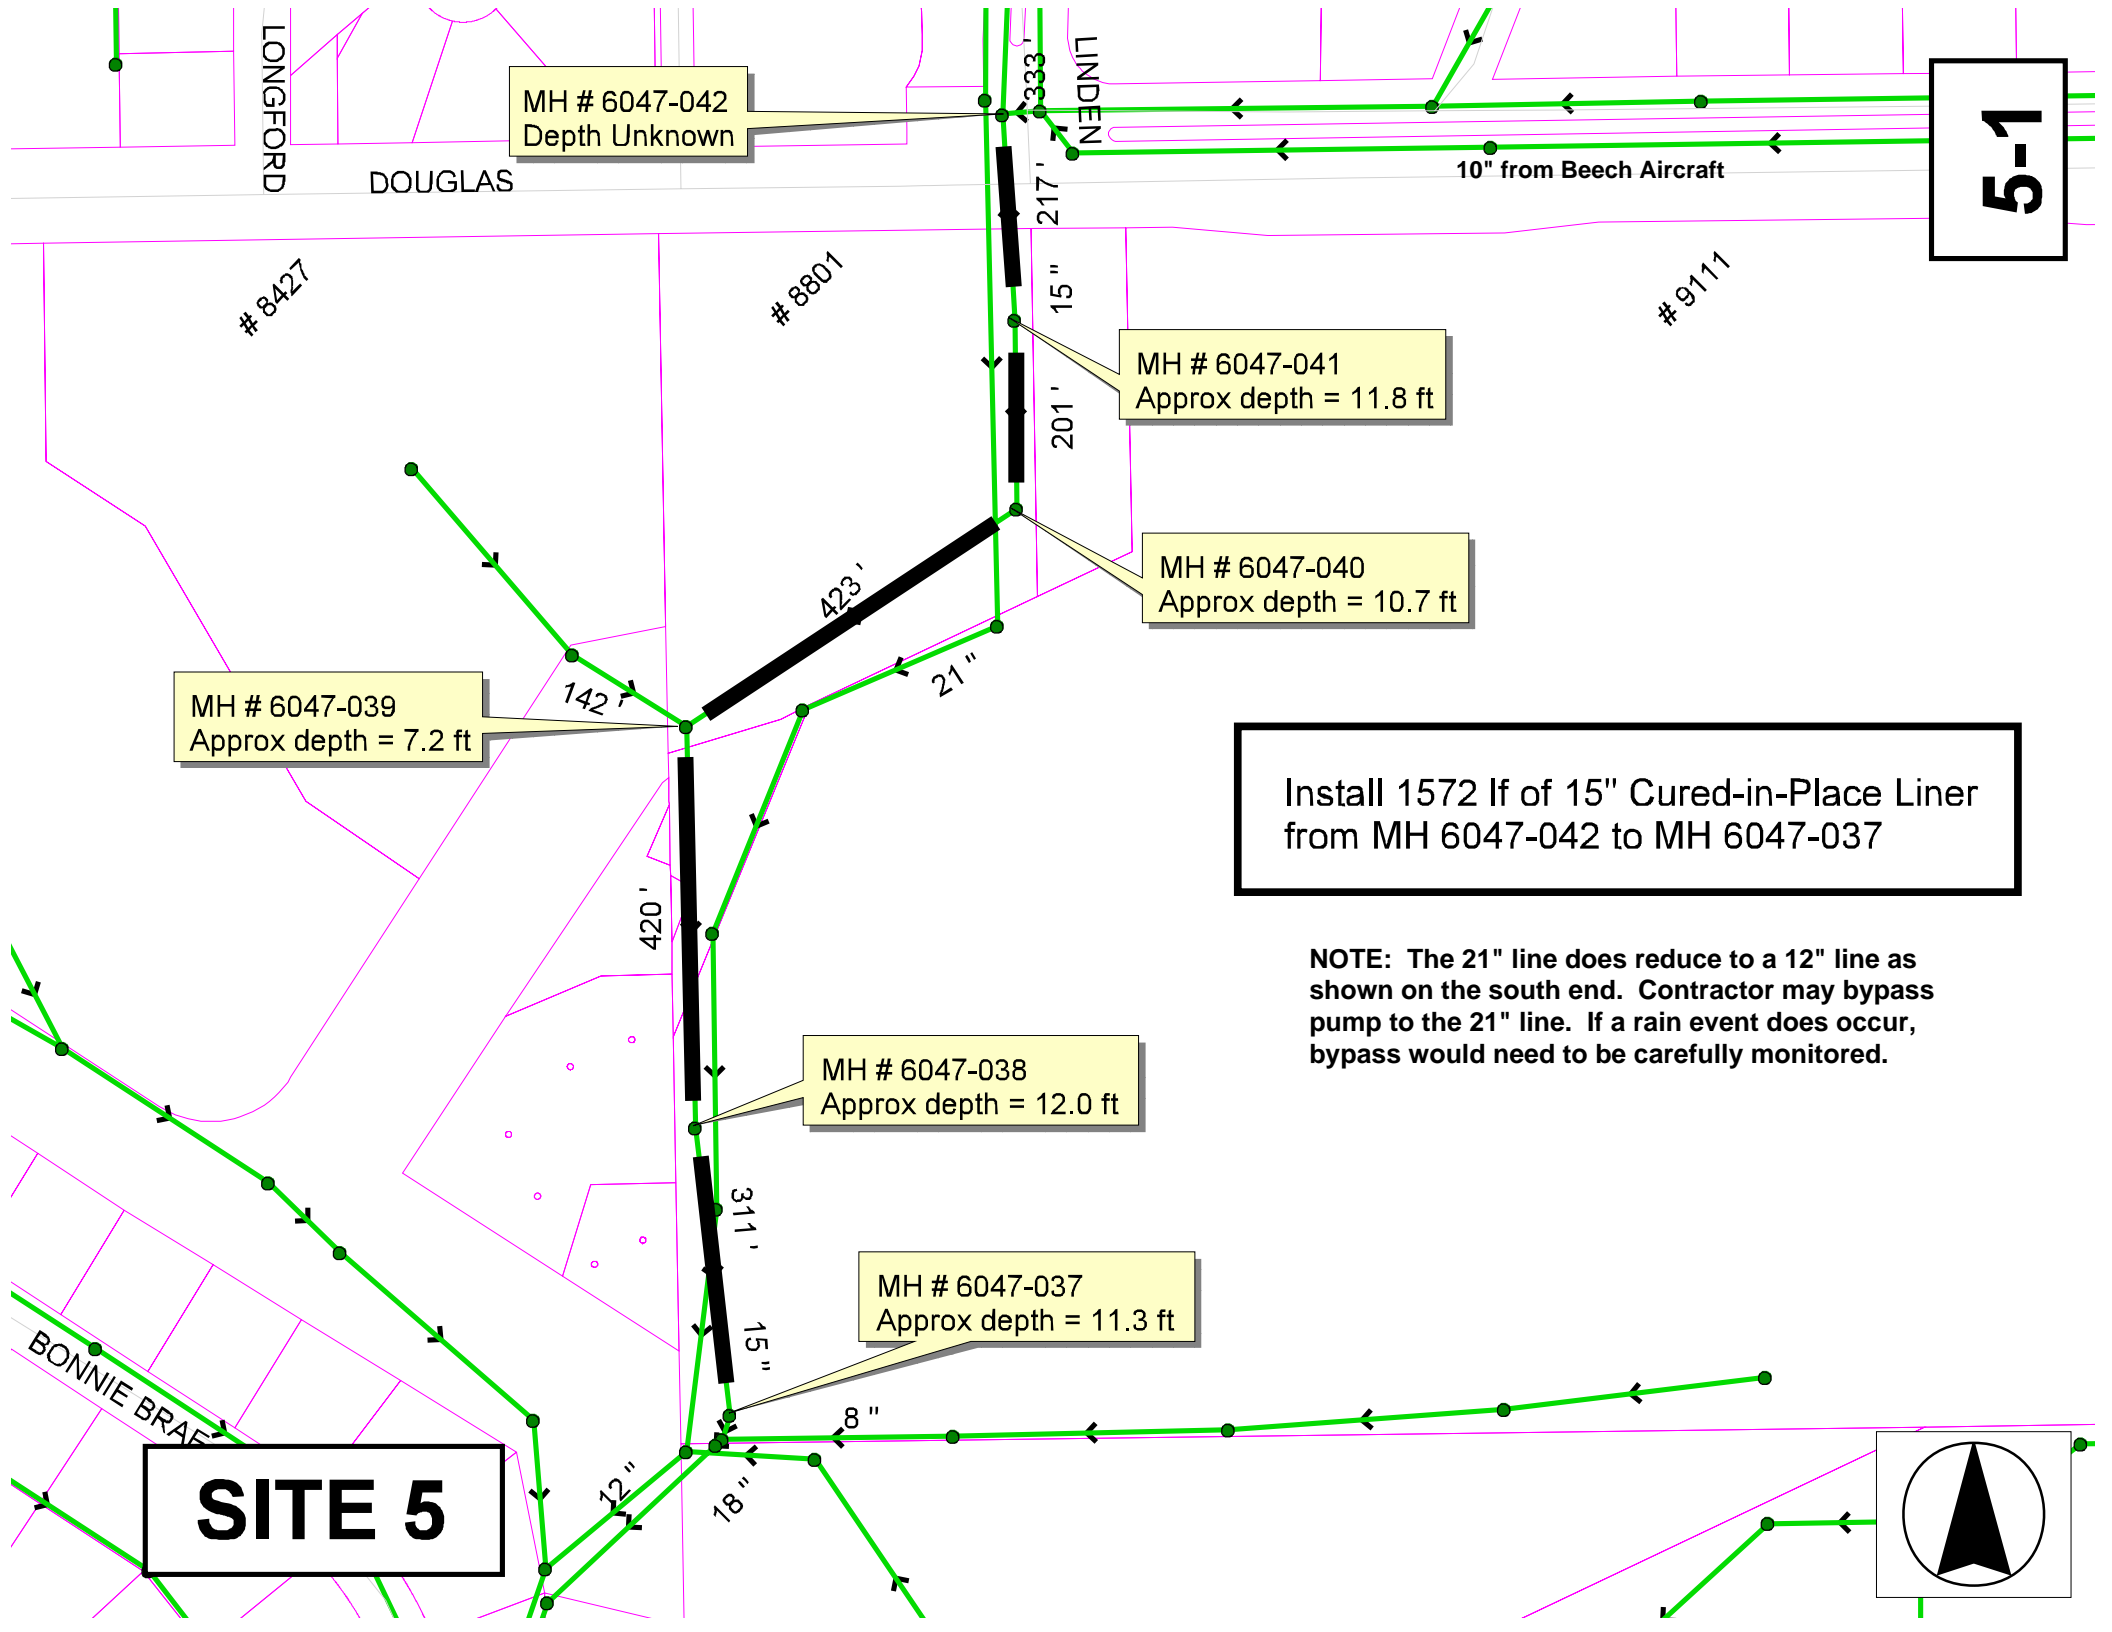
5-1

MH # 6047-042
Depth Unknown

MH # 6047-041
Approx depth = 11.8 ft

MH # 6047-040
Approx depth = 10.7 ft

MH # 6047-039
Approx depth = 7.2 ft

MH # 6047-038
Approx depth = 12.0 ft

MH # 6047-037
Approx depth = 11.3 ft

NOTE: The 21" line does reduce to a 12" line as
shown on the south end. Contractor may bypass
pump to the 21" line. If a rain event does occur,
bypass would need to be carefully monitored.
