Install 654 lf of 8"
Cured-in-Place Liner
from MH 5749-318
to 5749-316

SITE 1

Television Inspection Master Report

US Manhole: 5749-318 4320 Vesta
DS Manhole: 5749-317 4226 Vesta

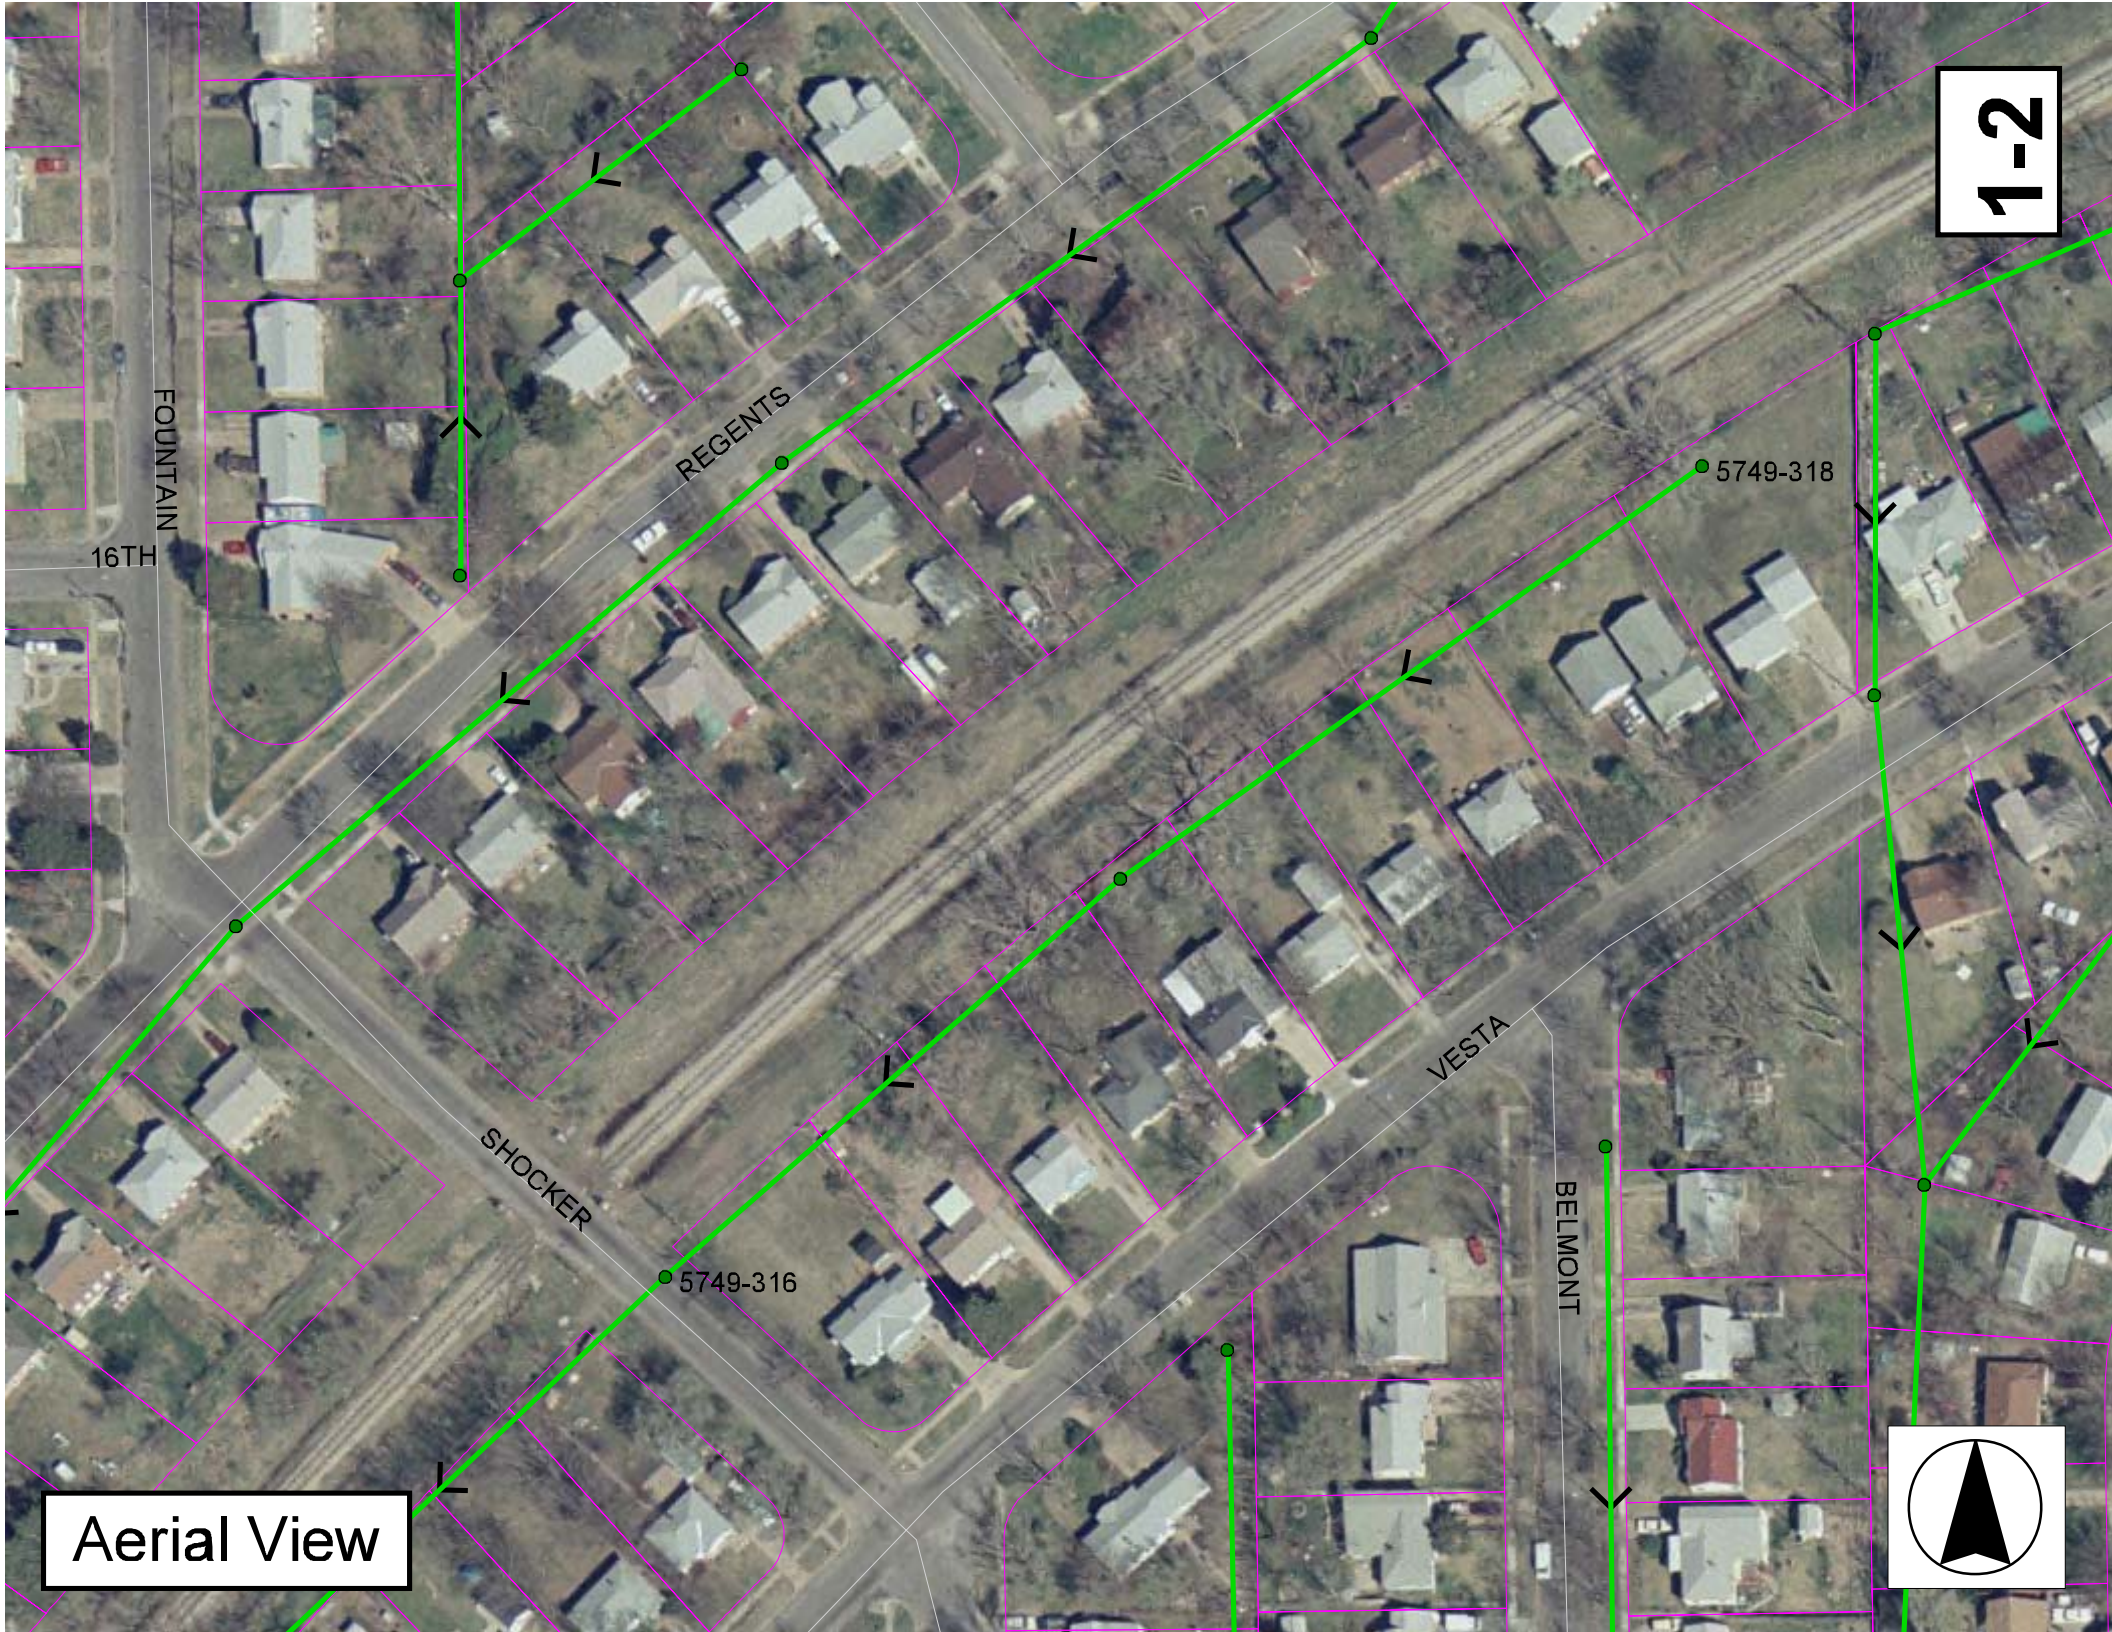
MH # 5749-318
Approx depth = 7.5 ft

MH # 5749-316
Approx depth = 7.6 ft
