SITE 4

Television Inspection Master Report

US Manhole: 4848-112
DS Manhole: 4848-111

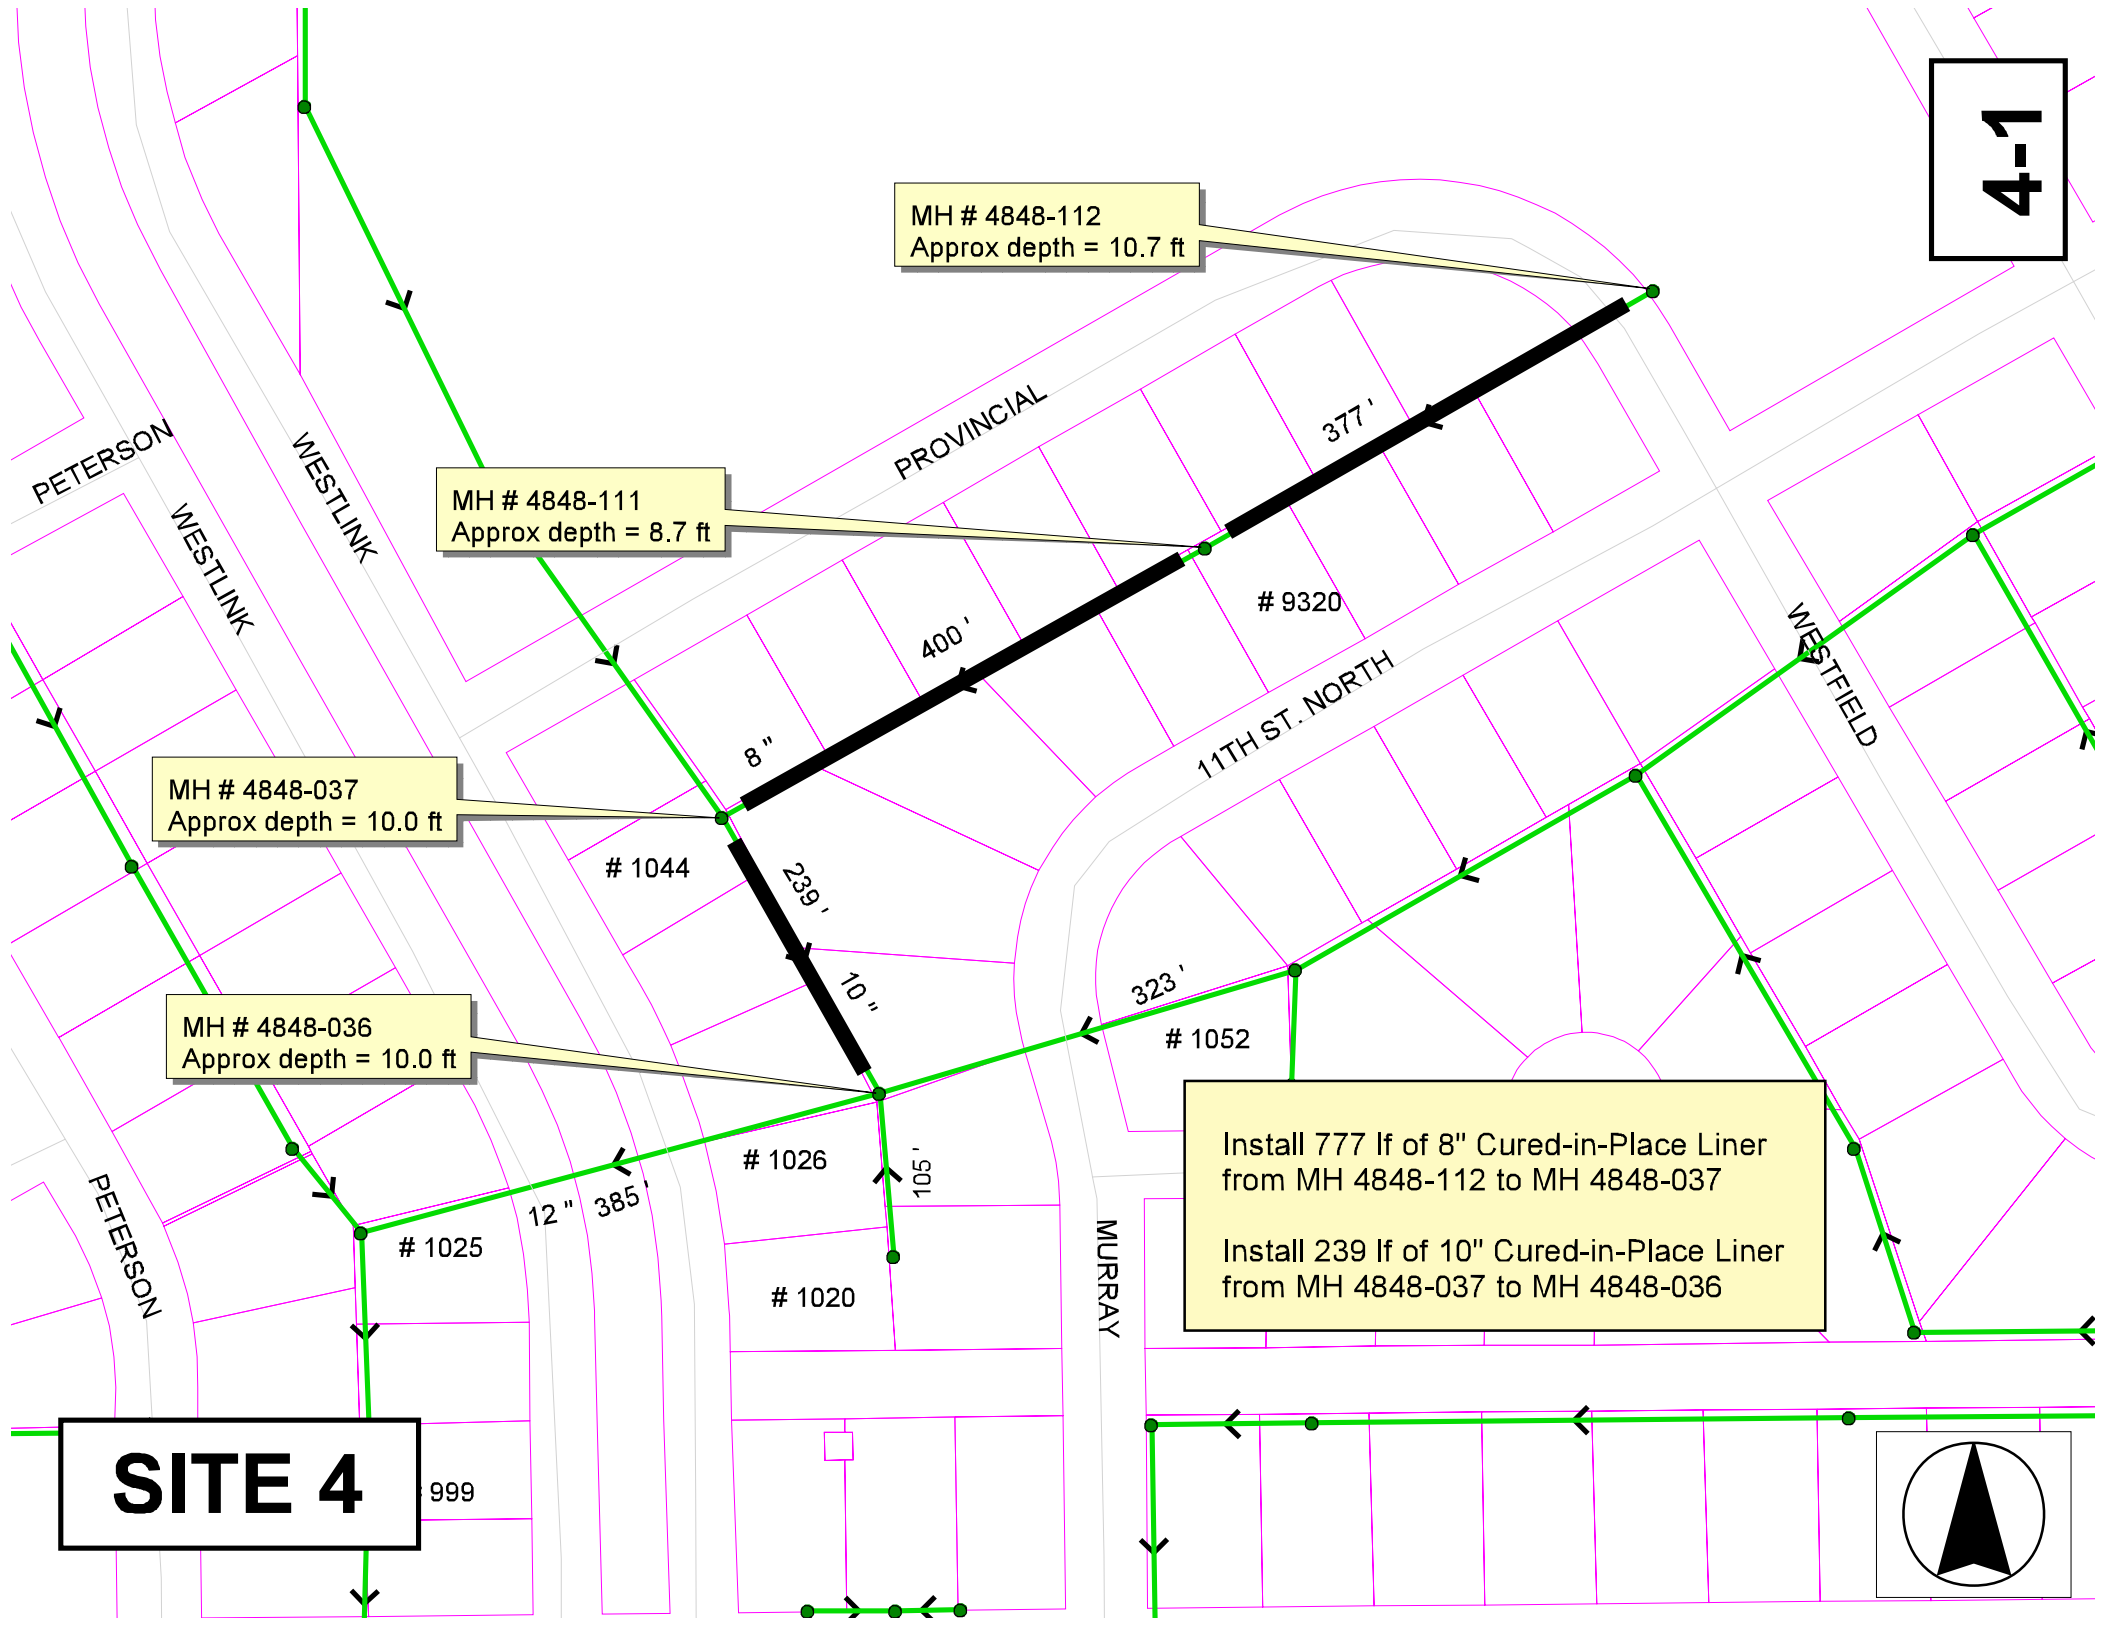
MH # 4848-112
Approx depth = 10.7 ft

MH # 4848-111
Approx depth = 8.7 ft

MH # 4848-037
Approx depth = 10.0 ft

MH # 4848-036
Approx depth = 10.0 ft

Install 777 lf of 8" Cured-in-Place Liner
from MH 4848-112 to MH 4848-037

Install 239 lf of 10" Cured-in-Place Liner
from MH 4848-037 to MH 4848-036
