Install 571 lf of 8" Cured-in-Place Liner from MH 4847-113 to MH 4847-111

SITE 7

Television Inspection Master Report

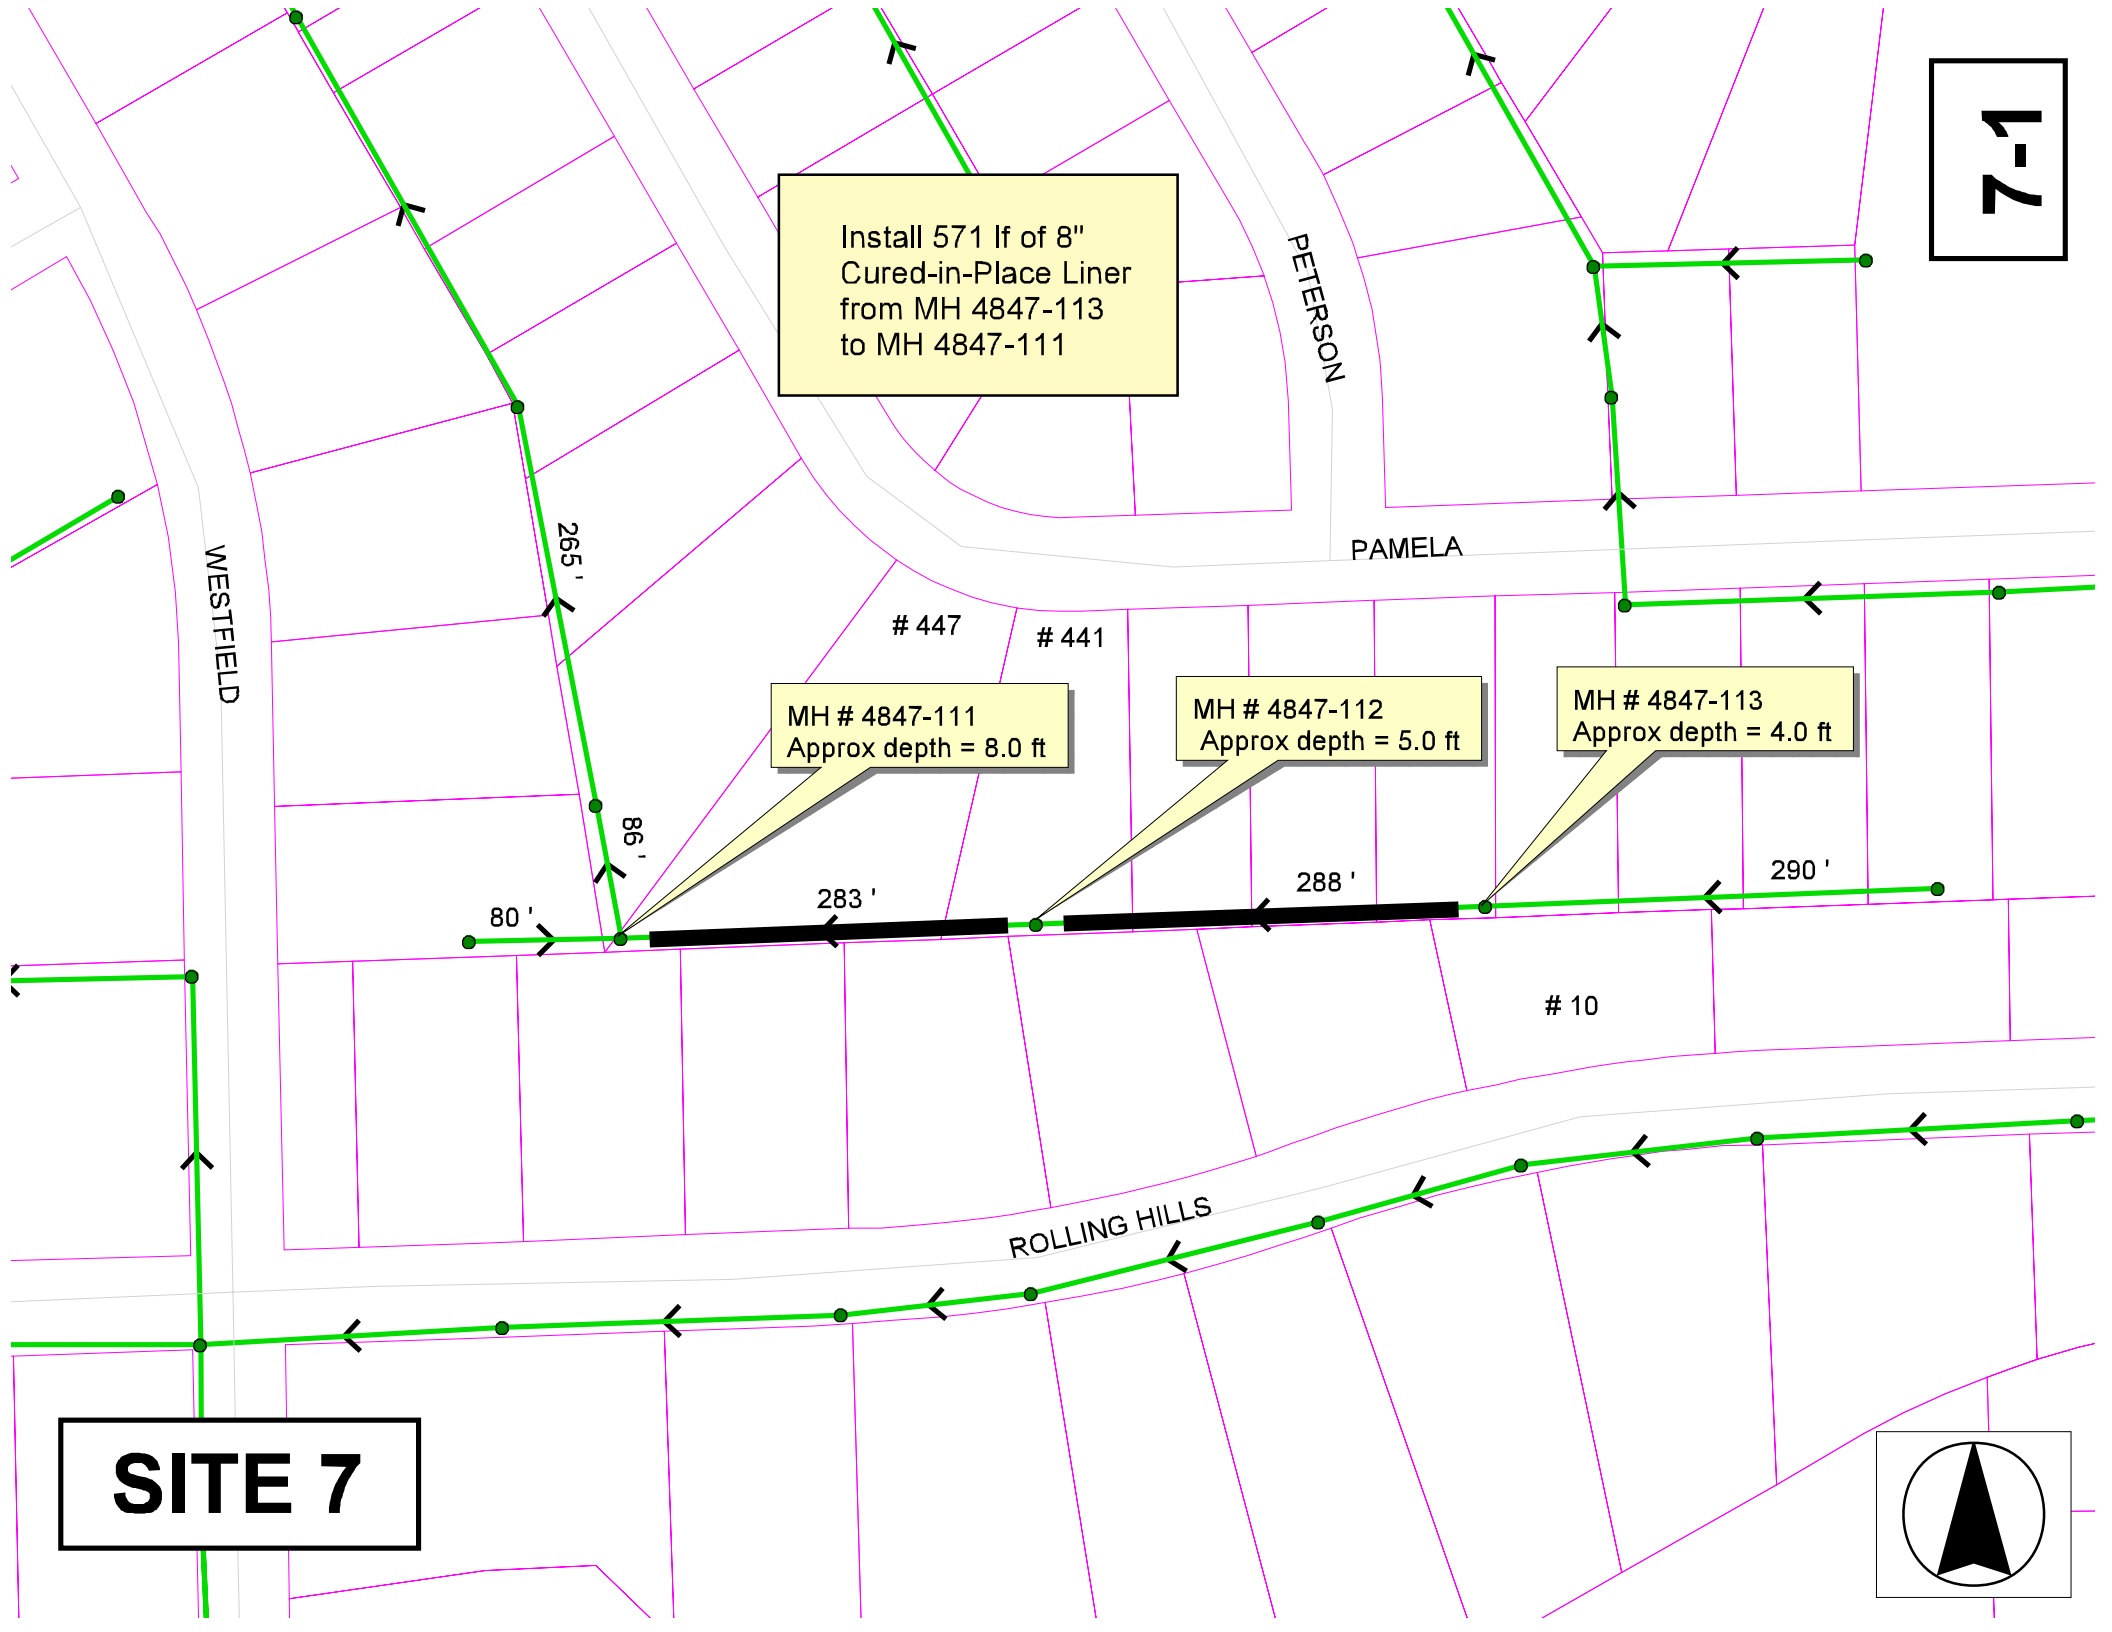
MH # 4847-111
Approx depth = 8.0 ft

MH # 4847-112
Approx depth = 5.0 ft

MH # 4847-113
Approx depth = 4.0 ft
