Television Inspection Master Report

US Manhole: 5547-408
DS Manhole: 5547-406

111 S HYDRAULIC
125 S HYDRAULIC AVE

Shape:	Round	Length Status:		Project No.:	A-451
Dia/Ht Width:	8	Material:	VCP	Index:	
Length:	148.3	Slope:	0.400	Surface:

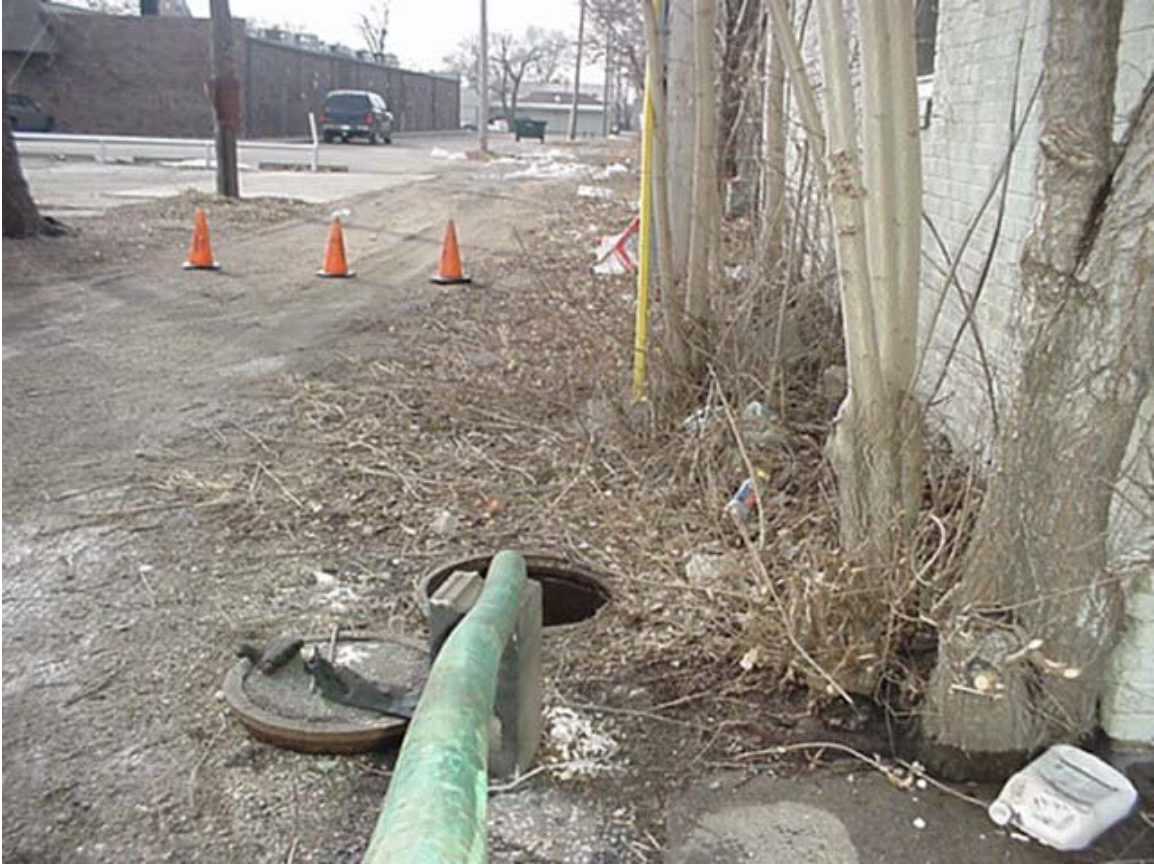
Standing north of MH 5547-408, looking south.

Pipe is more toward the center of the alley south of here.

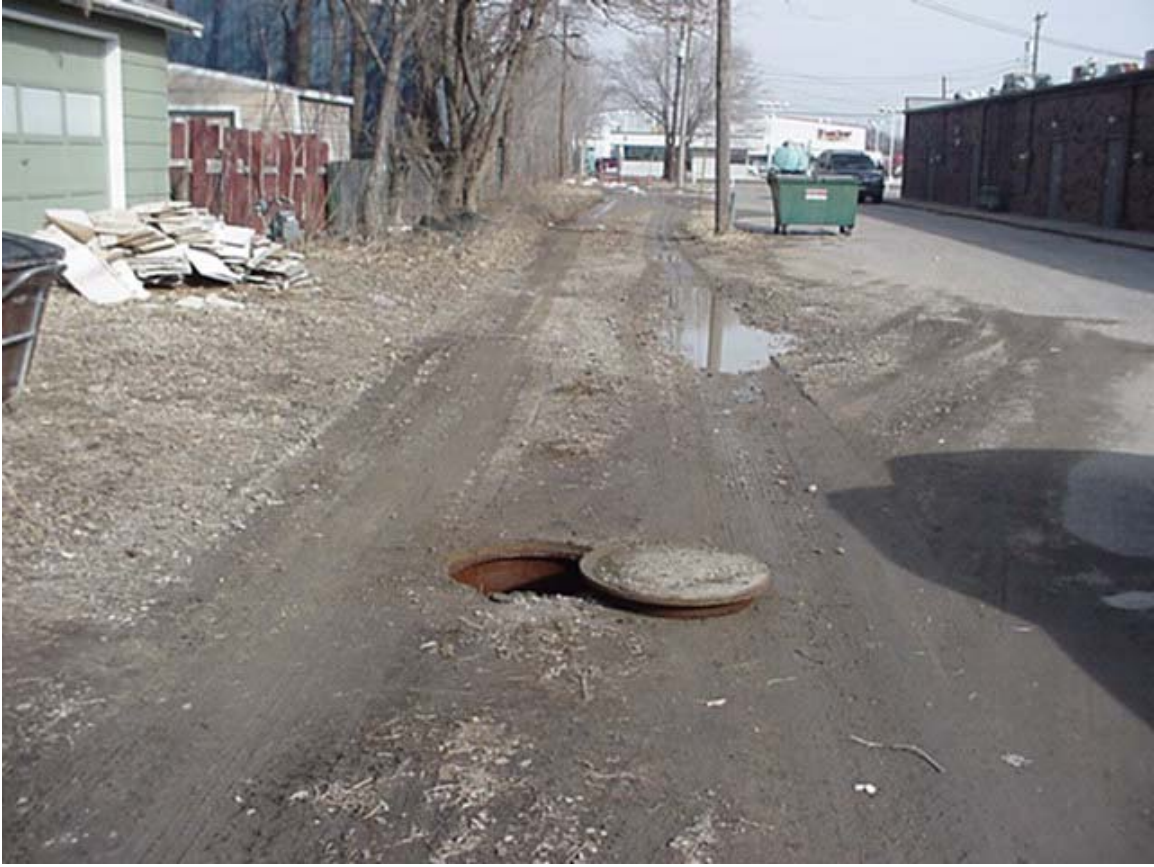
Standing south of MH 5547-404, looking north.

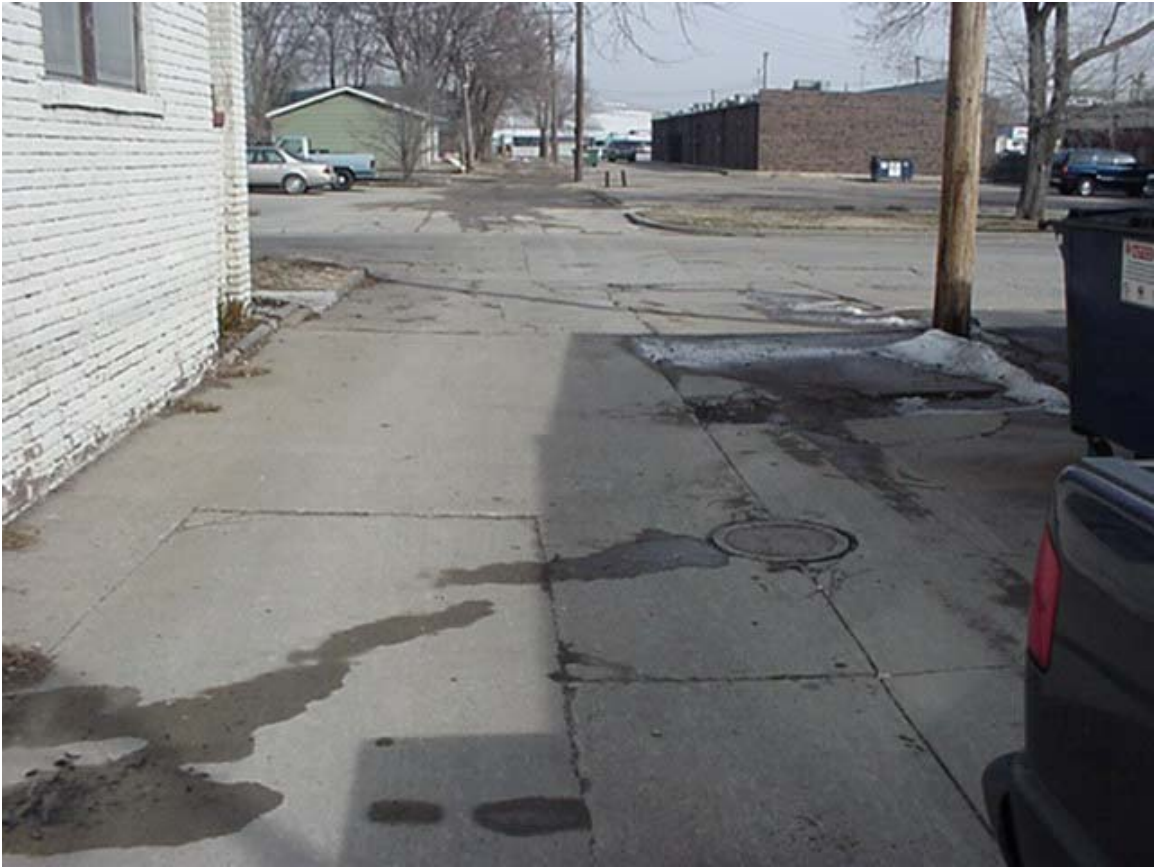
Standing south of MH 402, looking north (across English Street)

NOTE: The PVC repair from 140' to 148' appears to go through a storm water sewer manhole in English Street. Contractor may use the existing PVC if it is at proper grade.

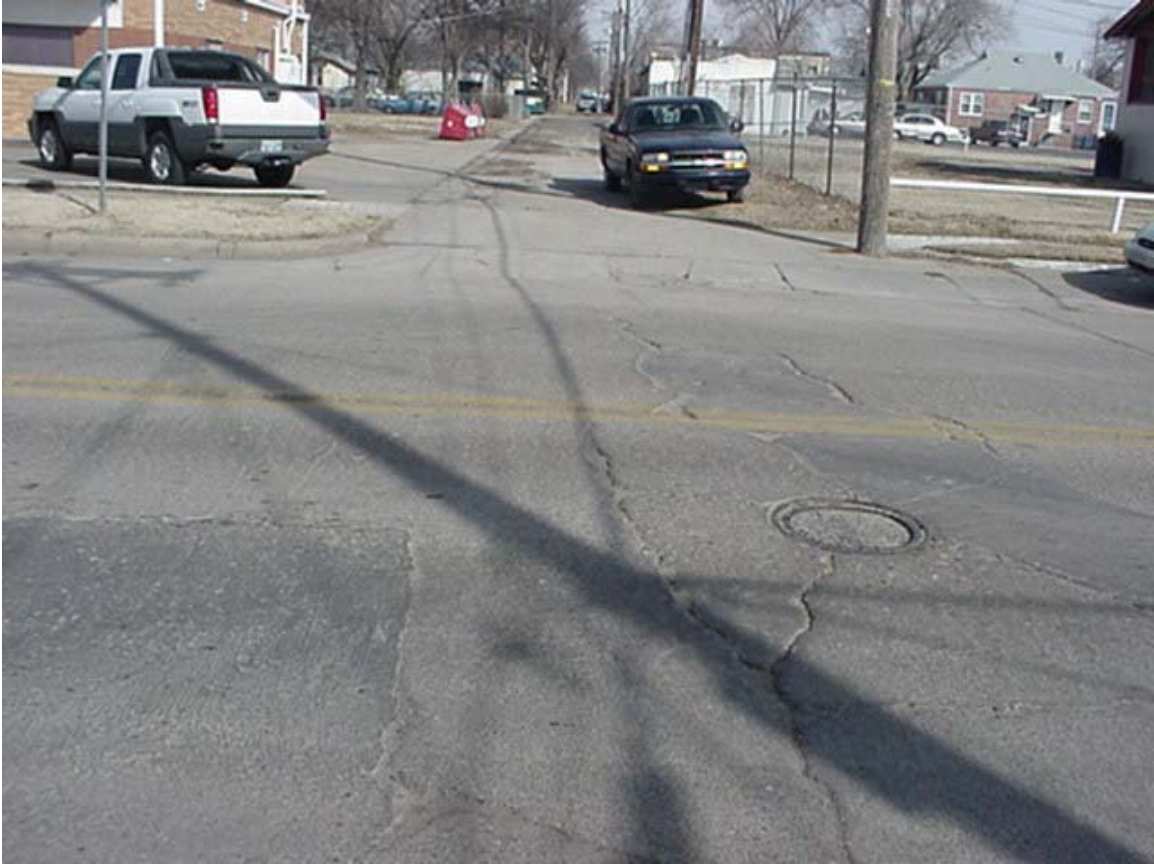
Standing in Waterman, looking north.

NOTE: The alley north of Waterman has approx. 50 lf of asphalt in very poor condition. Contractor will be required to use flowable fill and restore asphalt per standard city specs.
