POINT REPAIR:
Remove and replace 8 lf of 8" pipe
from the north wall of MH 6348-104
to 8 lf north of MH 6348-104

LOCATION IS SOUTH OF 13TH STREET NORTH,
BETWEEN 127TH ST. EAST & 143RD ST. EAST

SITE 4

Television Inspection Master Report

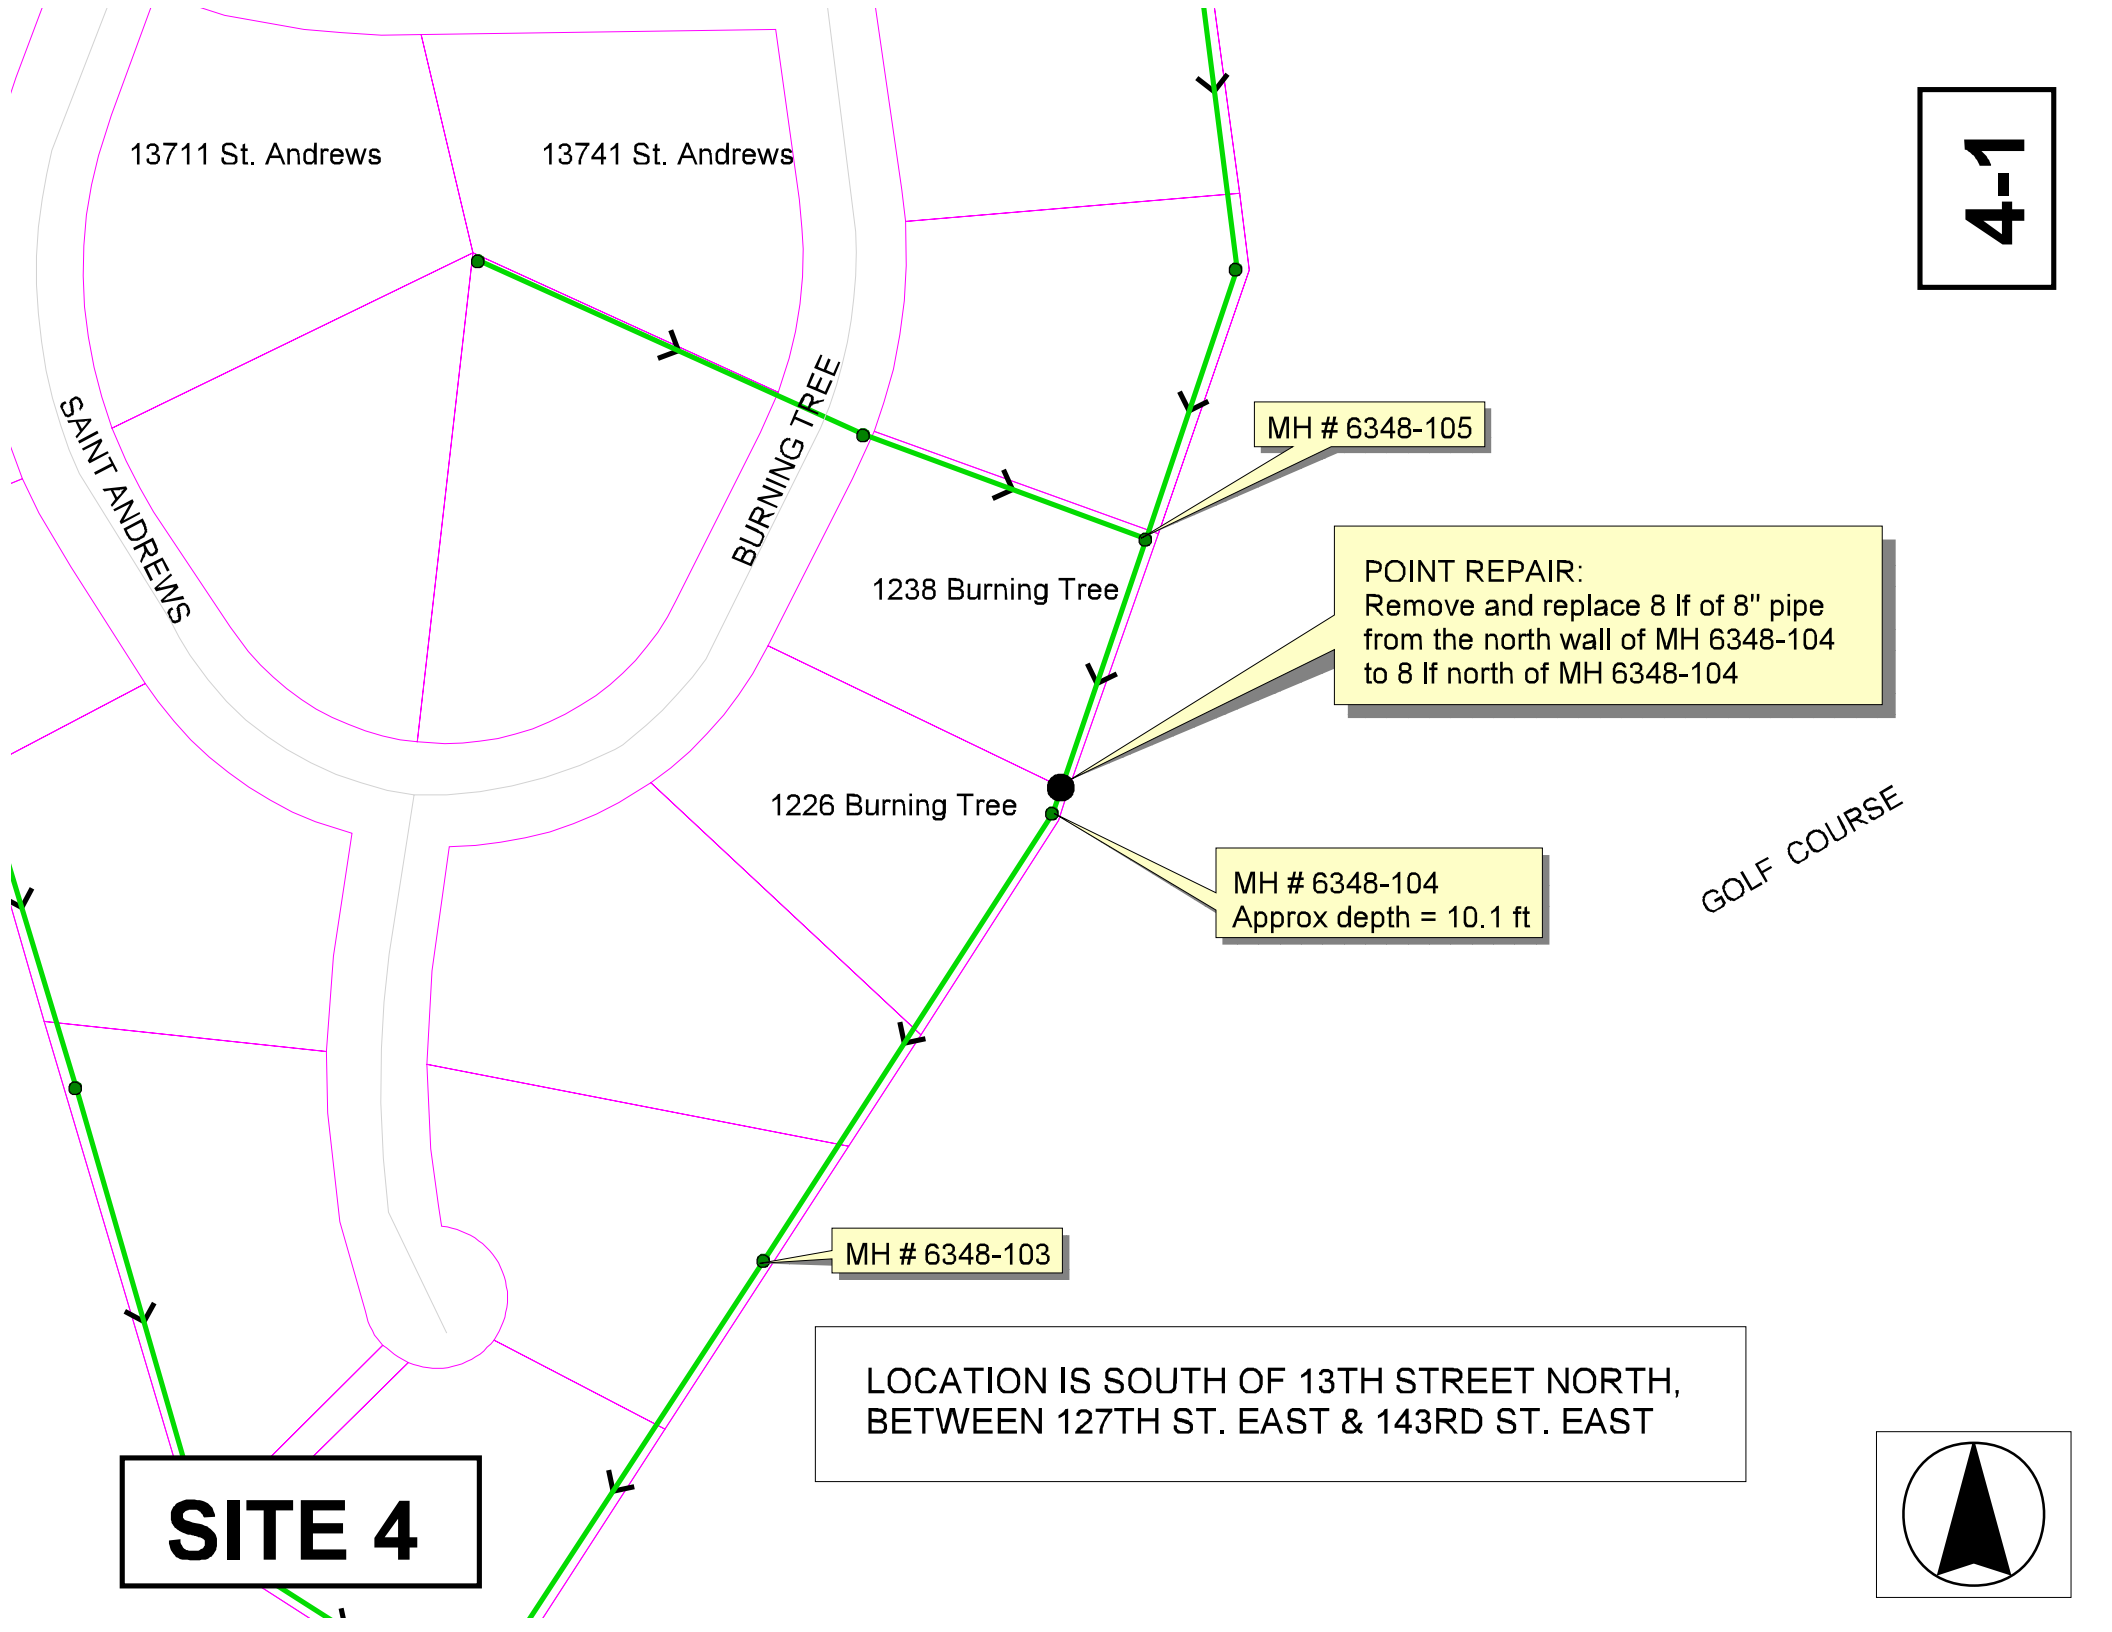
MH # 6348-104
Approx depth = 10.1 ft

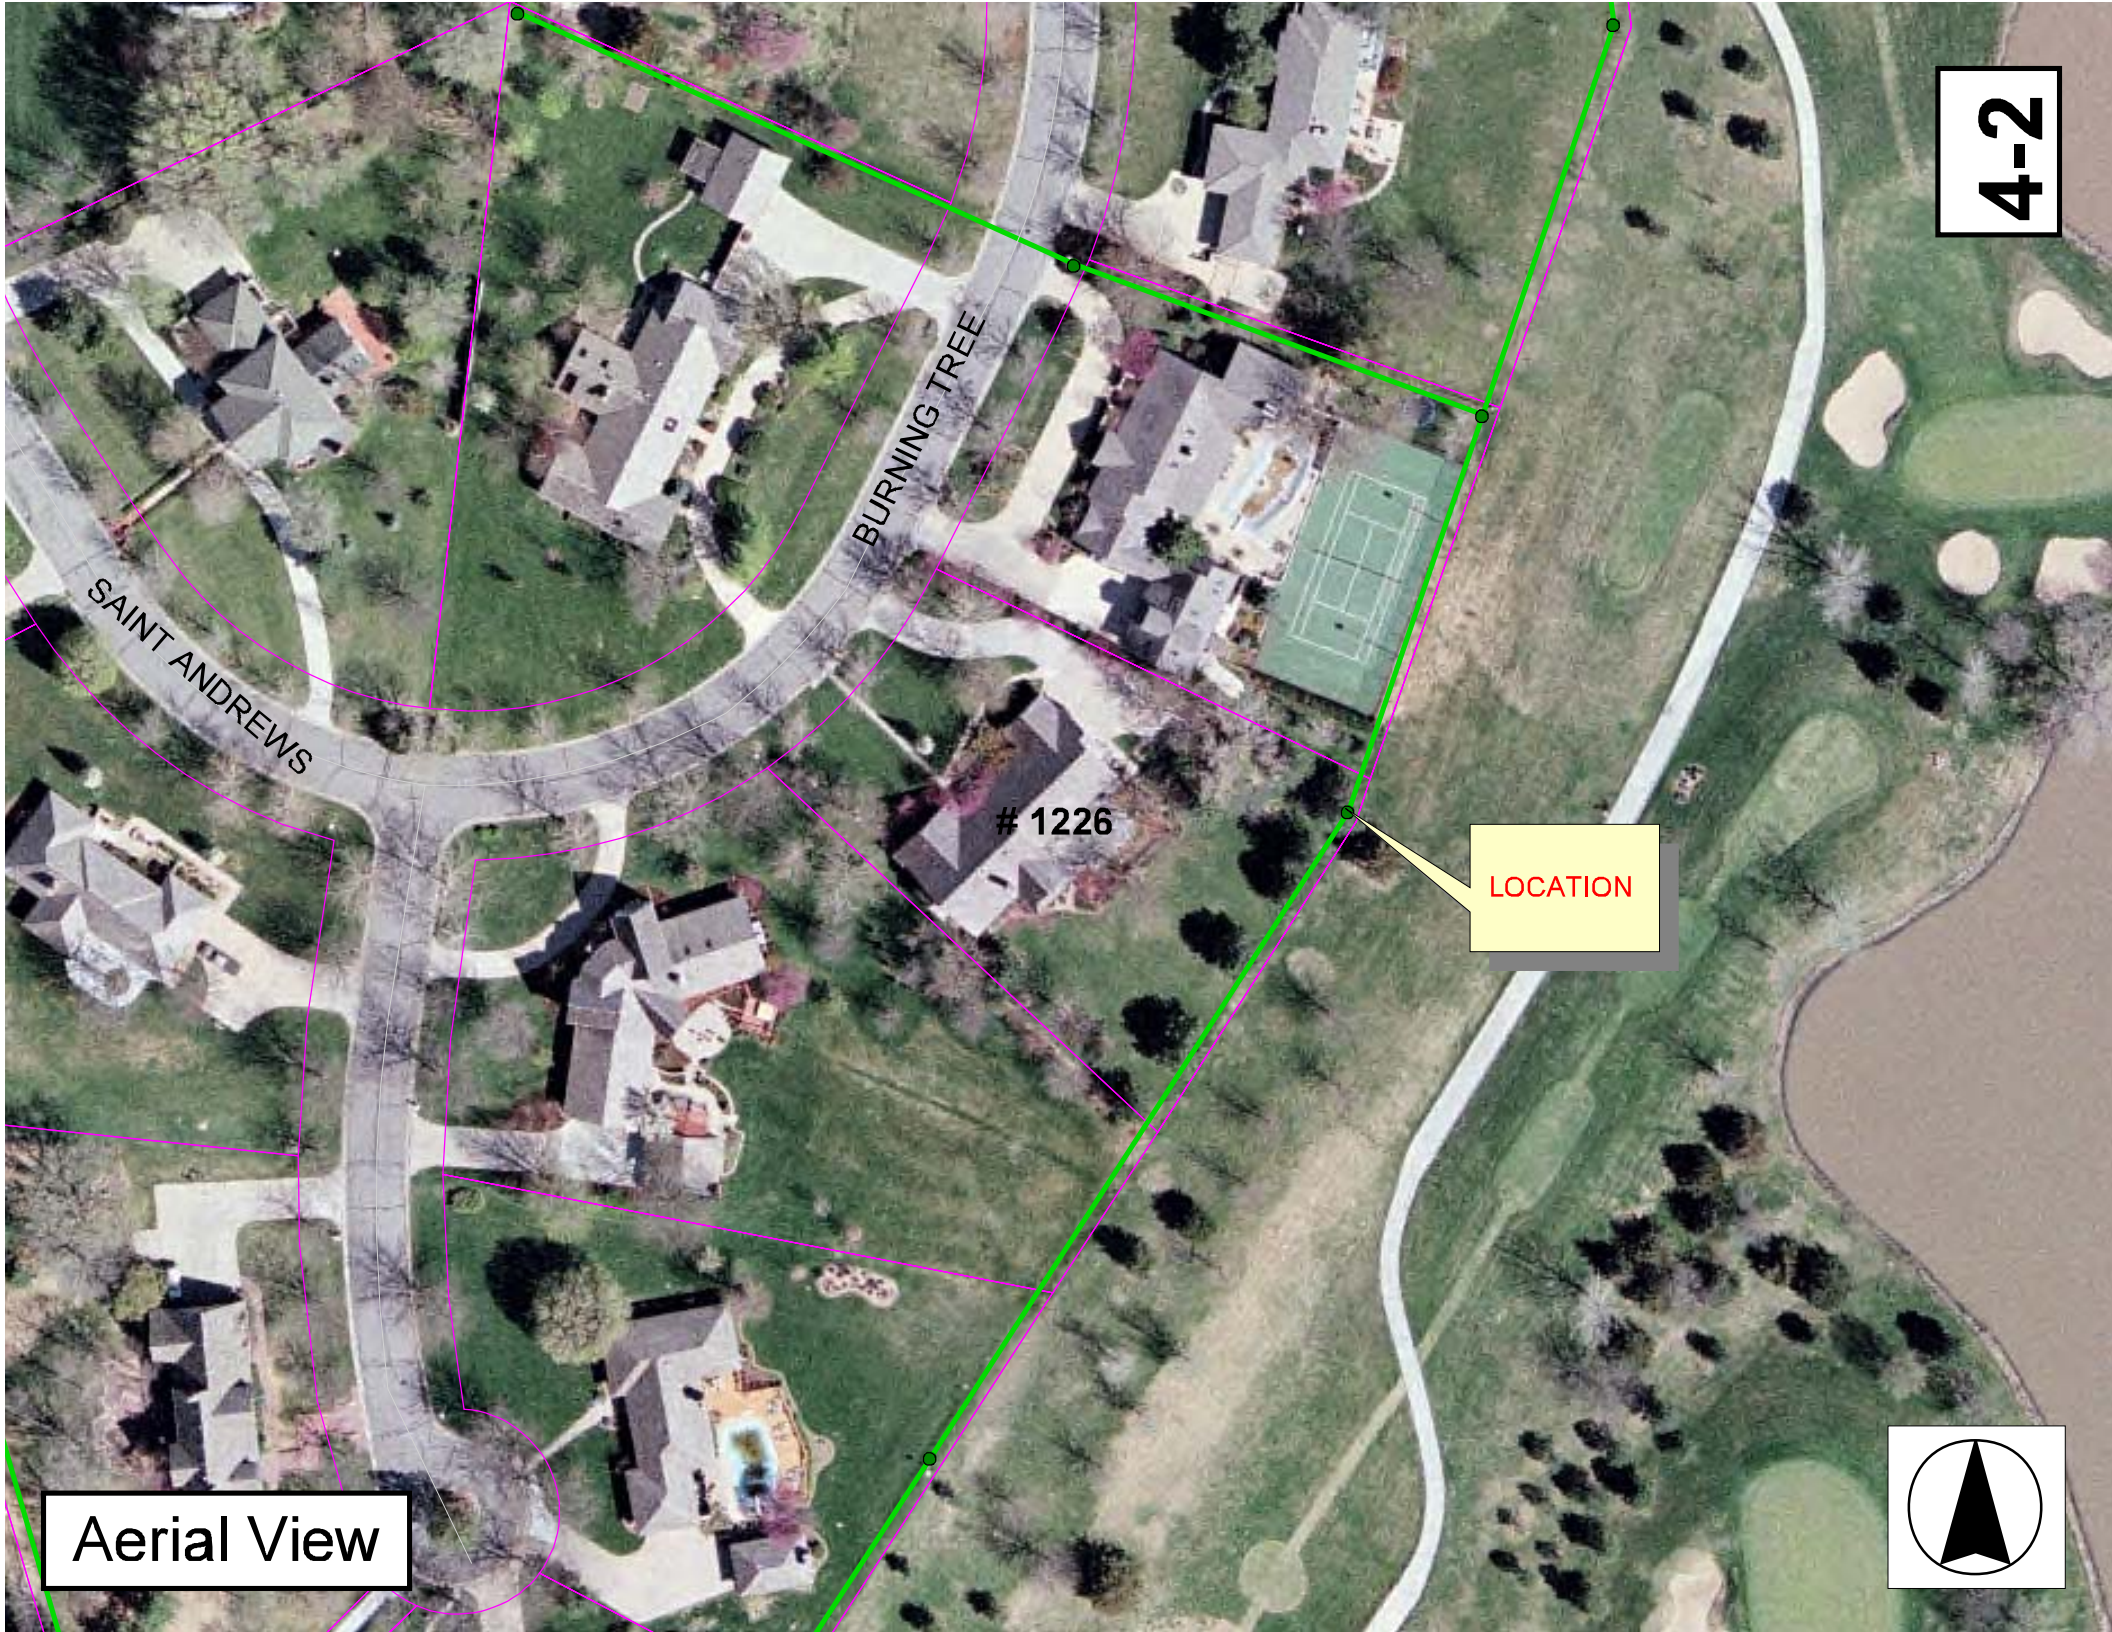
LOCATION

Obs. #	VTR Counter Comment	Dist	Location	Description	Rating	Obsrvd (gpm)	Est. (gpm)	Ratings			
								Struct	Clean	Remain (gpm)	
1		0.0	US Manhole							0.000	
2		85.0	West	Break-In Conn	1		0.001	0	0	0.001	
3		112.0	Crown	Broken Pipe	4		0.030	78	0	0.030	
				Pipe badly broken and shifting vertically. The break is located under a tennis court.							
4		180.0	Quad 4 / U-Lt	Crack-Radial	3		0.004	5	0	0.004	
5		183.0	Crown	Broken Pipe	3		0.010	60	0	0.010	
6		184.0	Camera Lens Submerge							0.000	
7		185.0	Camera Blocked	Broken Pipe	3		0.010	60	0	0.010	
				Bottom is gone from the pipe and pipe is shifting vertically. Needs repaired prior to lining.							
8		190.0	DS Manhole							0.000

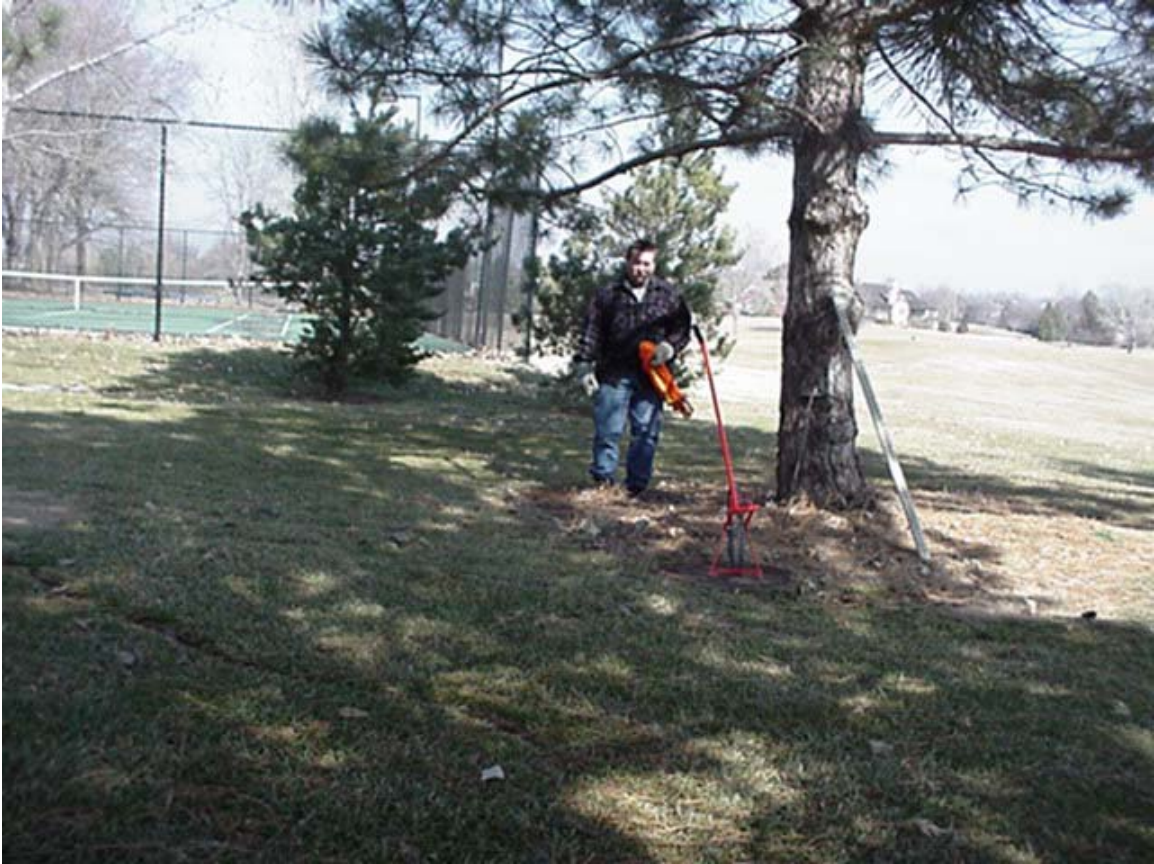
I'm standing southwest of MH 6348-104, looking northerly.
The orange measuring wheel is sitting on MH 6348-104.
Greg is standing at 8 ft. north of the manhole.
Point repair will be within the drip line of the pine tree.
All site restoration shall be incidental to the point repair.
