# Television Inspection Master Report

US Manhole: 5846-465  
DS Manhole: 5846-464

Date Insp: 12/26/2001

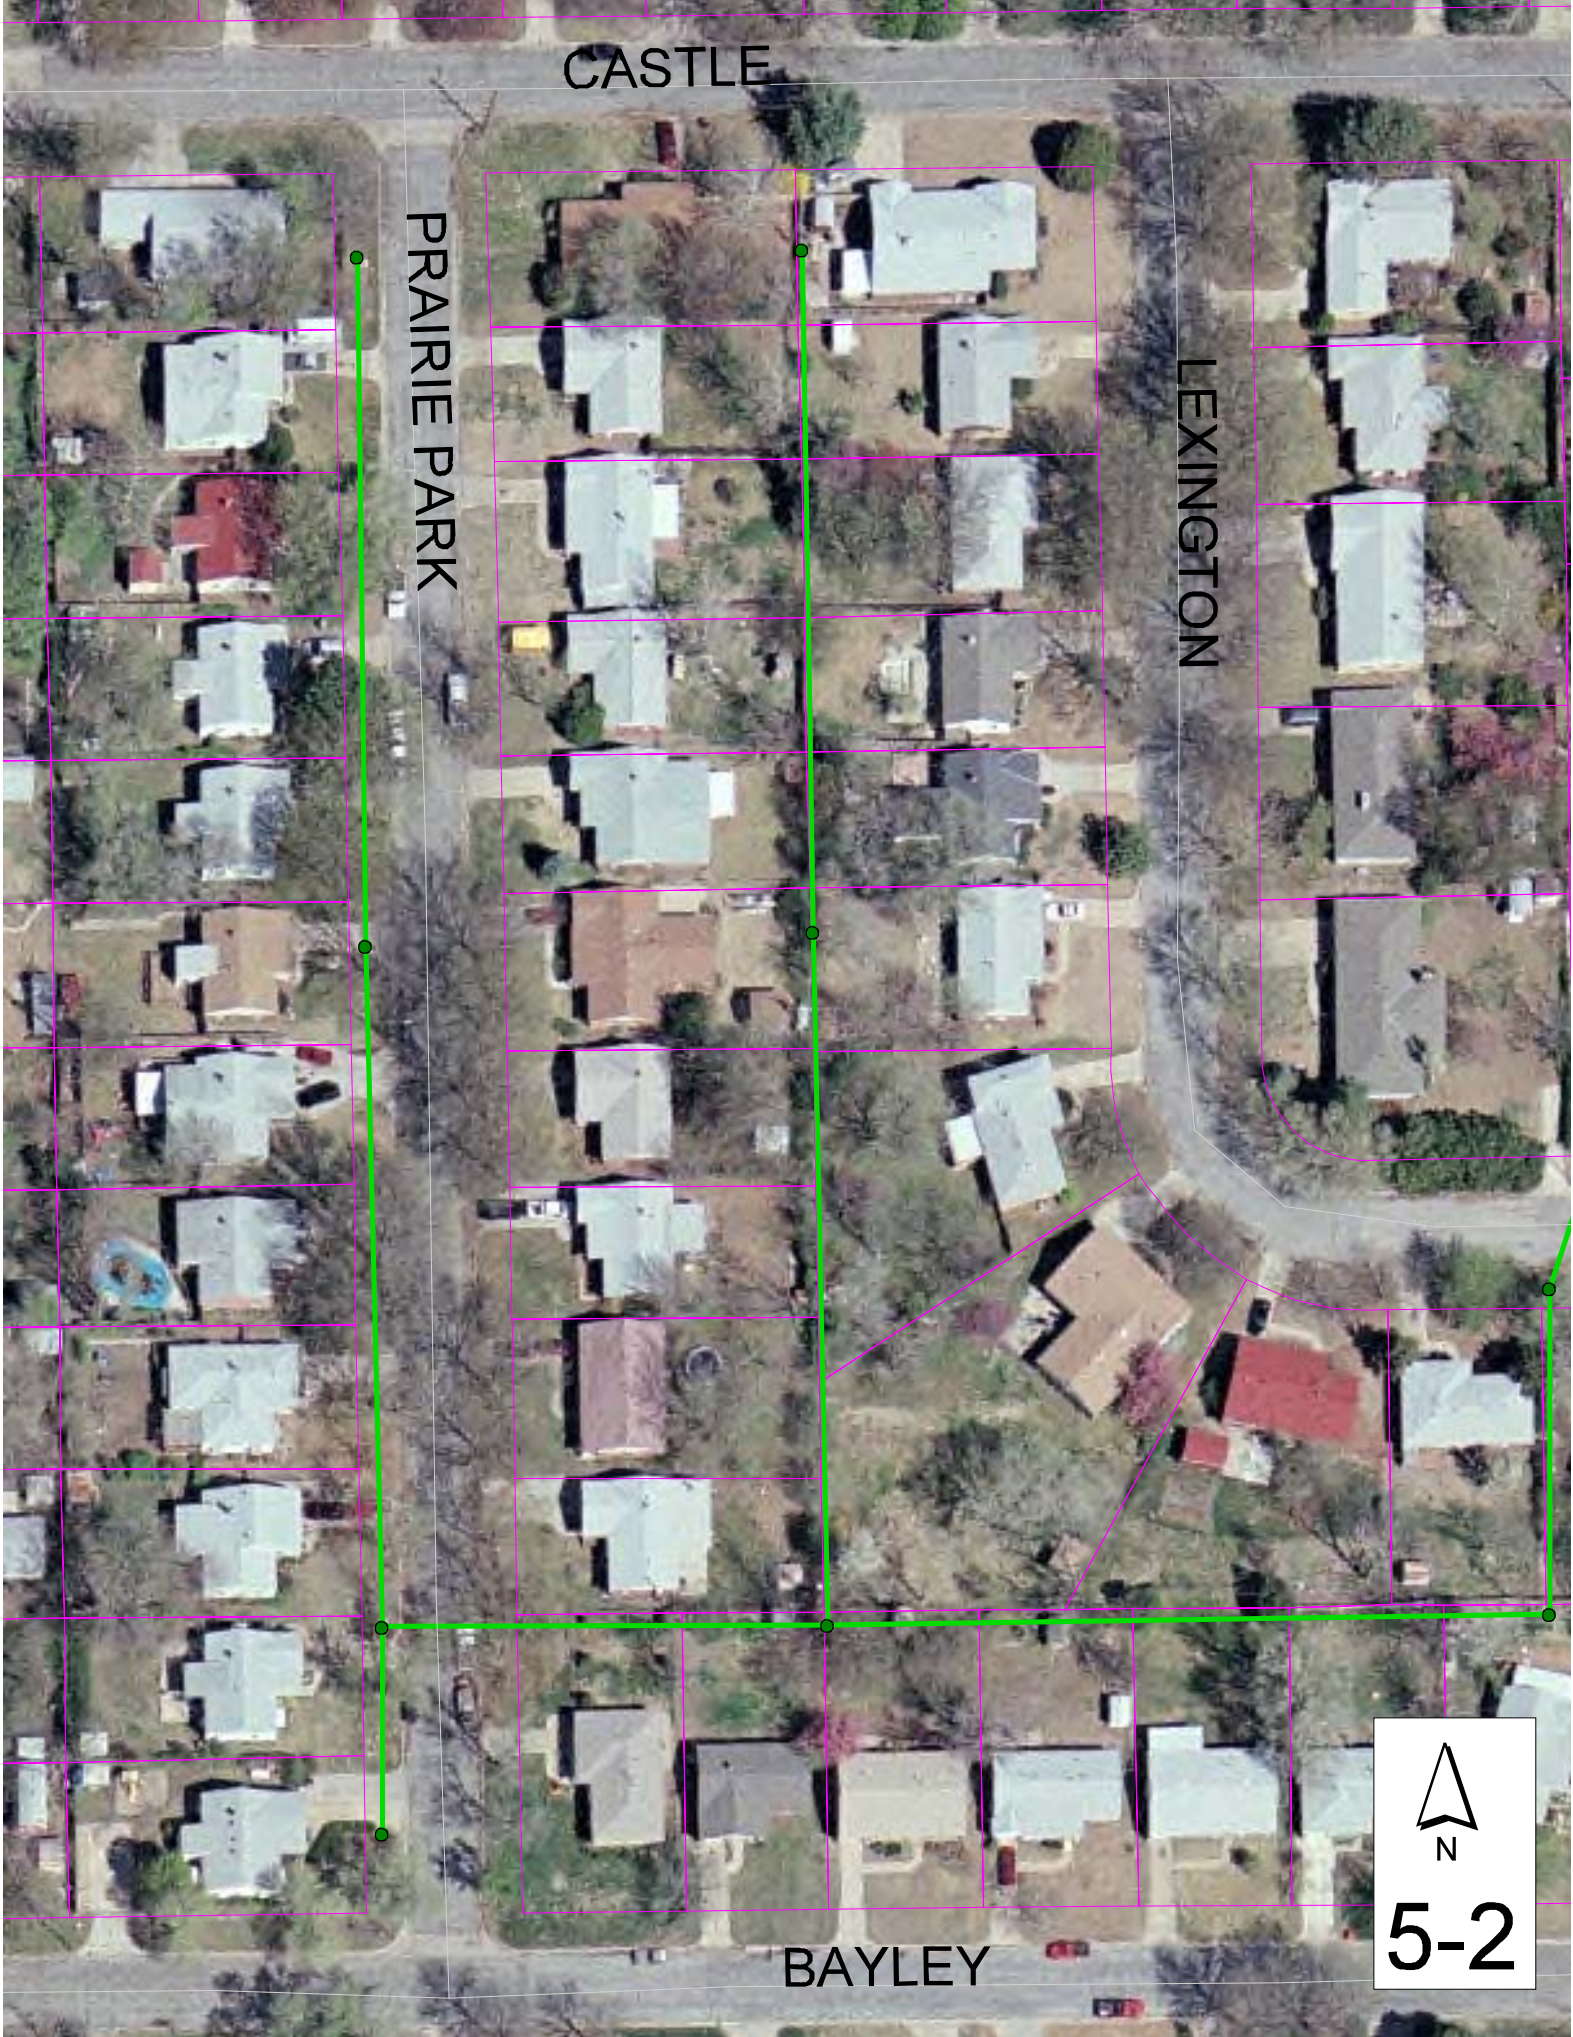
5-2

MH # 5846-465  
Approx depth = 7.0 ft

MH # 5846-464  
Replace Manhole Frame & Cover  
Rework Manhole Bench & Invert  
Approx depth = 12.4 ft

MH # 5846-459  
Rework Manhole Bench & Invert  
Approx Manhole depth = 15.2 ft

POINT REPAIR:  
Remove and replace 7 lf of pipe  
from 113 ft south of MH 5846-465  
to 120 ft south of MH 5846-465  
(includes two service connections)

POINT REPAIR:  
Construct an Outside Drop  
for the line coming into  
manhole 5846-459 from the north
