# Television Inspection Master Report

US Manhole: 5346-139  
DS Manhole: 5346-136

US Manhole: 5346-136  
DS Manhole: 5346-134

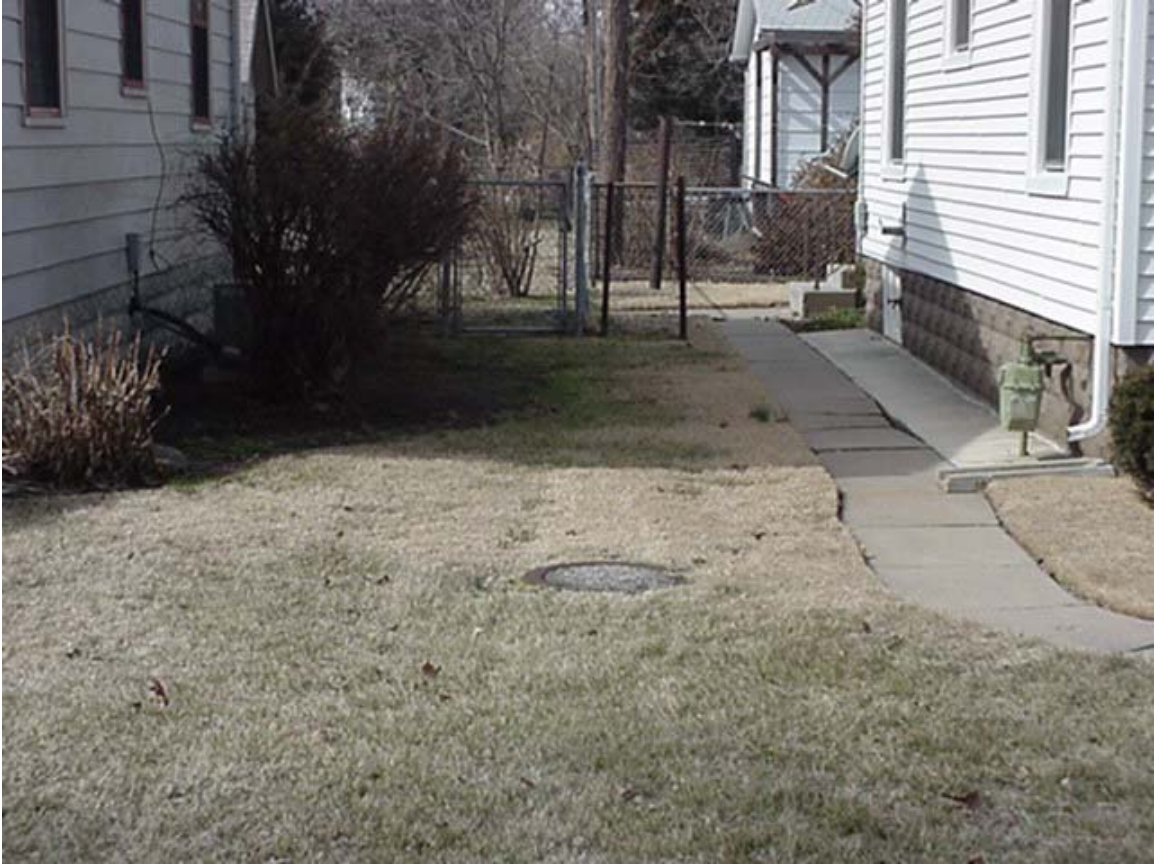
Standing in Vine Street, looking west.  
This is MH 5346-134.

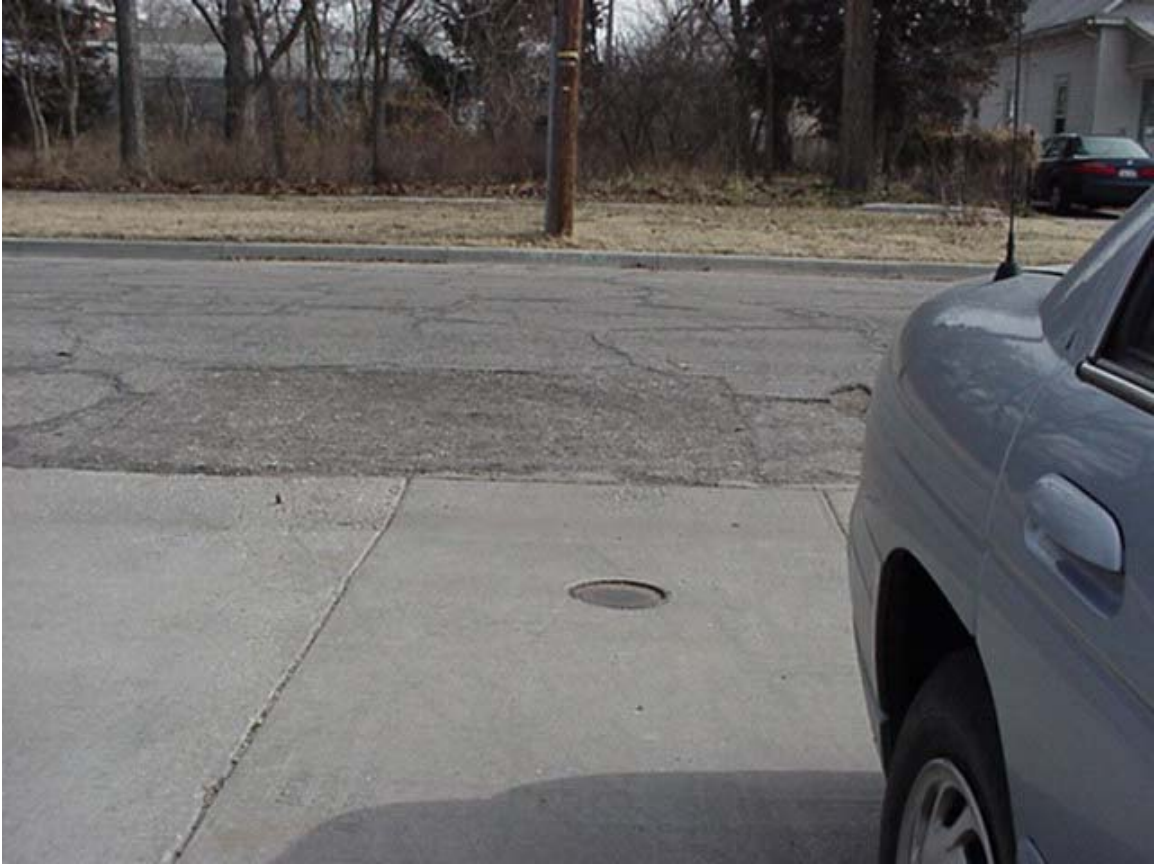
Standing west of Glenn Street R/W, looking east.

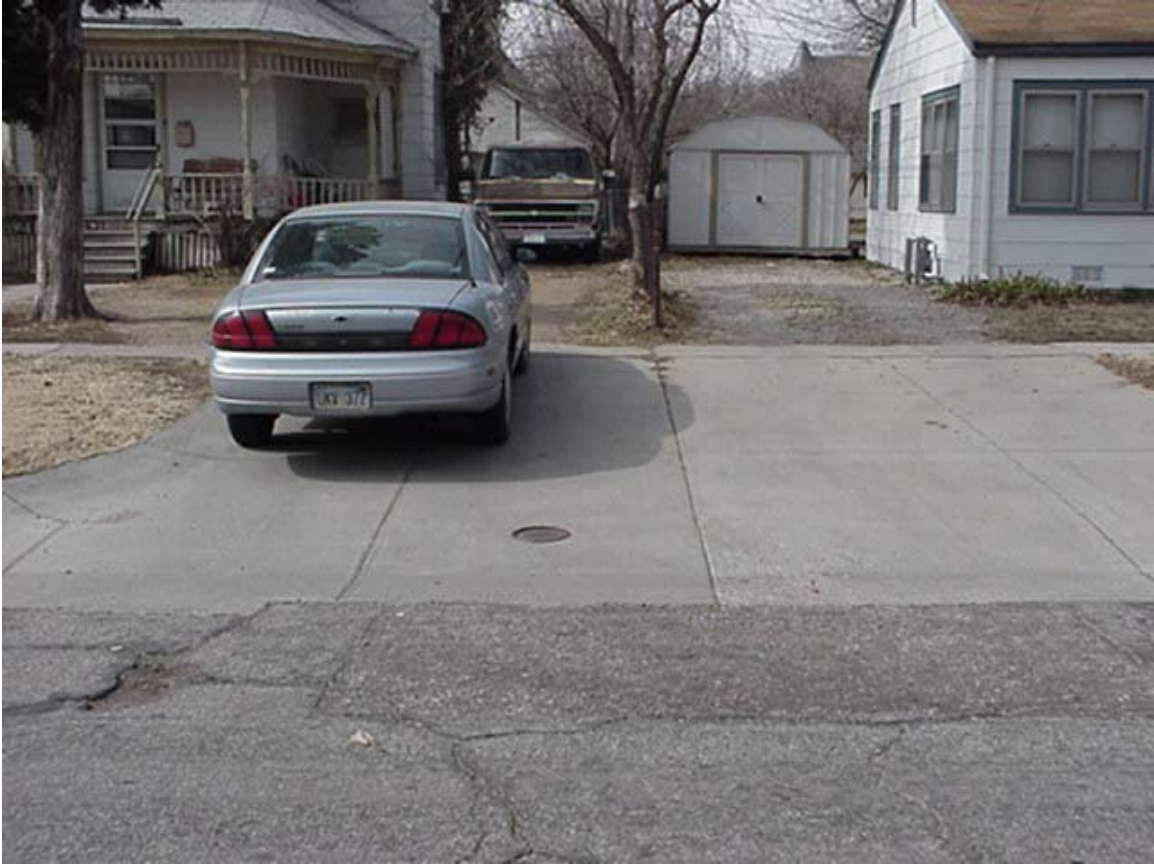
Standing in Glenn Street, looking west.  
New MH 5346-135 should have the lid centered in the sidewalk.

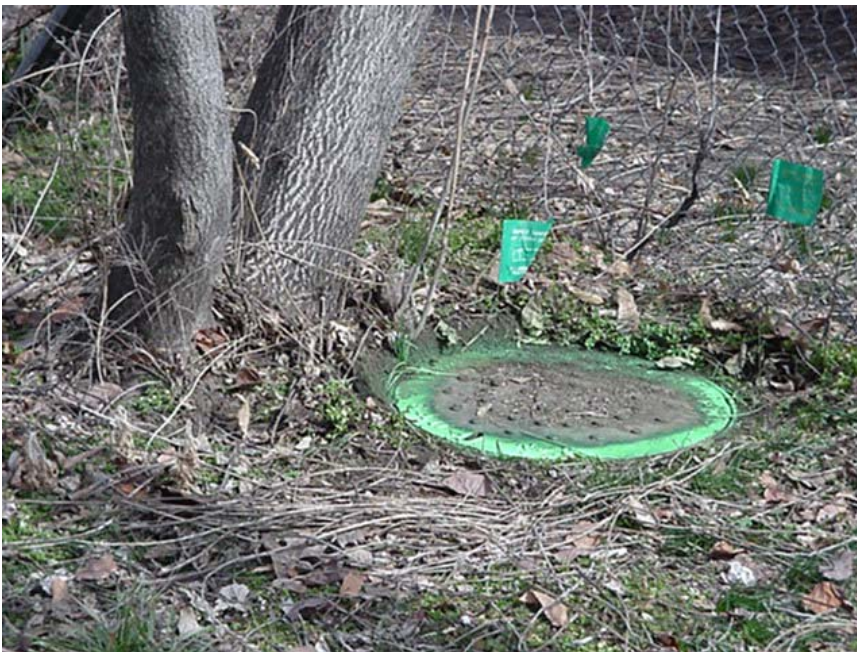
Closer view of MH 5346-218.
