POINT REPAIR:
Remove and replace 11 lf of 8" pipe from west wall of MH 6047-209 to 11 lf west of MH 6047-209
AND
Remove and replace 6 lf of 8" pipe from east wall of MH 6047-209 to 6 lf east of MH 6047-209

Television Inspection Master Report

US Manhole: 6047-210 8020 E MOCKINGBIRD LA **Date Insp:** 2/11/2004 **Basin:** E01G1
DS Manhole: 6047-209 8102 E MOCKINGBIRD LA

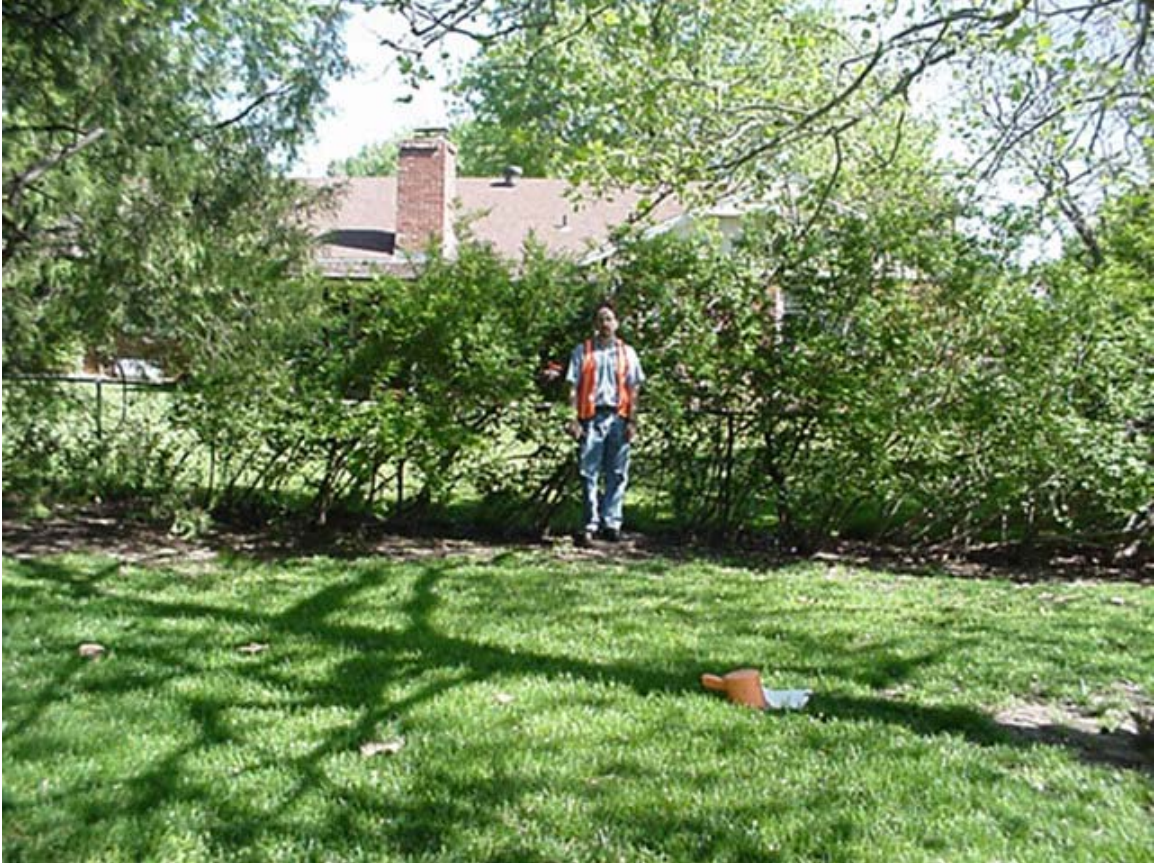
In the yard of 8102 Mockingbird, where we need to dig on both sides of the manhole.

I'm standing in the yard, looking north. Randy is standing on MH 6047-209
