SITE 3

Television Inspection Master Report

US Manhole: 5547-044
DS Manhole: 5547-042

Shape: Round	Length Status:	Project No.: A-137
Dia/Ht Width: 8	Material: VCP	Index:
Length: 170.0	Slope: 0.247	Surface:
Pipe Sec Length:	Comment:

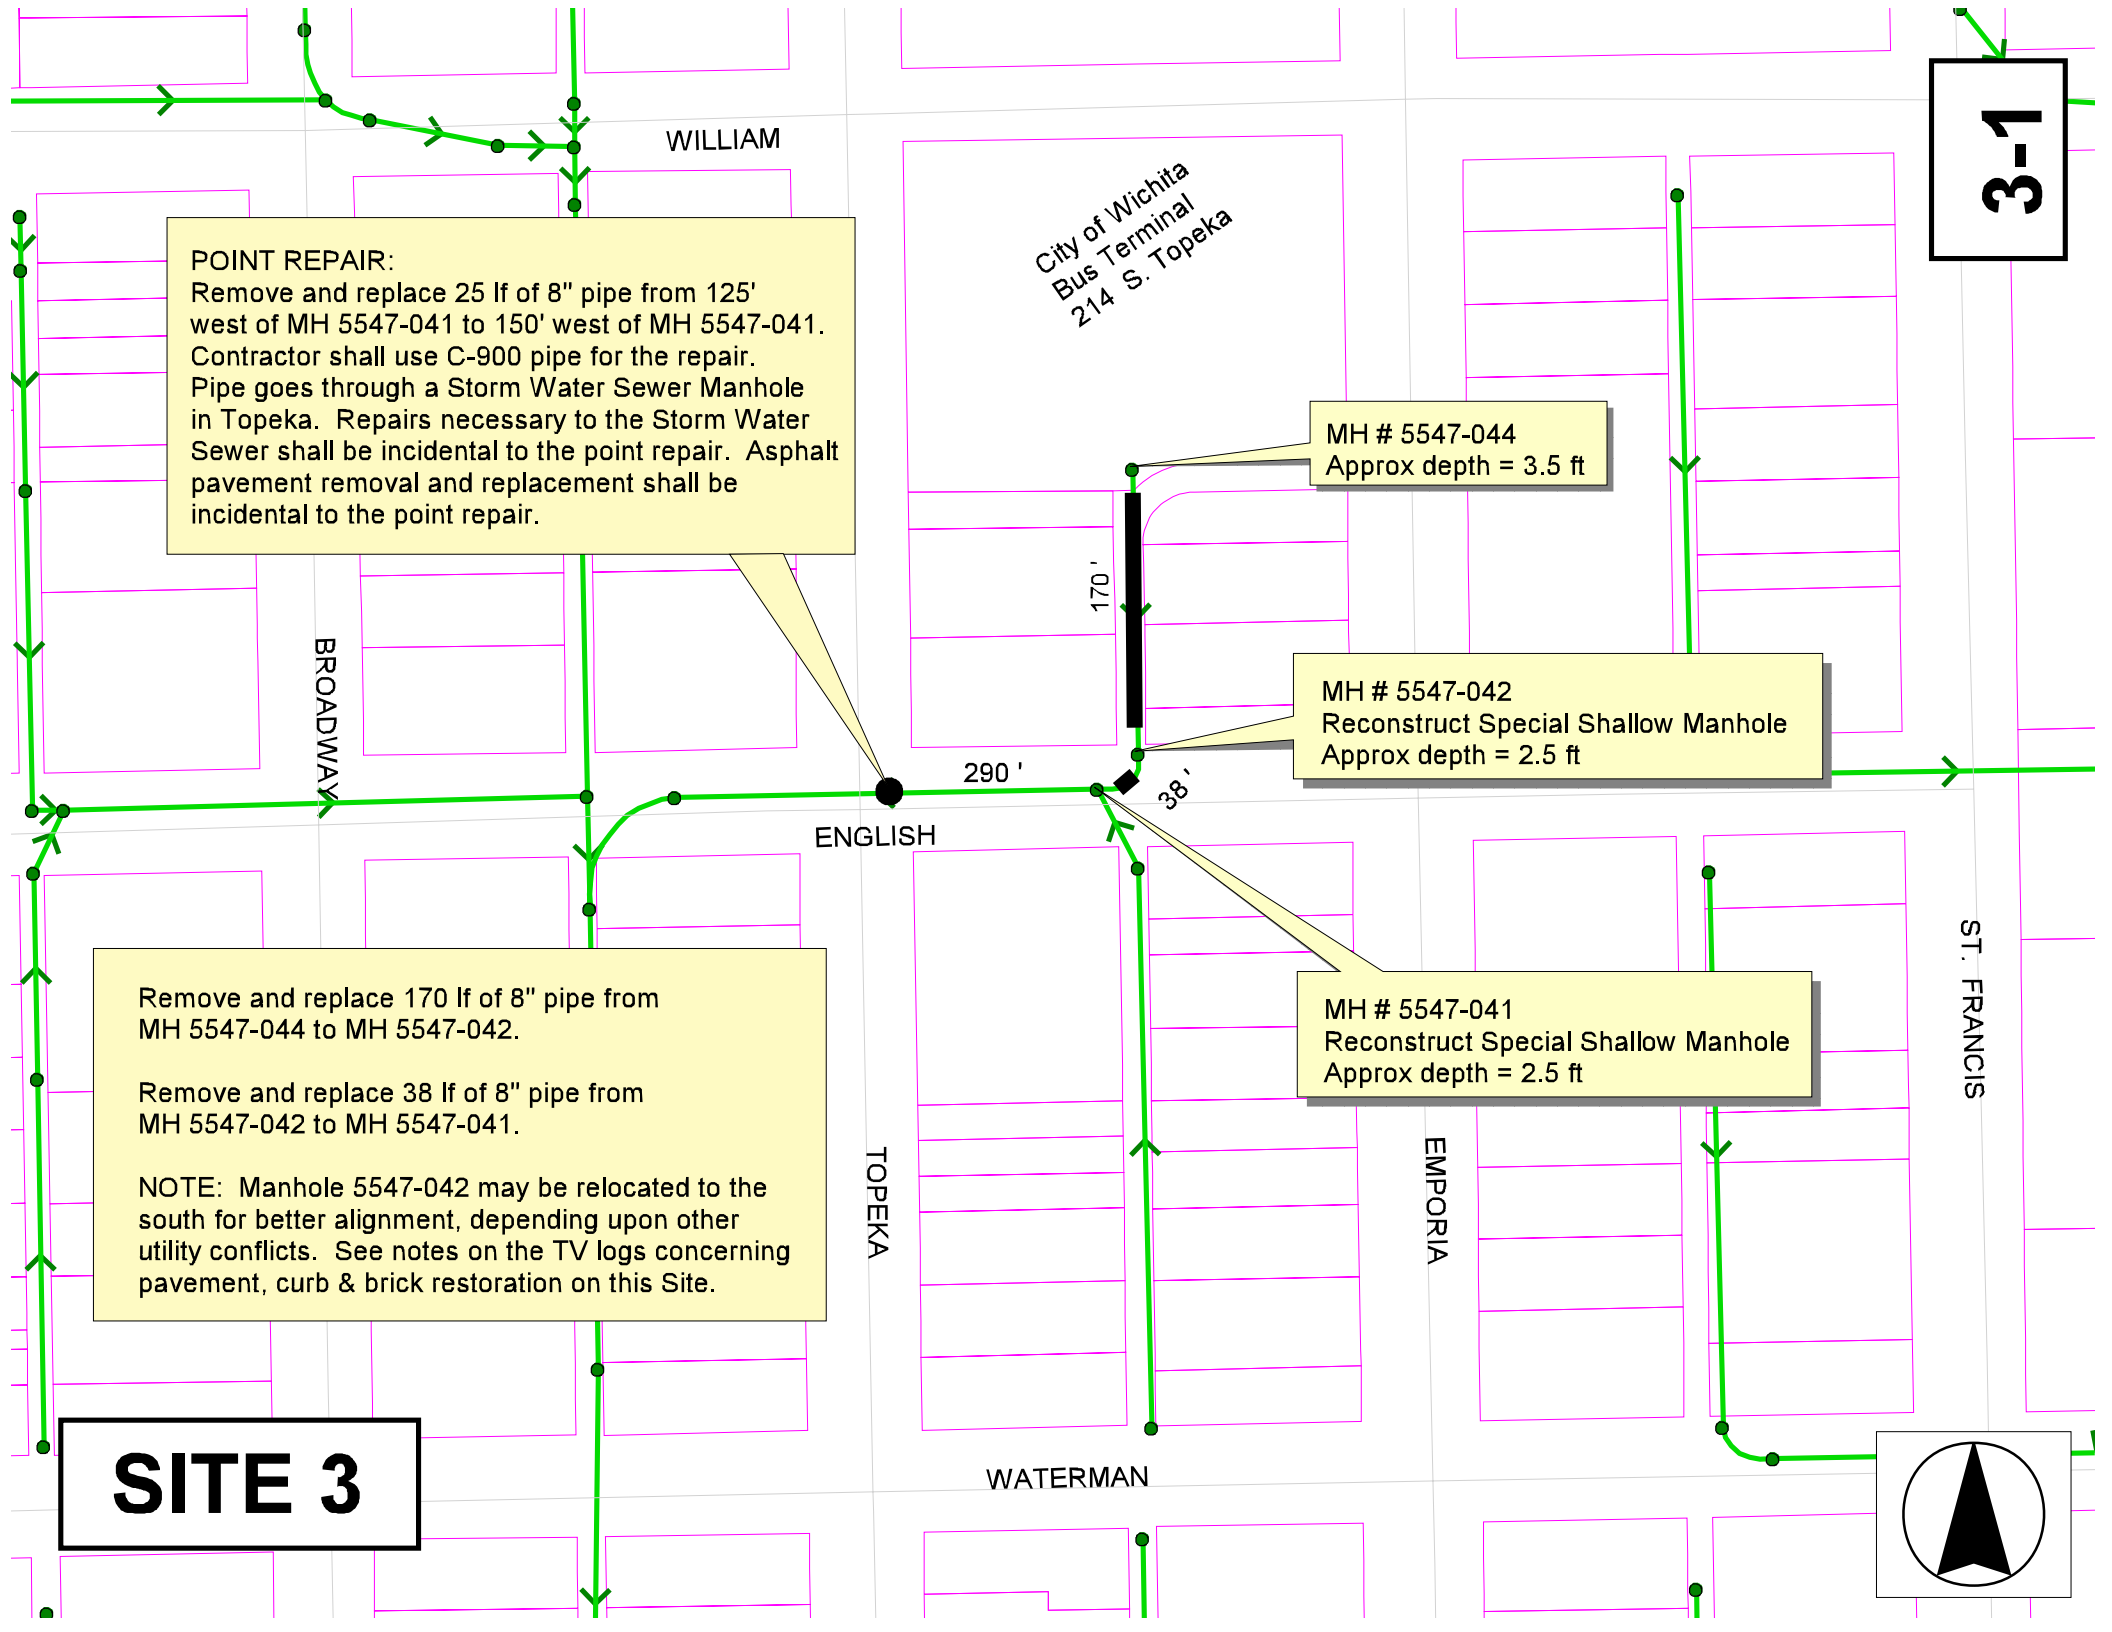
MH # 5547-044
Approx depth = 3.5 ft

MH # 5547-042
Reconstruct Special Shallow Manhole
Approx depth = 2.5 ft

MH # 5547-041
Reconstruct Special Shallow Manhole
Approx depth = 2.5 ft

POINT REPAIR:
Remove and replace 25 lf of 8" pipe from 125' west of MH 5547-041 to 150' west of MH 5547-041. Contractor shall use C-900 pipe for the repair. Pipe goes through a Storm Water Sewer Manhole in Topeka. Repairs necessary to the Storm Water Sewer shall be incidental to the point repair. Asphalt pavement removal and replacement shall be incidental to the point repair.

Remove and replace 170 lf of 8" pipe from MH 5547-044 to MH 5547-042.

Remove and replace 38 lf of 8" pipe from MH 5547-042 to MH 5547-041.

NOTE: Manhole 5547-042 may be relocated to the south for better alignment, depending upon other utility conflicts. See notes on the TV logs concerning pavement, curb & brick restoration on this Site.
