SITE 7

Television Inspection Master Report

US Structure: 6448-001
DS Structure: 6447-026

11 N SCOTTSDALE ST

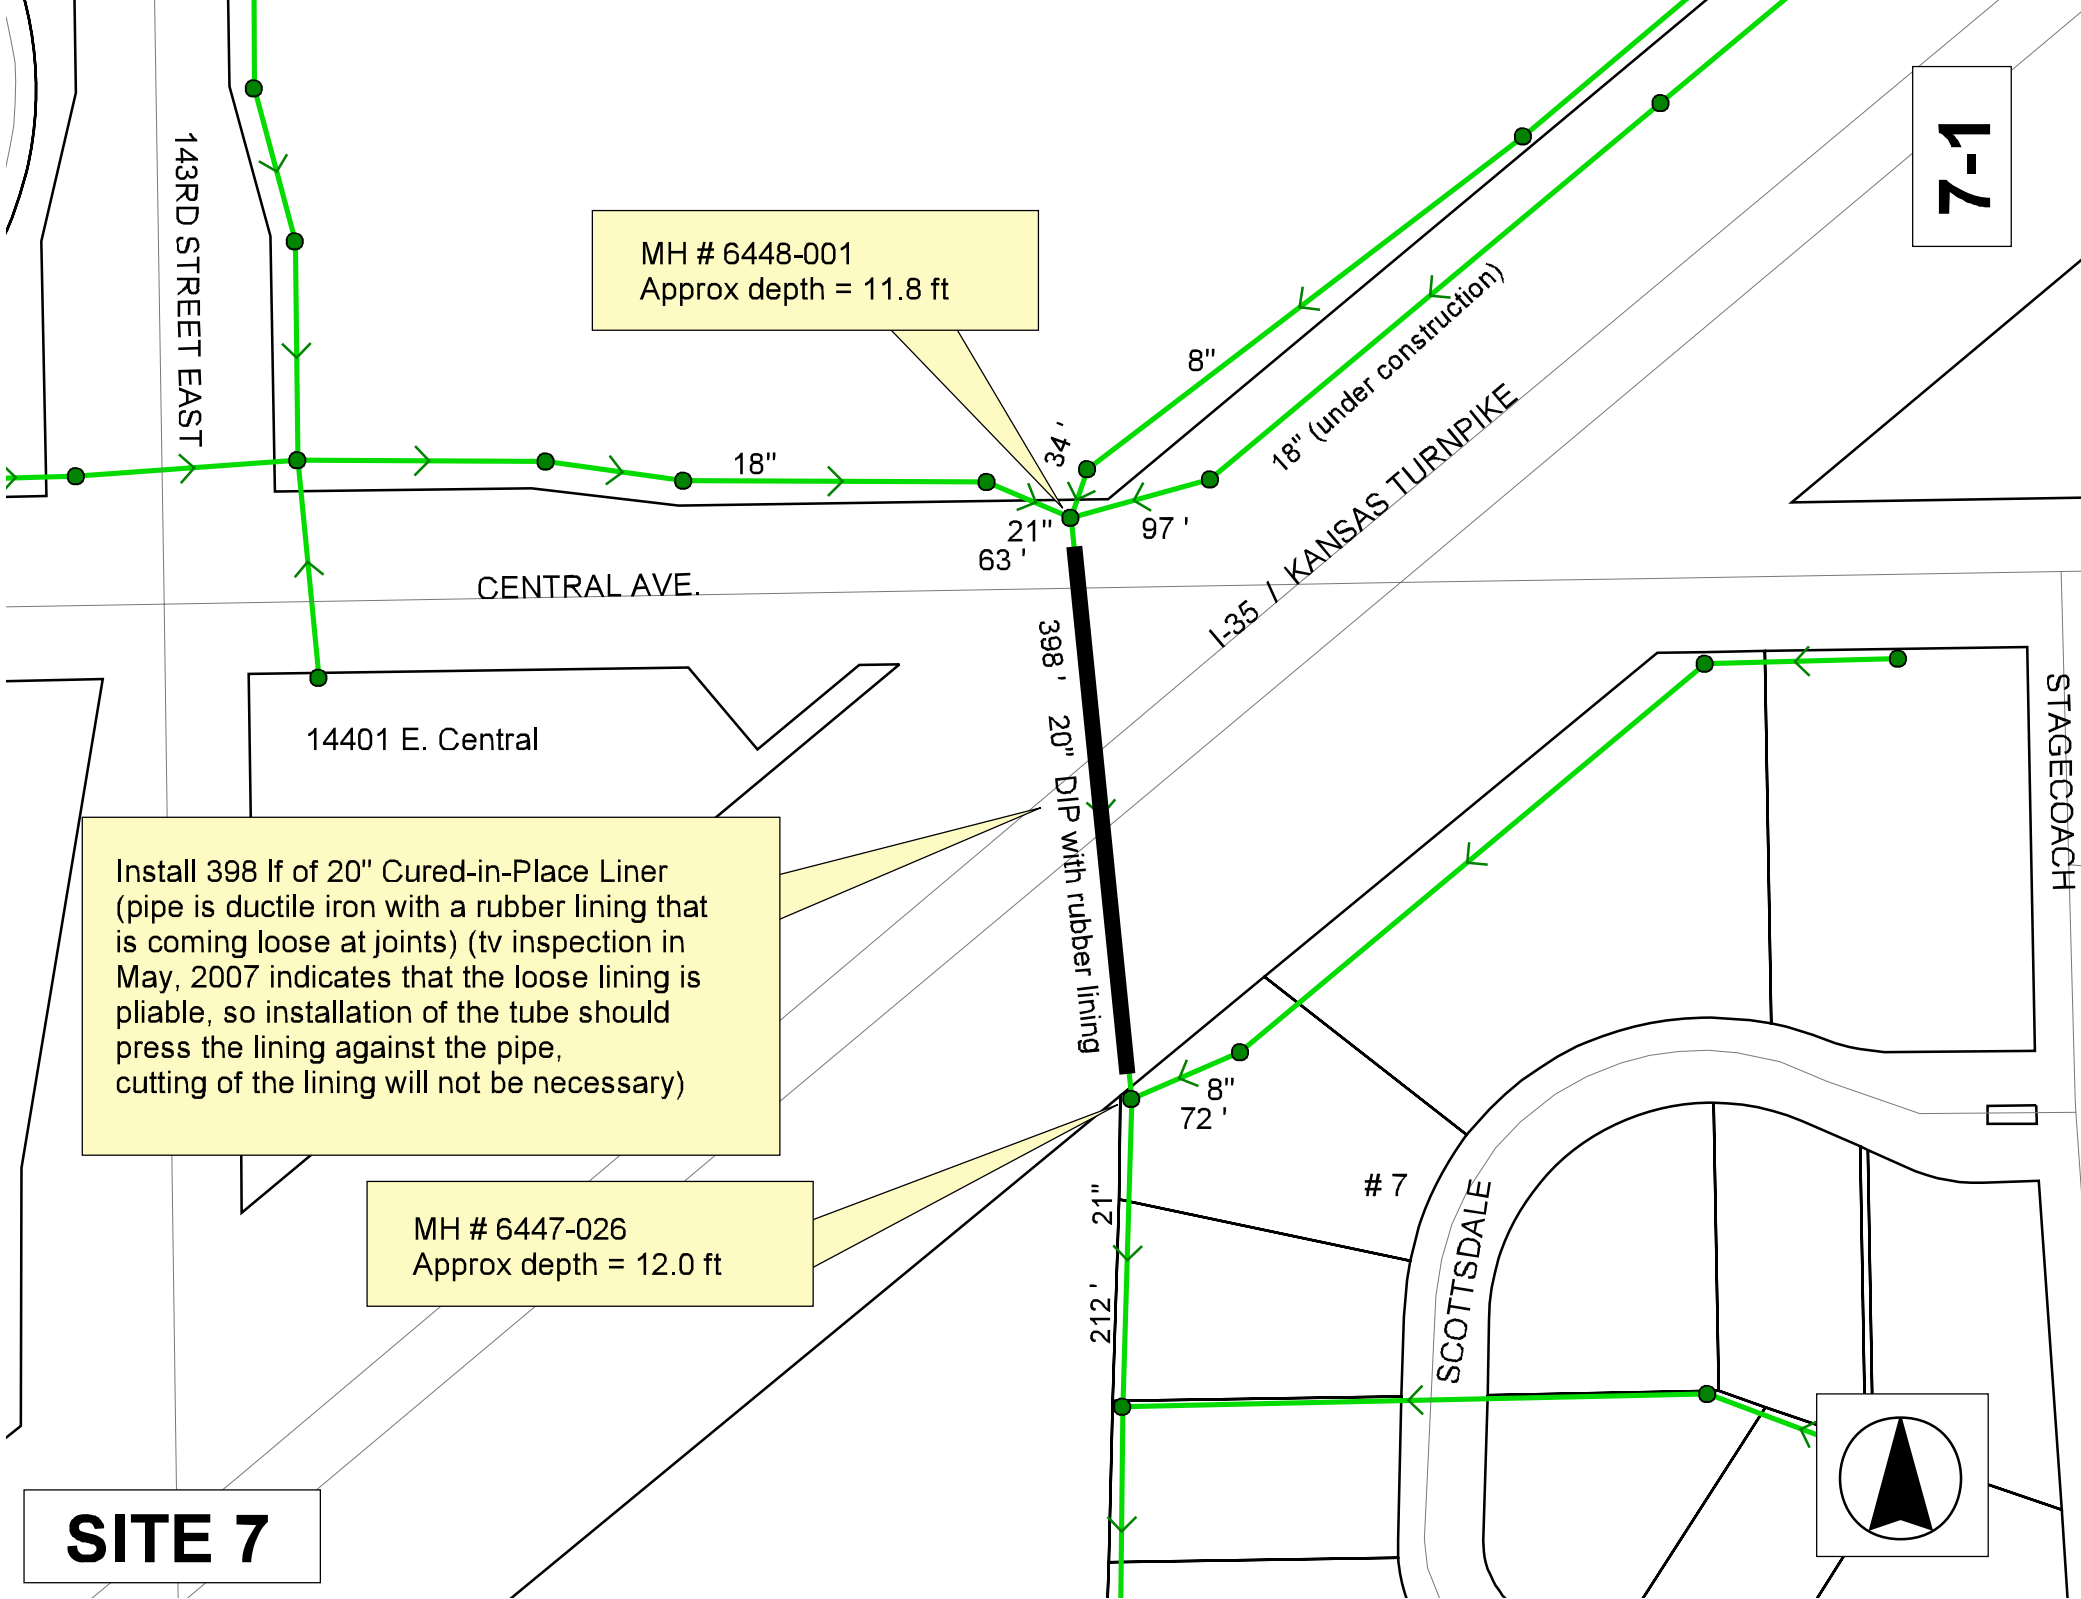
Install 398 lf of 20" Cured-in-Place Liner (pipe is ductile iron with a rubber lining that is coming loose at joints) (tv inspection in May, 2007 indicates that the loose lining is pliable, so installation of the tube should press the lining against the pipe, cutting of the lining will not be necessary)
