SITE 2

Sewer CCTV Observations

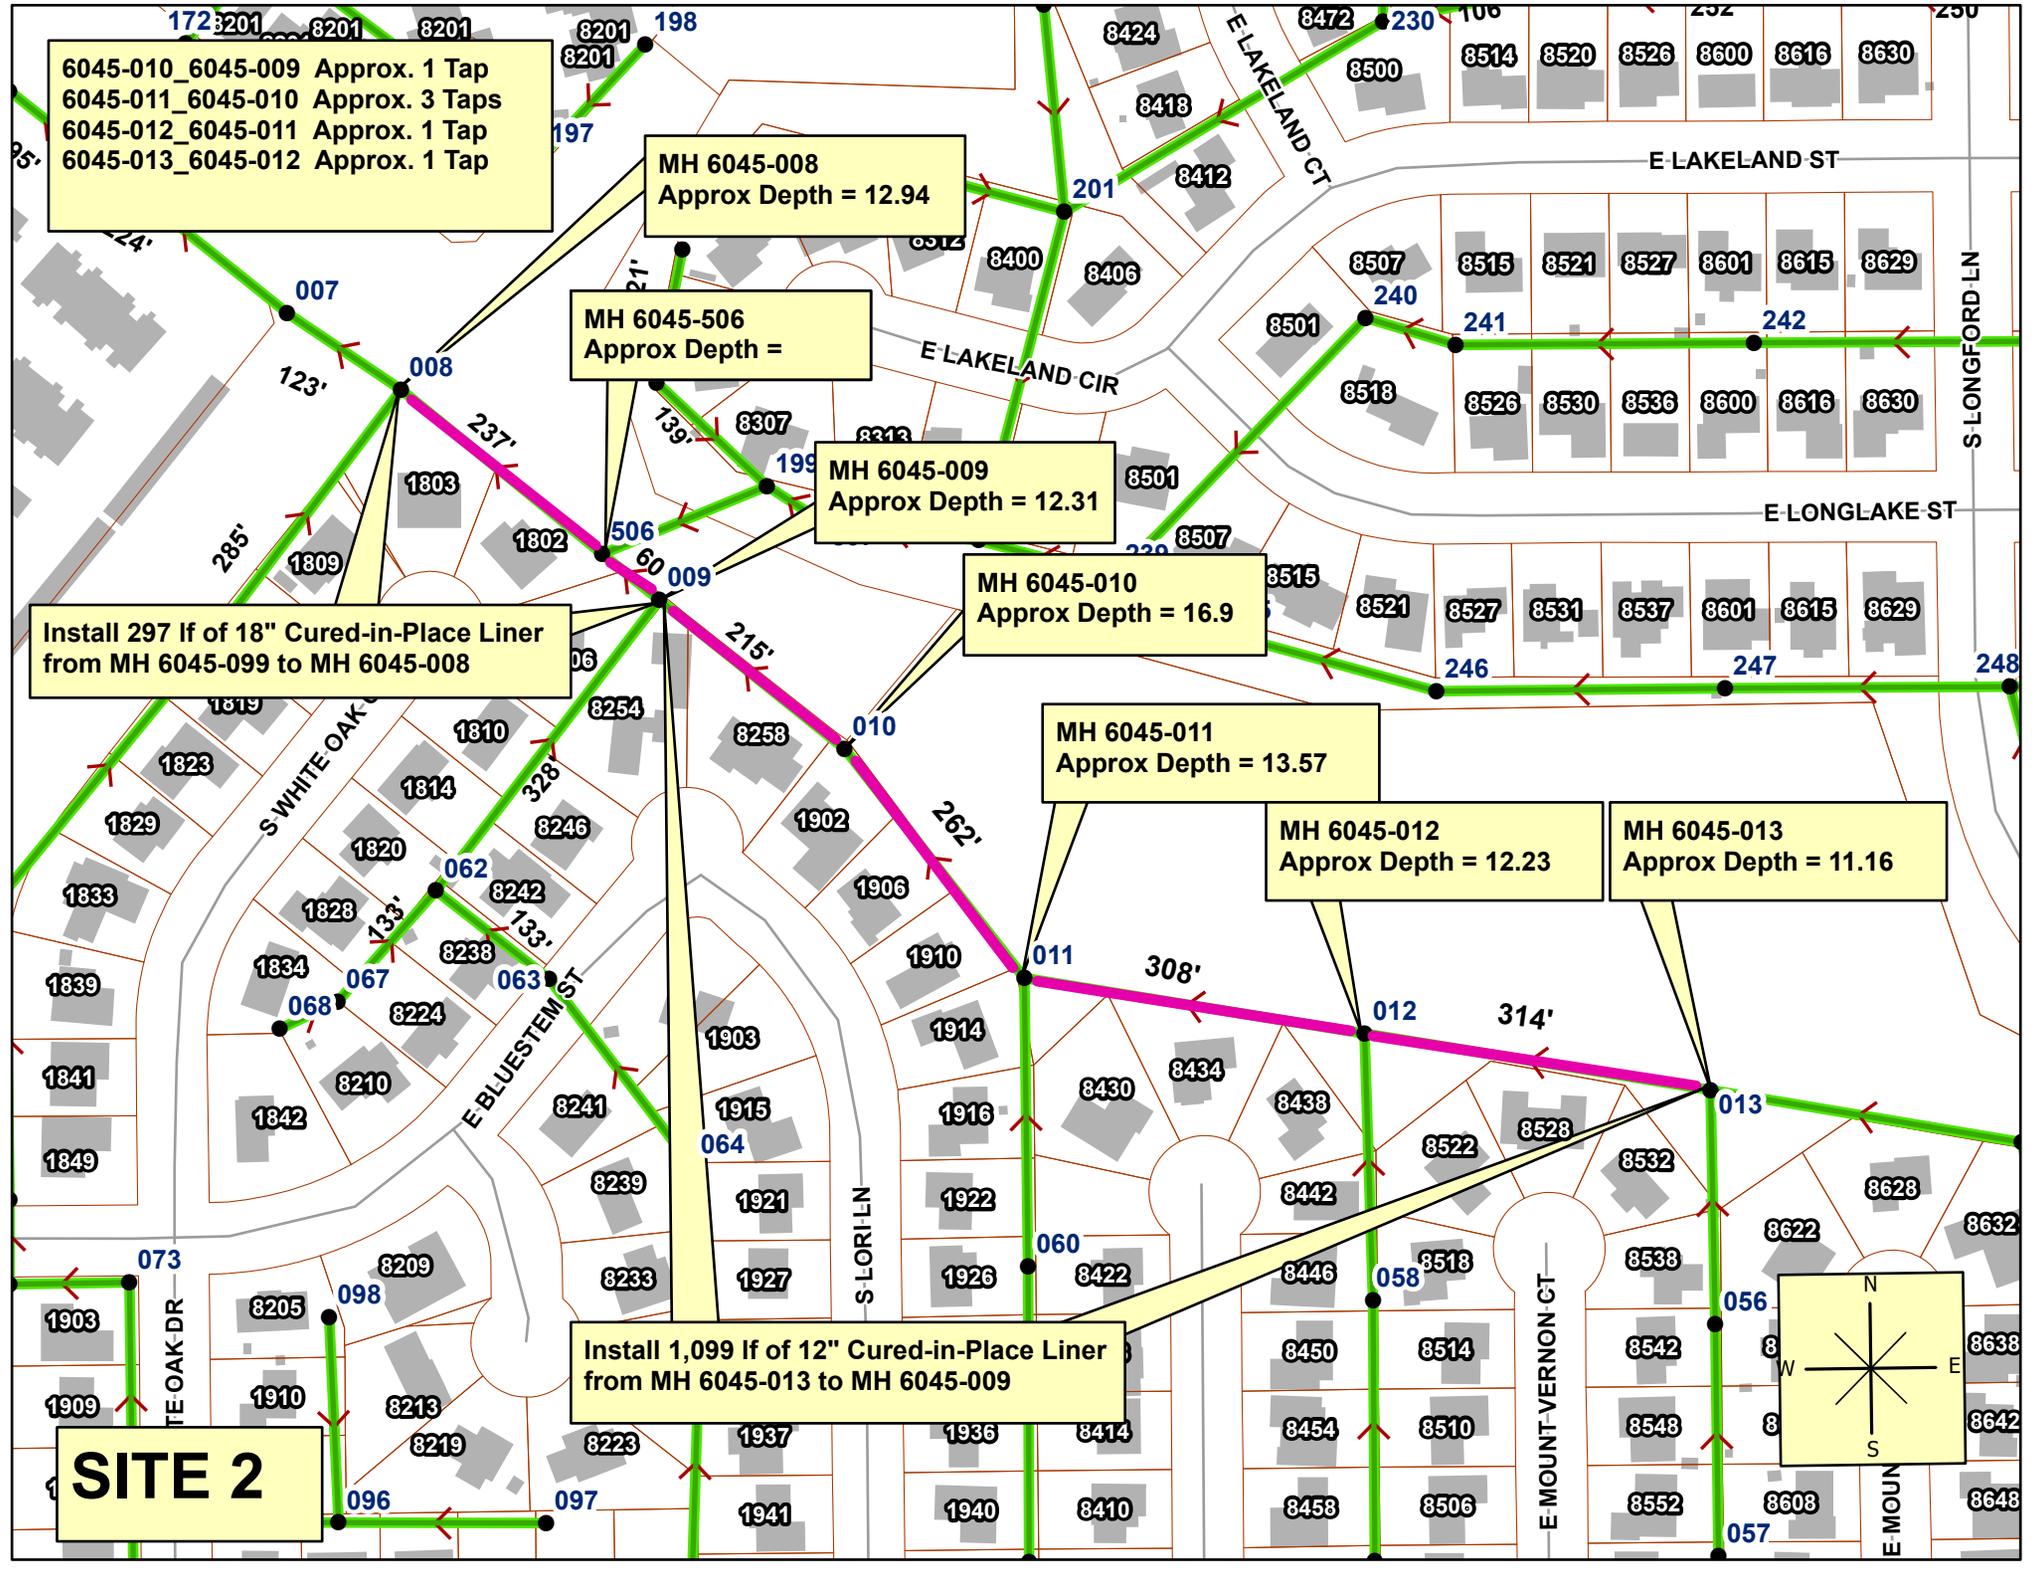
6045-010_6045-009 Approx. 1 Tap
6045-011_6045-010 Approx. 3 Taps
6045-012_6045-011 Approx. 1 Tap
6045-013_6045-012 Approx. 1 Tap

Install 297 lf of 18" Cured-in-Place Liner
from MH 6045-099 to MH 6045-008

Install 1,099 lf of 12" Cured-in-Place Liner
from MH 6045-013 to MH 6045-009
