Install 459 lf of 8" Cured-in-Place Liner  
from MH 5948-108 to MH 5948-106

**SITE 5**

**Sewer CCTV Observations**

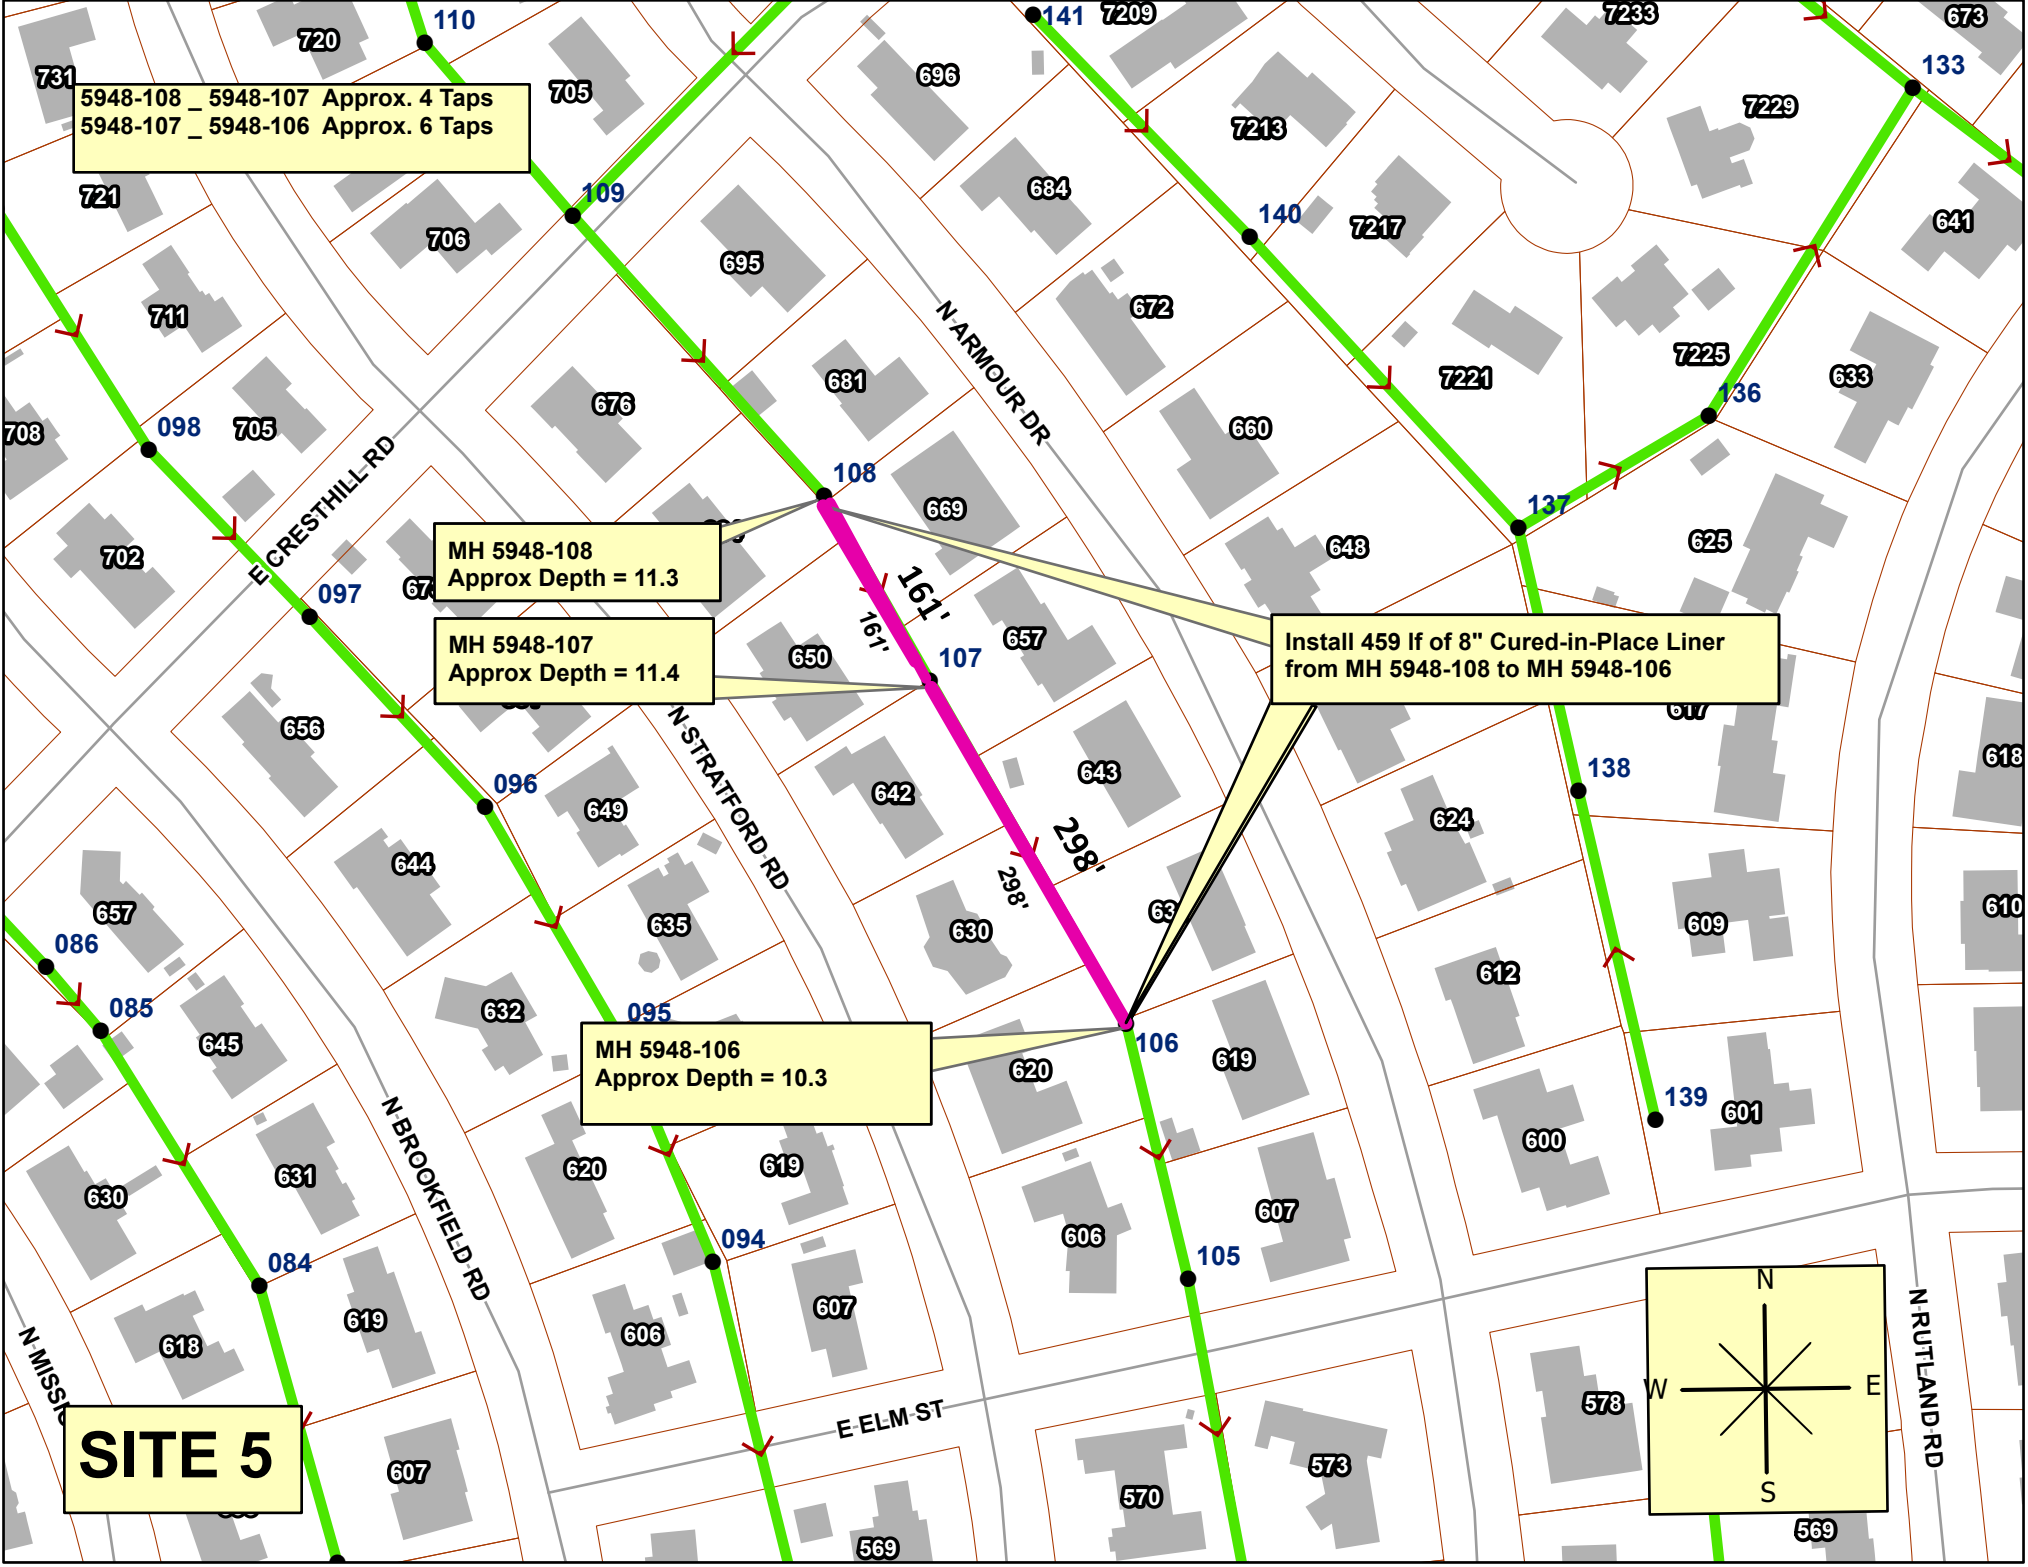
5948-108 \_ 5948-107 Approx. 4 Taps  
5948-107 \_ 5948-106 Approx. 6 Taps

MH 5948-108  
Approx Depth = 11.3

MH 5948-107  
Approx Depth = 11.4

MH 5948-106  
Approx Depth = 10.3
