Church of Christ  
600 S. Poplar

SITE 2

# Television Inspection Master Report

US Structure: 5646-155  
DS Structure: 5646-154

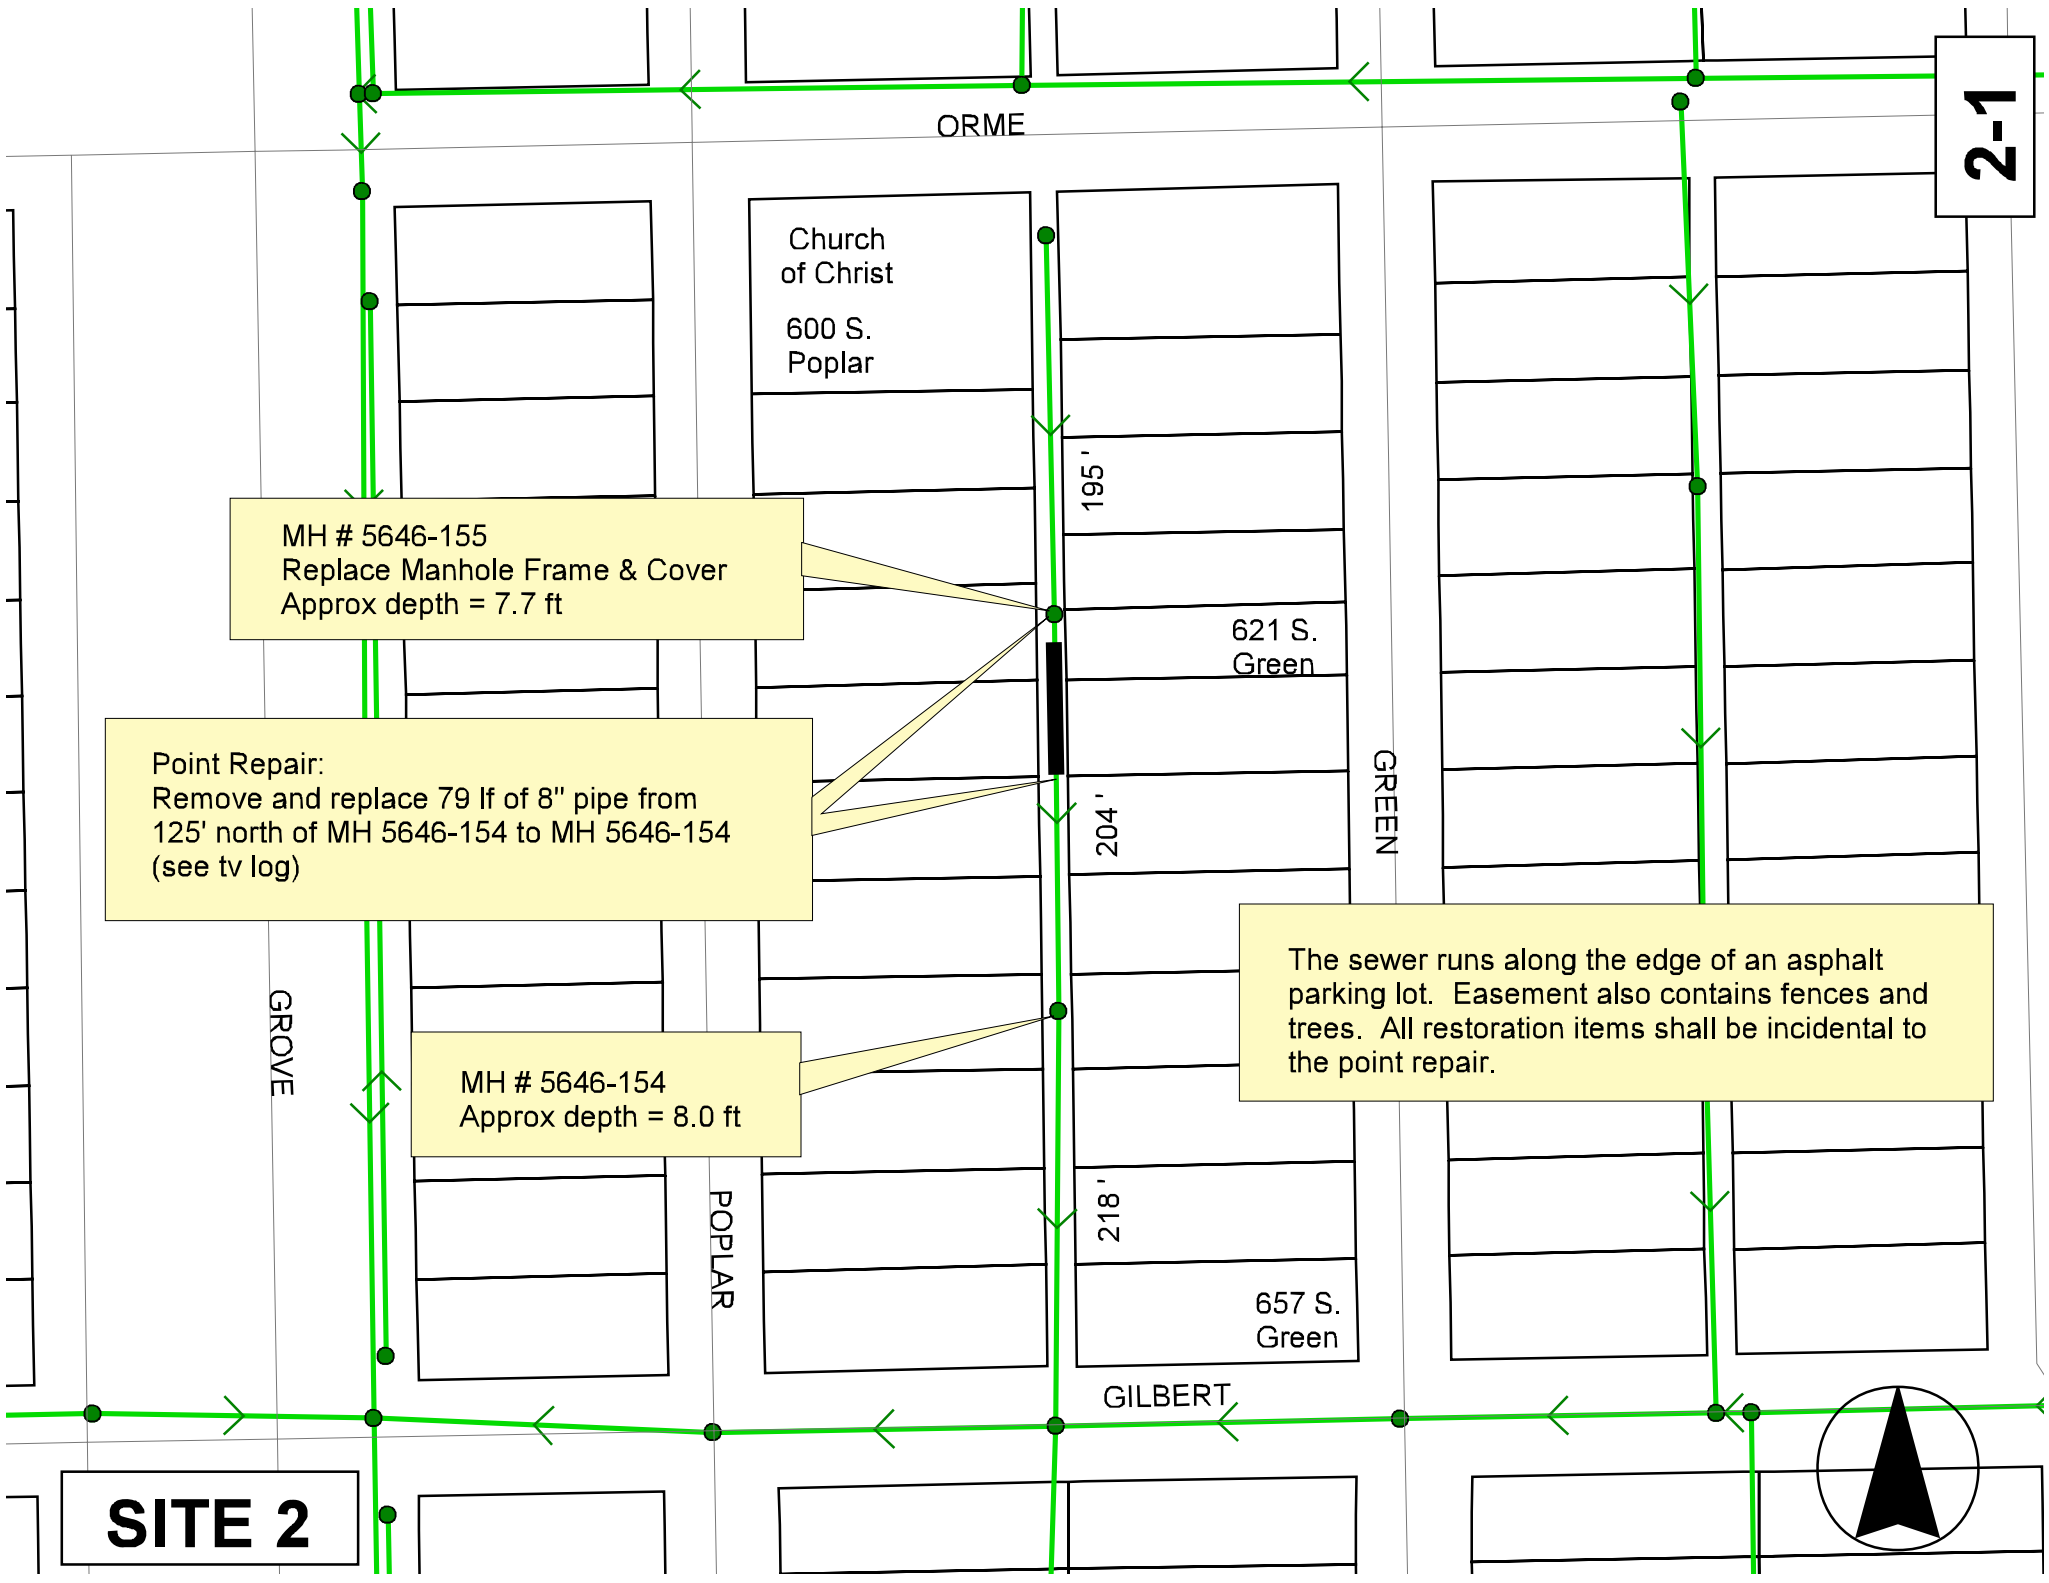
MH # 5646-155  
Replace Manhole Frame & Cover  
Approx depth = 7.7 ft

The sewer runs along the edge of an asphalt parking lot. Easement also contains fences and trees. All restoration items shall be incidental to the point repair.

MH # 5646-154  
Approx depth = 8.0 ft

Point Repair:  
Remove and replace 79 lf of 8" pipe from  
125' north of MH 5646-154 to MH 5646-154  
(see tv log)
