Defect Listing Plot

Pipe Segment Refere... 14	City WICHITA	Street MCLEAN BLVD	Material PolyVinyl Chloride	Location C... Easement/R...	Sewer Use Stormwater
Upstream MH 0+44.08	Total Length	Up Rim to Invert 9	Shape Circular	Location Details LINE 0	
DS Manhole INVERT RIVER	Length surveyed 36.9	Down Rim to Invert 0	Height 18	Width 18	Pipe Joint...
SPR 0	MPR 0	PO Number 603 PPD 133119		Customer DONDLINGER	
SPRI 0	MPRI 0	Work Order		Purpose Pre-Acceptance	
QSR 0000	QMR 0000	Direction Downstream	Date 20200124	Media label	
OPR 0	Surveyed By Chuck	Pre-Cleaning Jetting	Time 12:13	Weather Light Rain	
OPRI 0	Certificate Number U-0118-070300421		End Time 12:16	Additional Info TV14	
	Date Cleaned 20200124

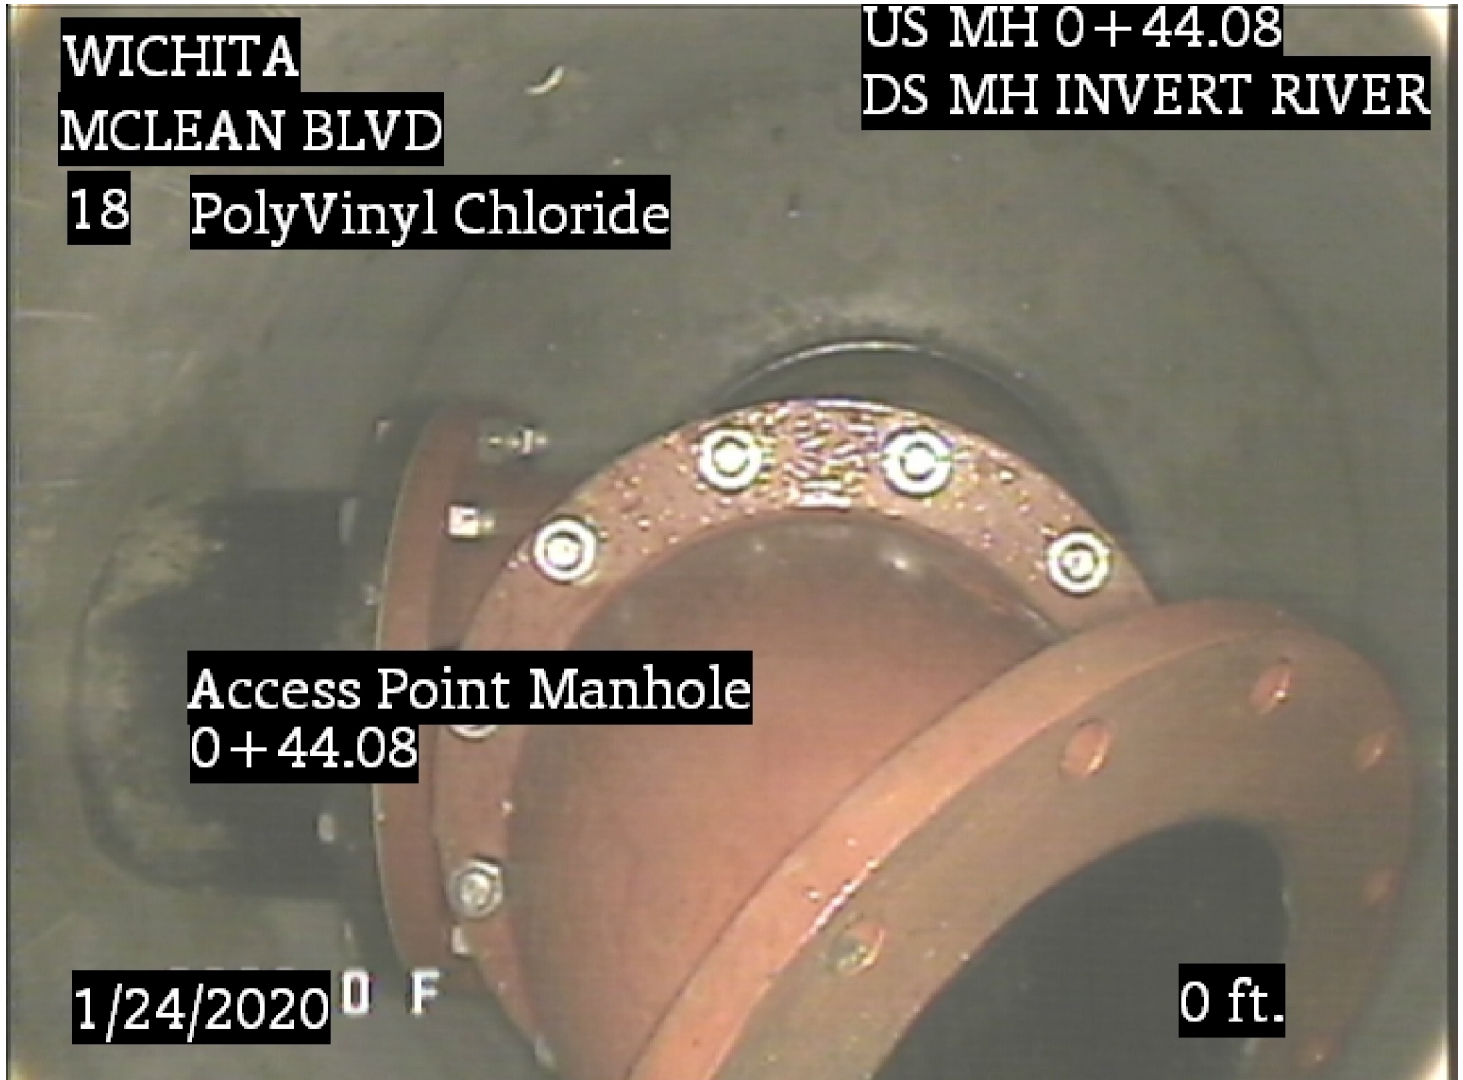
Distance:	0.0 ft.
Condition:	Access Point Manhole
Grade:	0
Remarks:	0+44.08

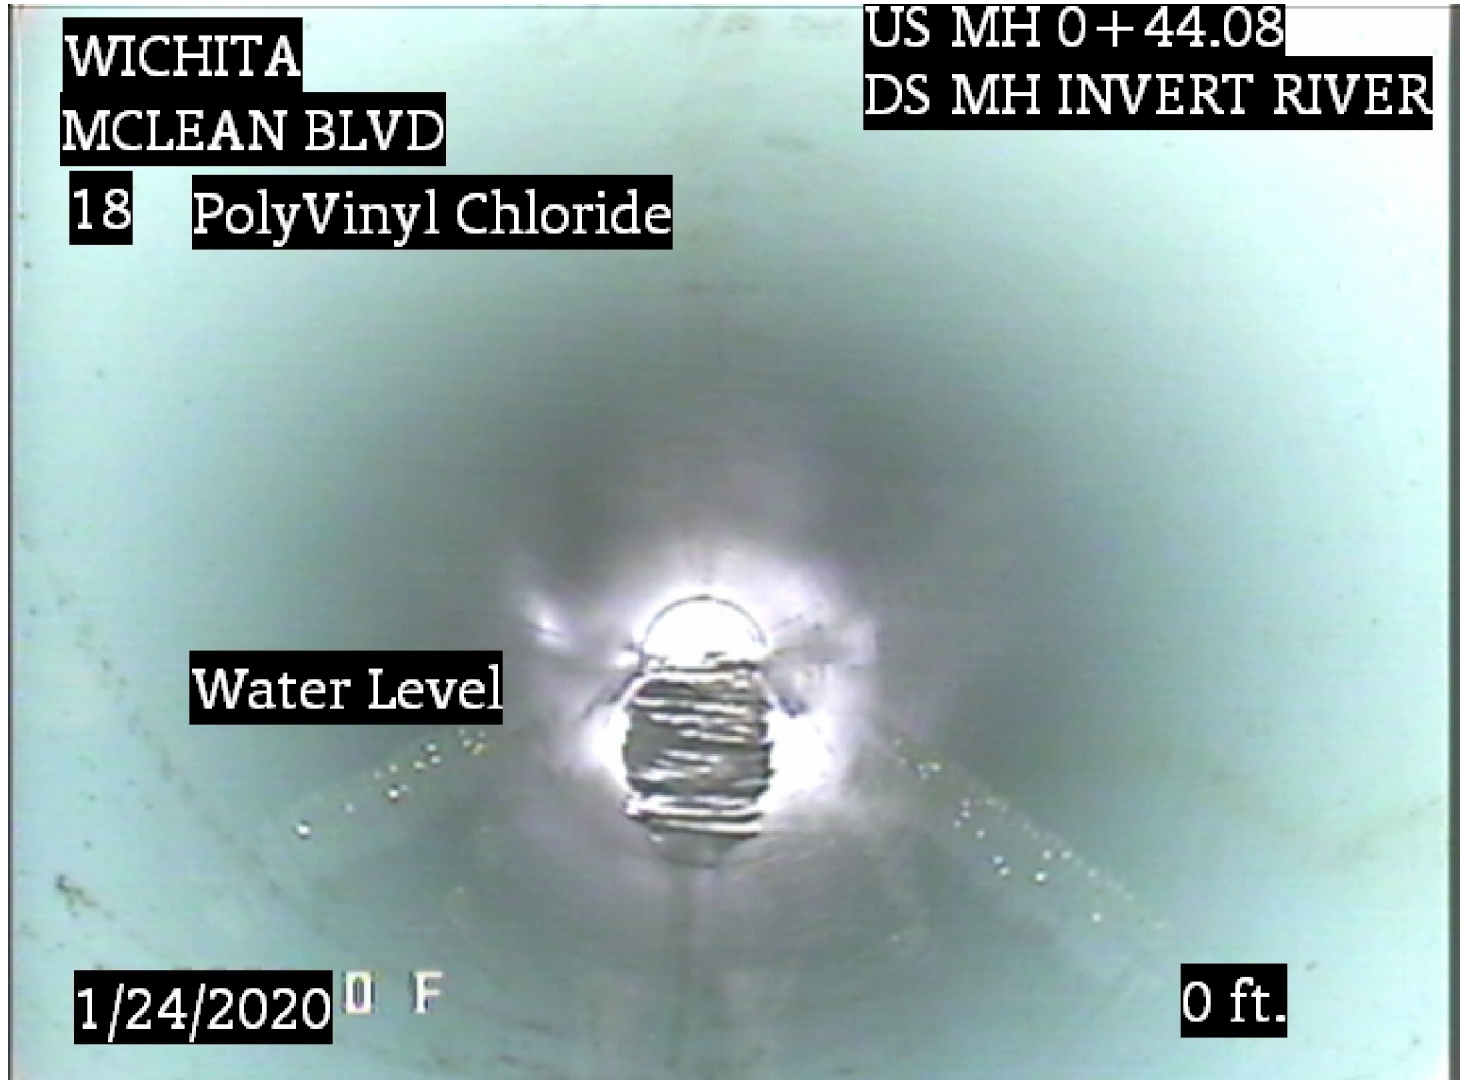
Distance:	0.0 ft.
Condition:	Water Level
Grade:	0
Remarks:	N/A

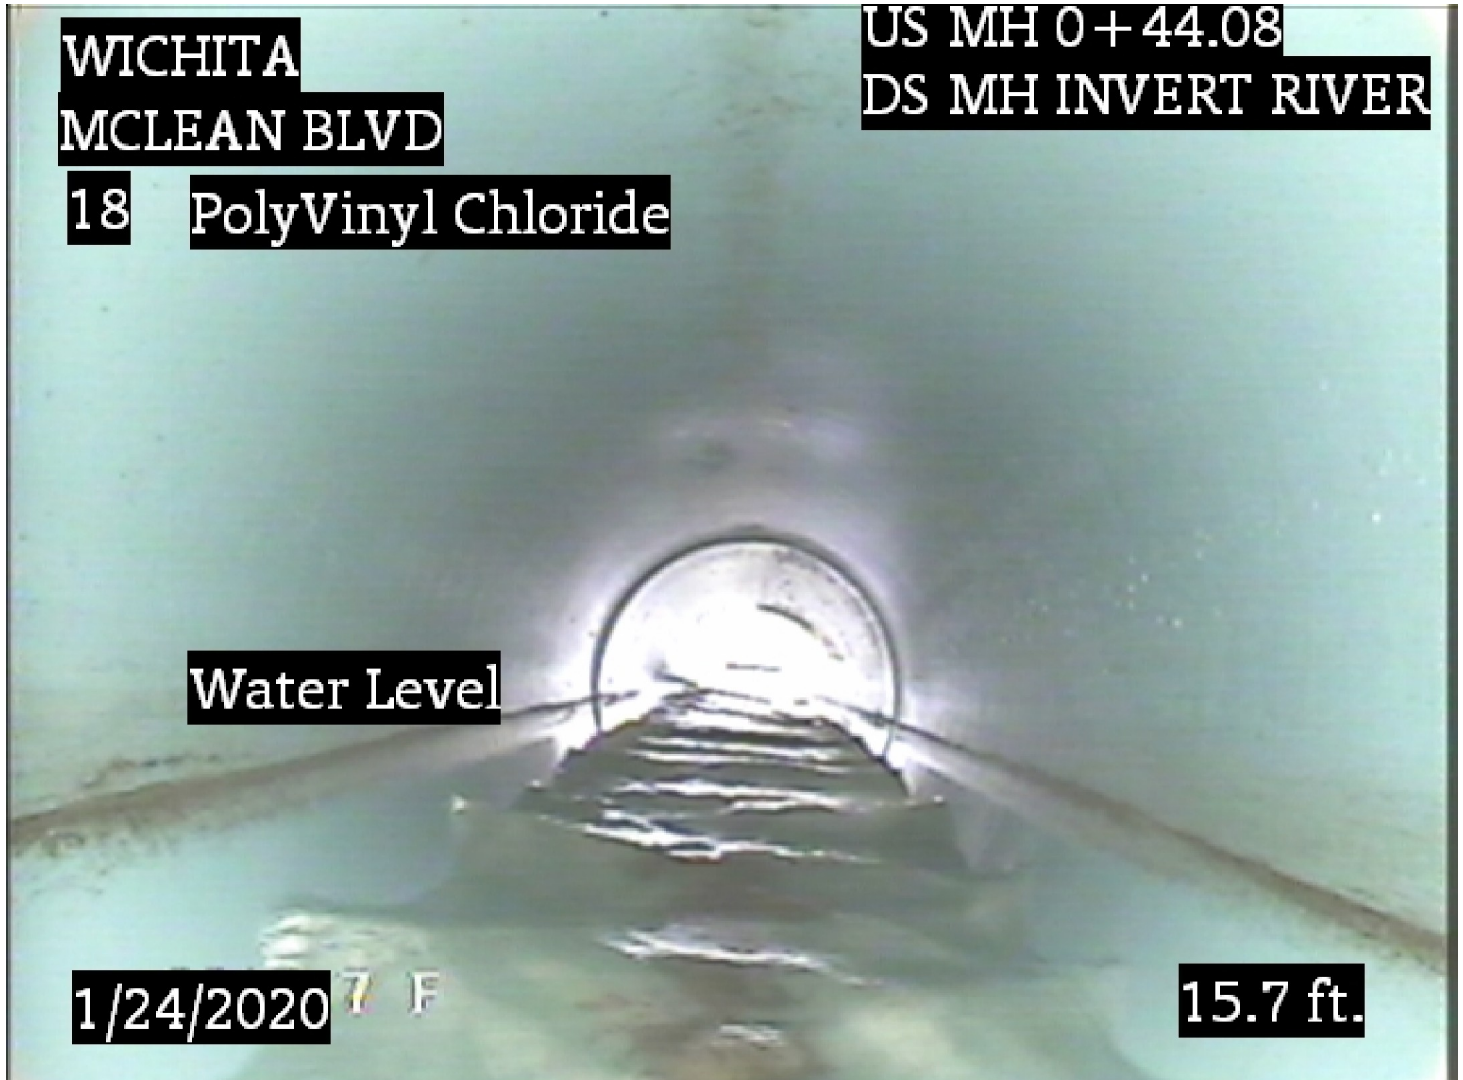
Distance:	15.7 ft.
Condition:	Water Level
Grade:	0
Remarks:	N/A

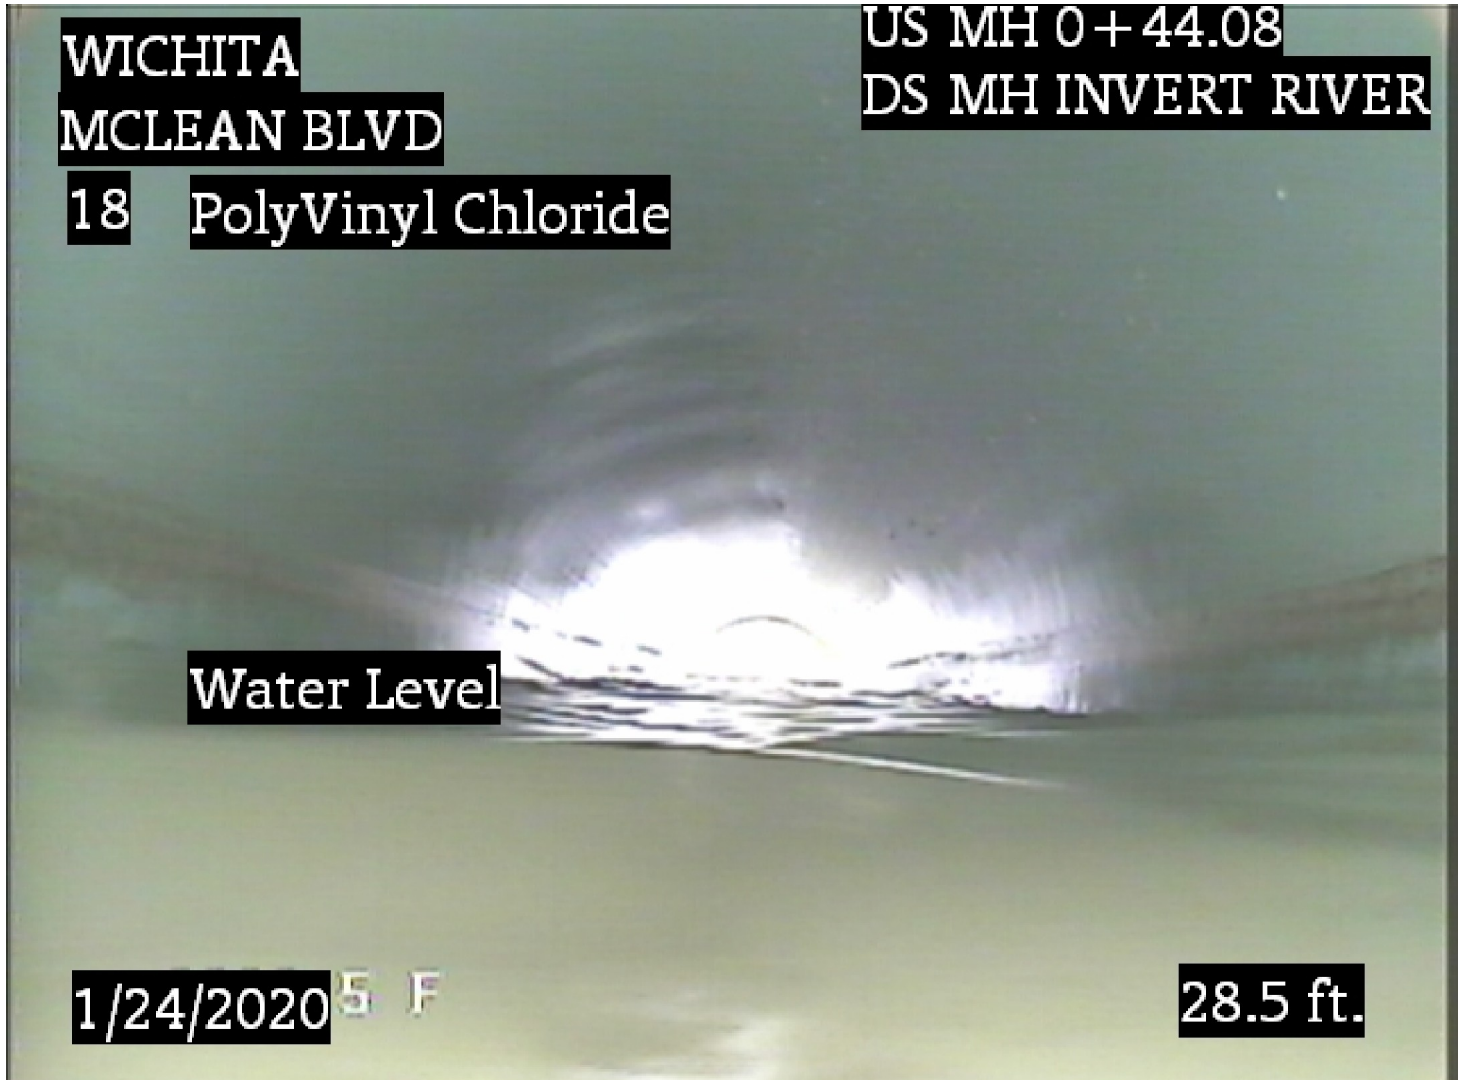
Distance:	28.5 ft.
Condition:	Water Level
Grade:	0
Remarks:	N/A
