**SITE 9**

# Television Inspection Master Report

US Structure: 5450-260      2522 N WELLINGTON PL      Date Insp: 3/6/2007      Basin: C04A  
DS Structure: 5450-259      116 W 24TH ST      Dir Televised: Upstream To Downstream

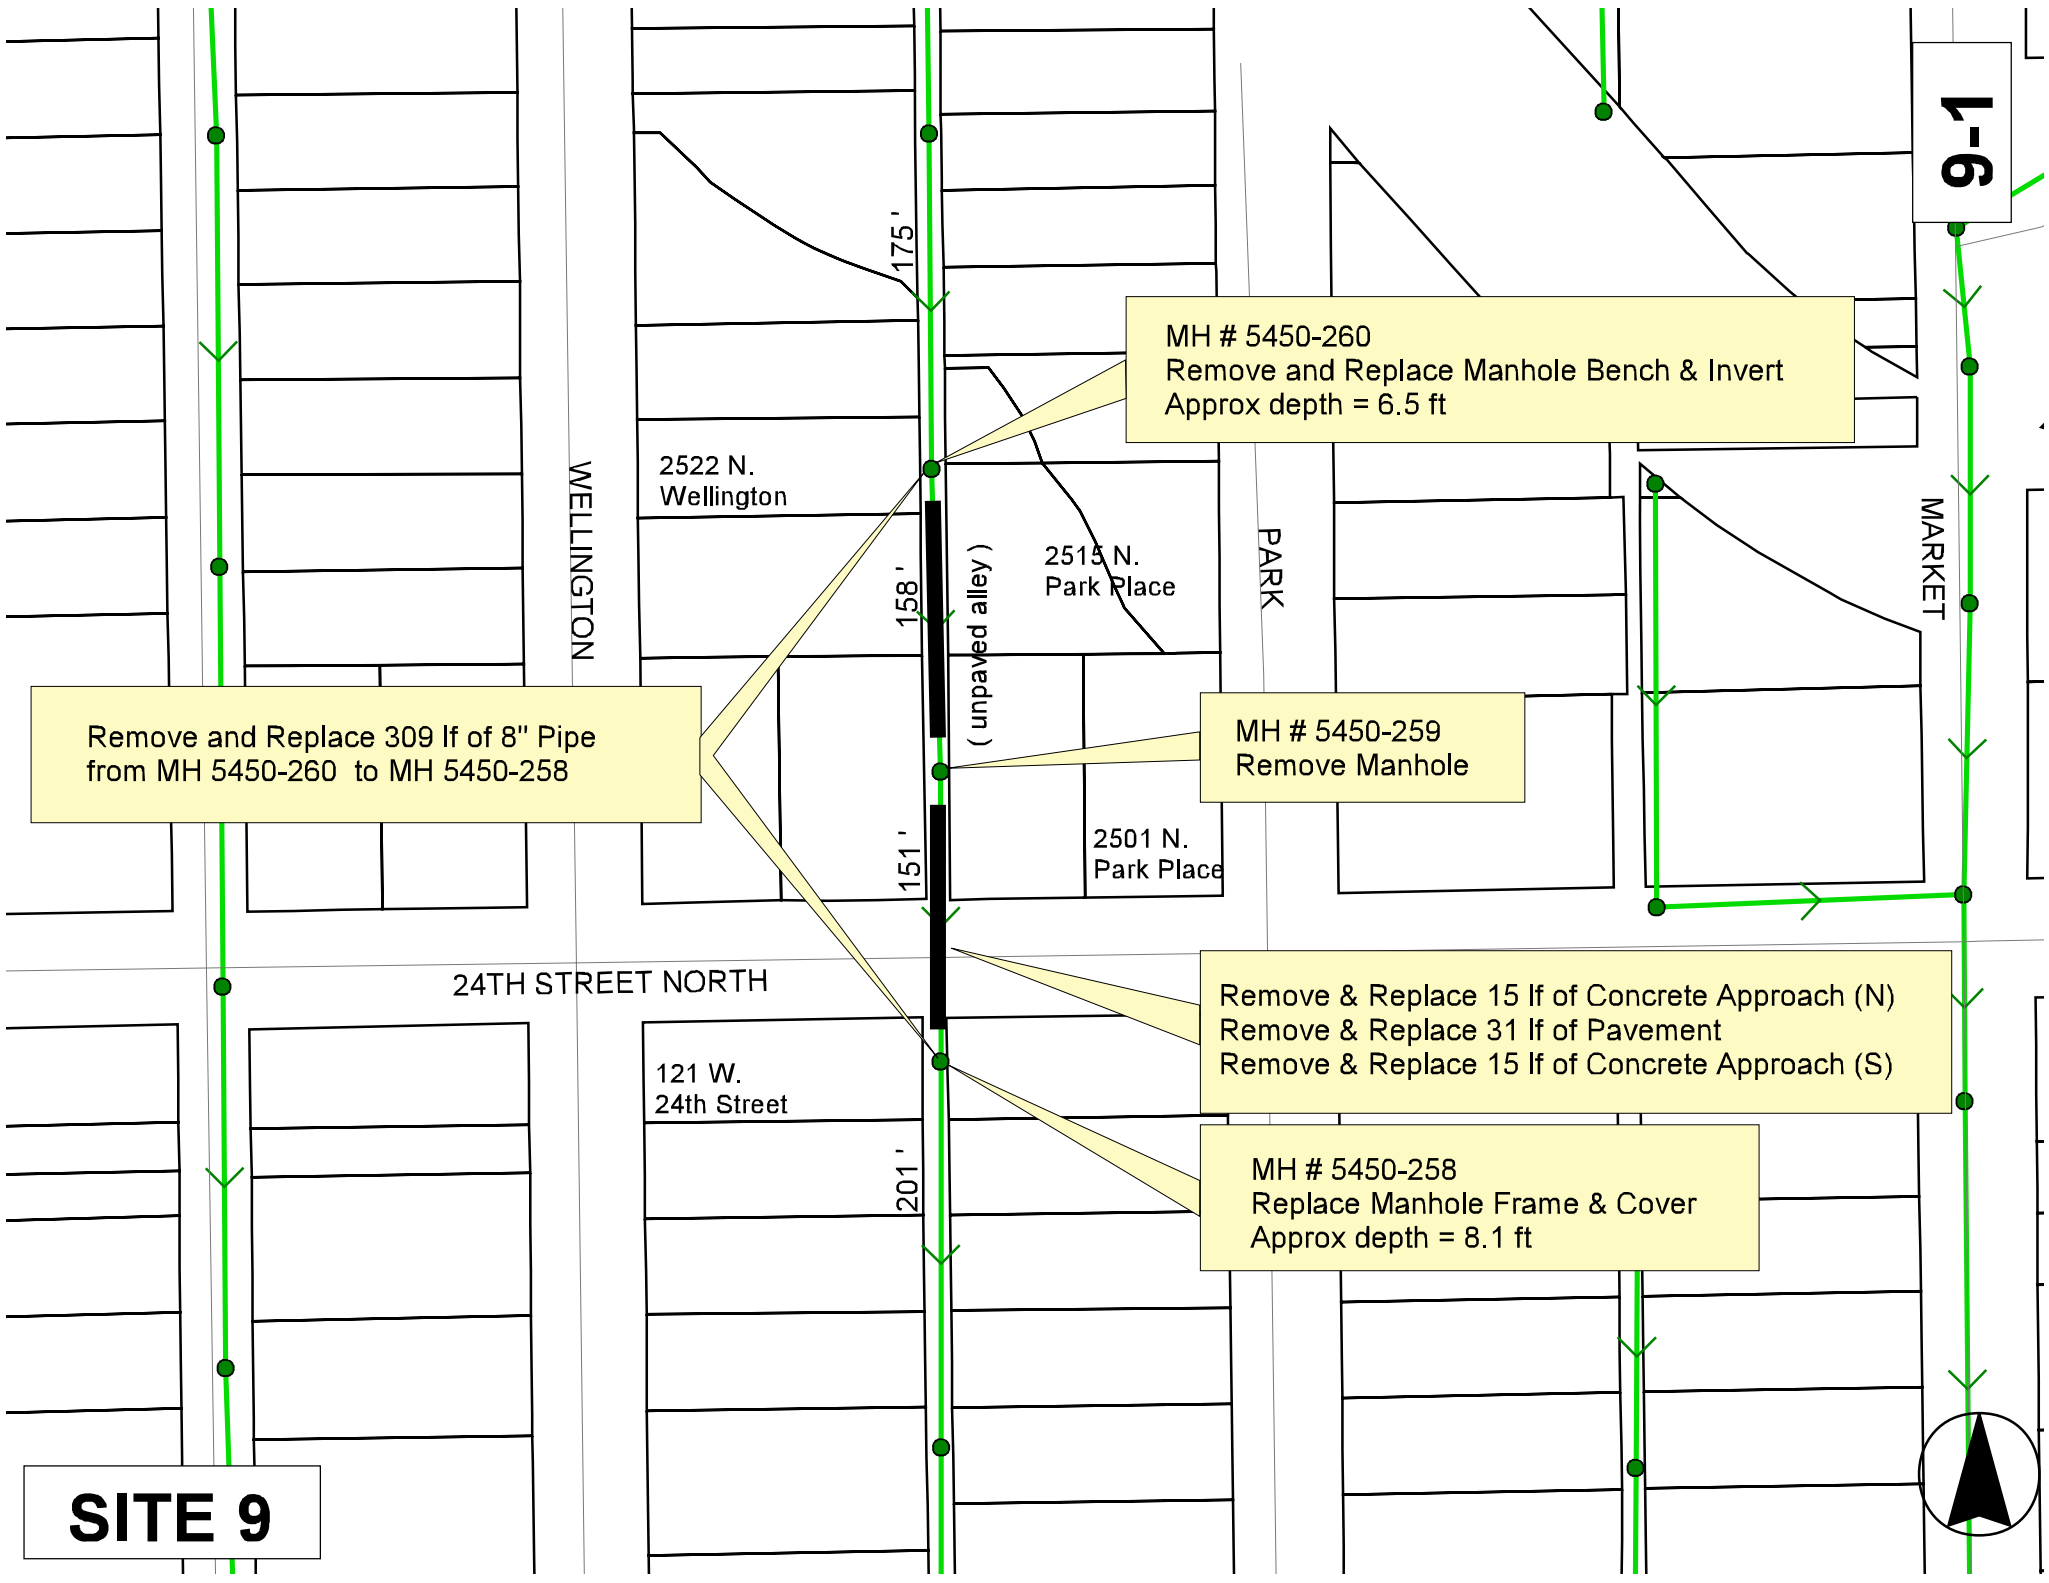
MH # 5450-260  
Remove and Replace Manhole Bench & Invert  
Approx depth = 6.5 ft

MH # 5450-259  
Remove Manhole

MH # 5450-258  
Replace Manhole Frame & Cover  
Approx depth = 8.1 ft

Remove and Replace 309 lf of 8" Pipe  
from MH 5450-260 to MH 5450-258

Remove & Replace 15 lf of Concrete Approach (N)  
Remove & Replace 31 lf of Pavement  
Remove & Replace 15 lf of Concrete Approach (S)
