**SITE 3**

MAP 1 OF 2

**3-1**

# Television Inspection Master Report

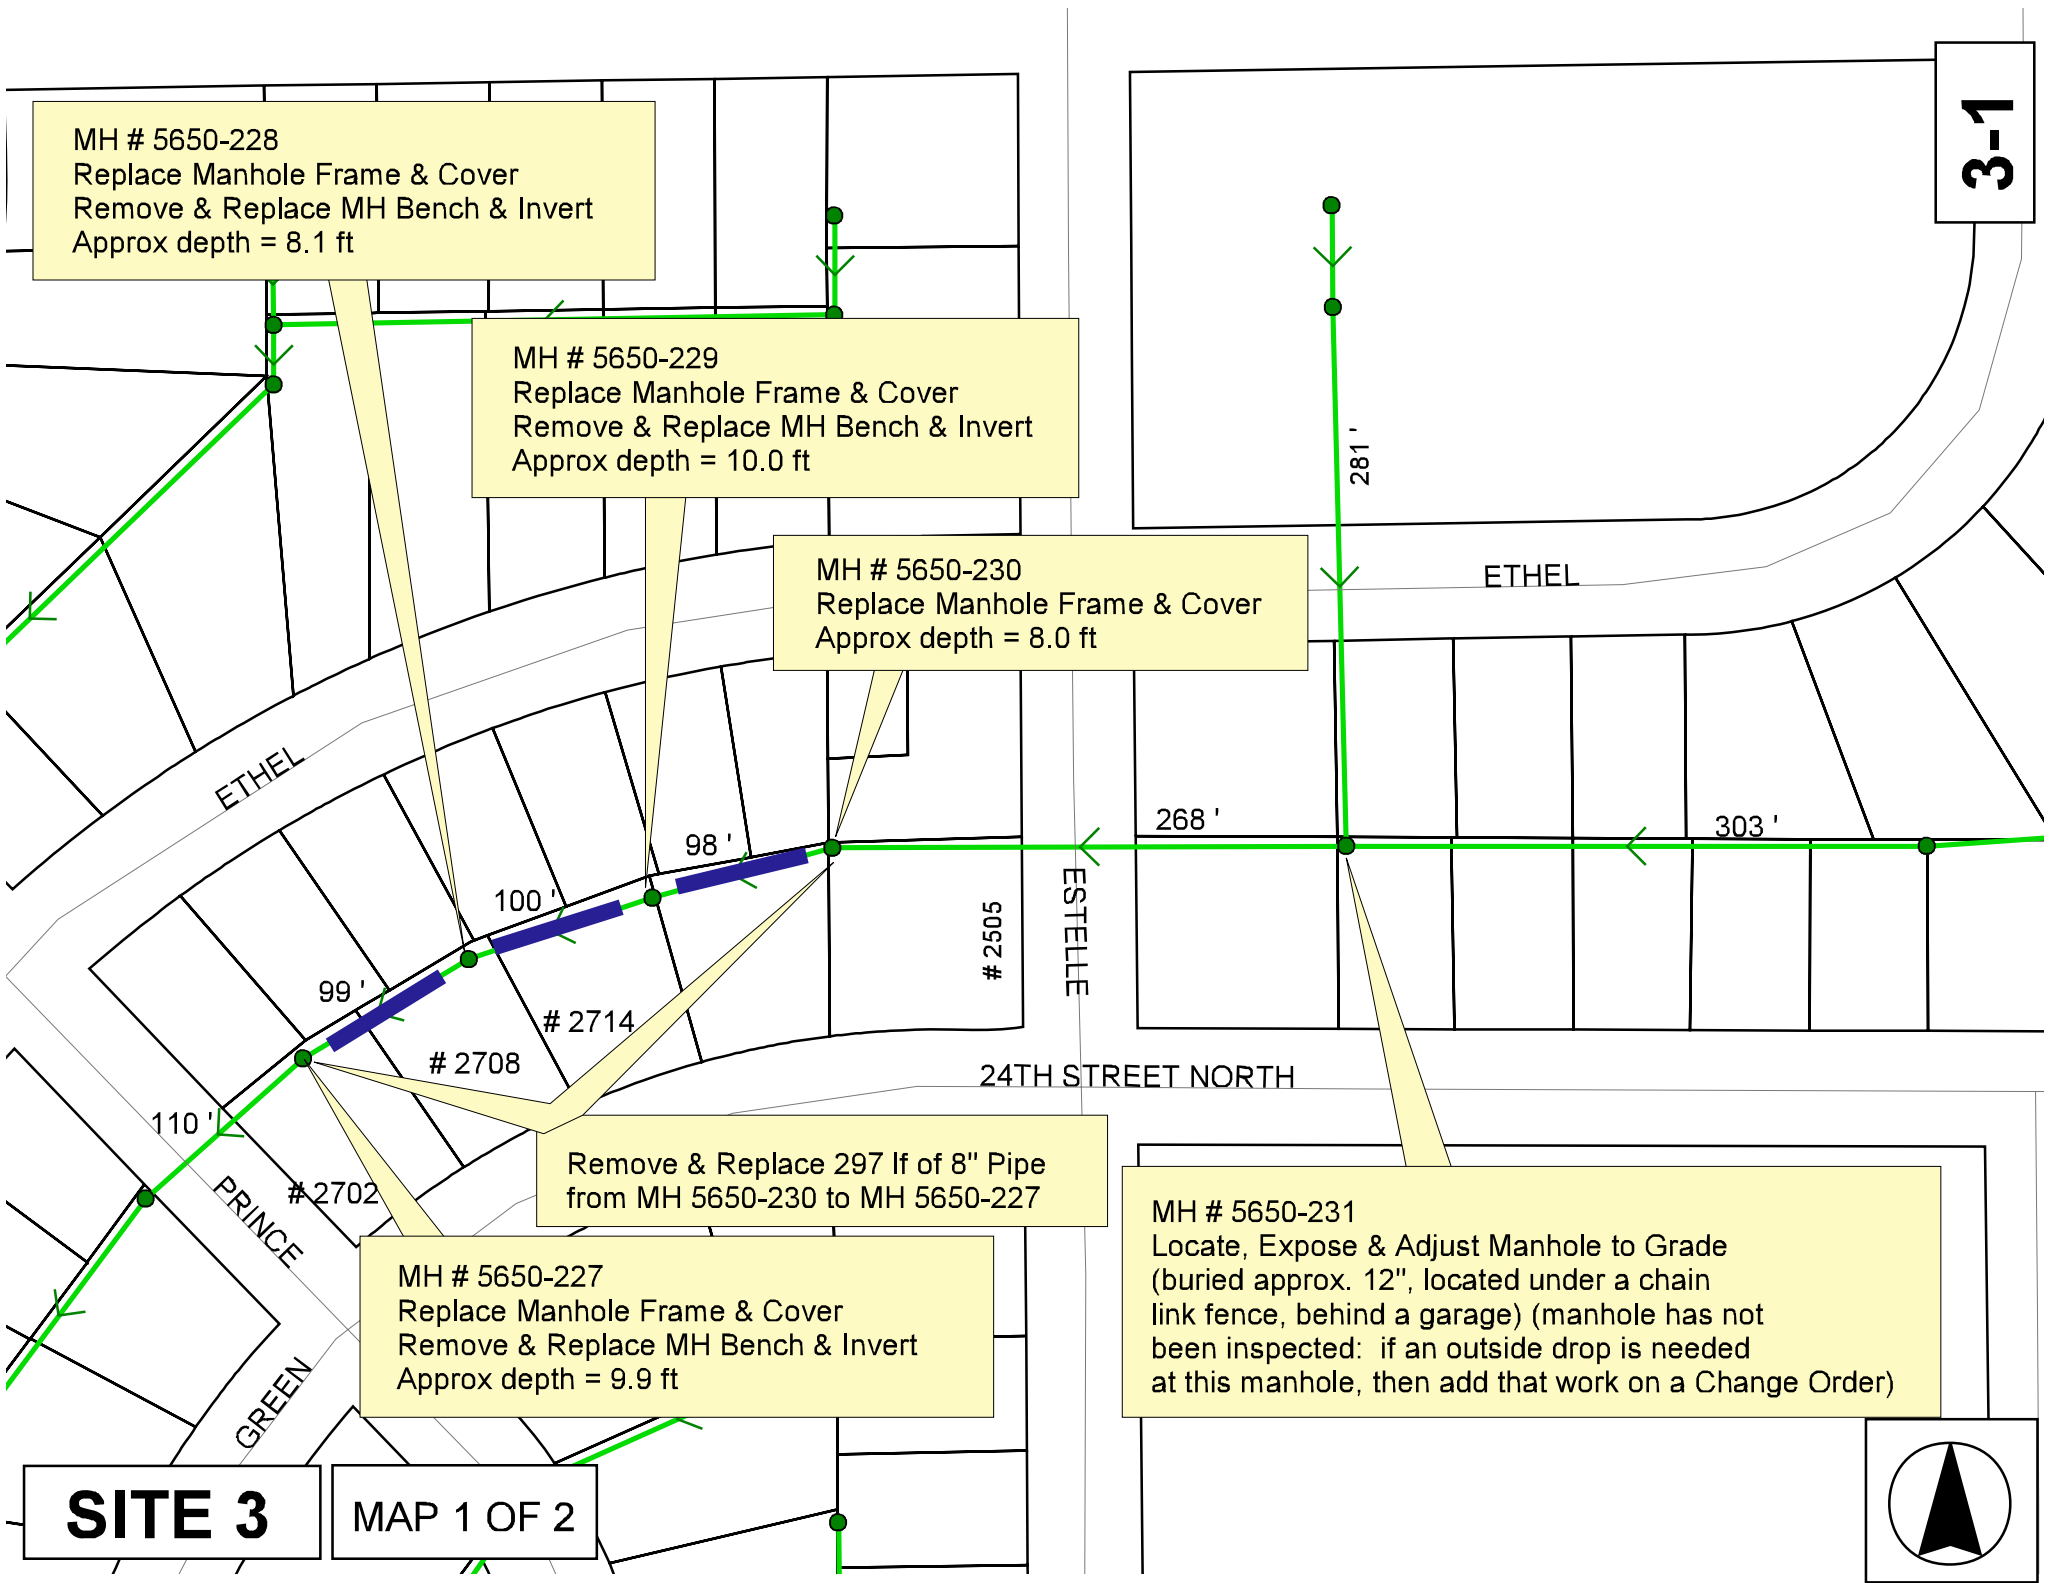
MH # 5650-228  
Replace Manhole Frame & Cover  
Remove & Replace MH Bench & Invert  
Approx depth = 8.1 ft

MH # 5650-229  
Replace Manhole Frame & Cover  
Remove & Replace MH Bench & Invert  
Approx depth = 10.0 ft

MH # 5650-230  
Replace Manhole Frame & Cover  
Approx depth = 8.0 ft

MH # 5650-227  
Replace Manhole Frame & Cover  
Remove & Replace MH Bench & Invert  
Approx depth = 9.9 ft

MH # 5650-231  
Locate, Expose & Adjust Manhole to Grade  
(buried approx. 12", located under a chain  
link fence, behind a garage) (manhole has not  
been inspected: if an outside drop is needed  
at this manhole, then add that work on a Change Order)

Remove & Replace 297 lf of 8" Pipe  
from MH 5650-230 to MH 5650-227

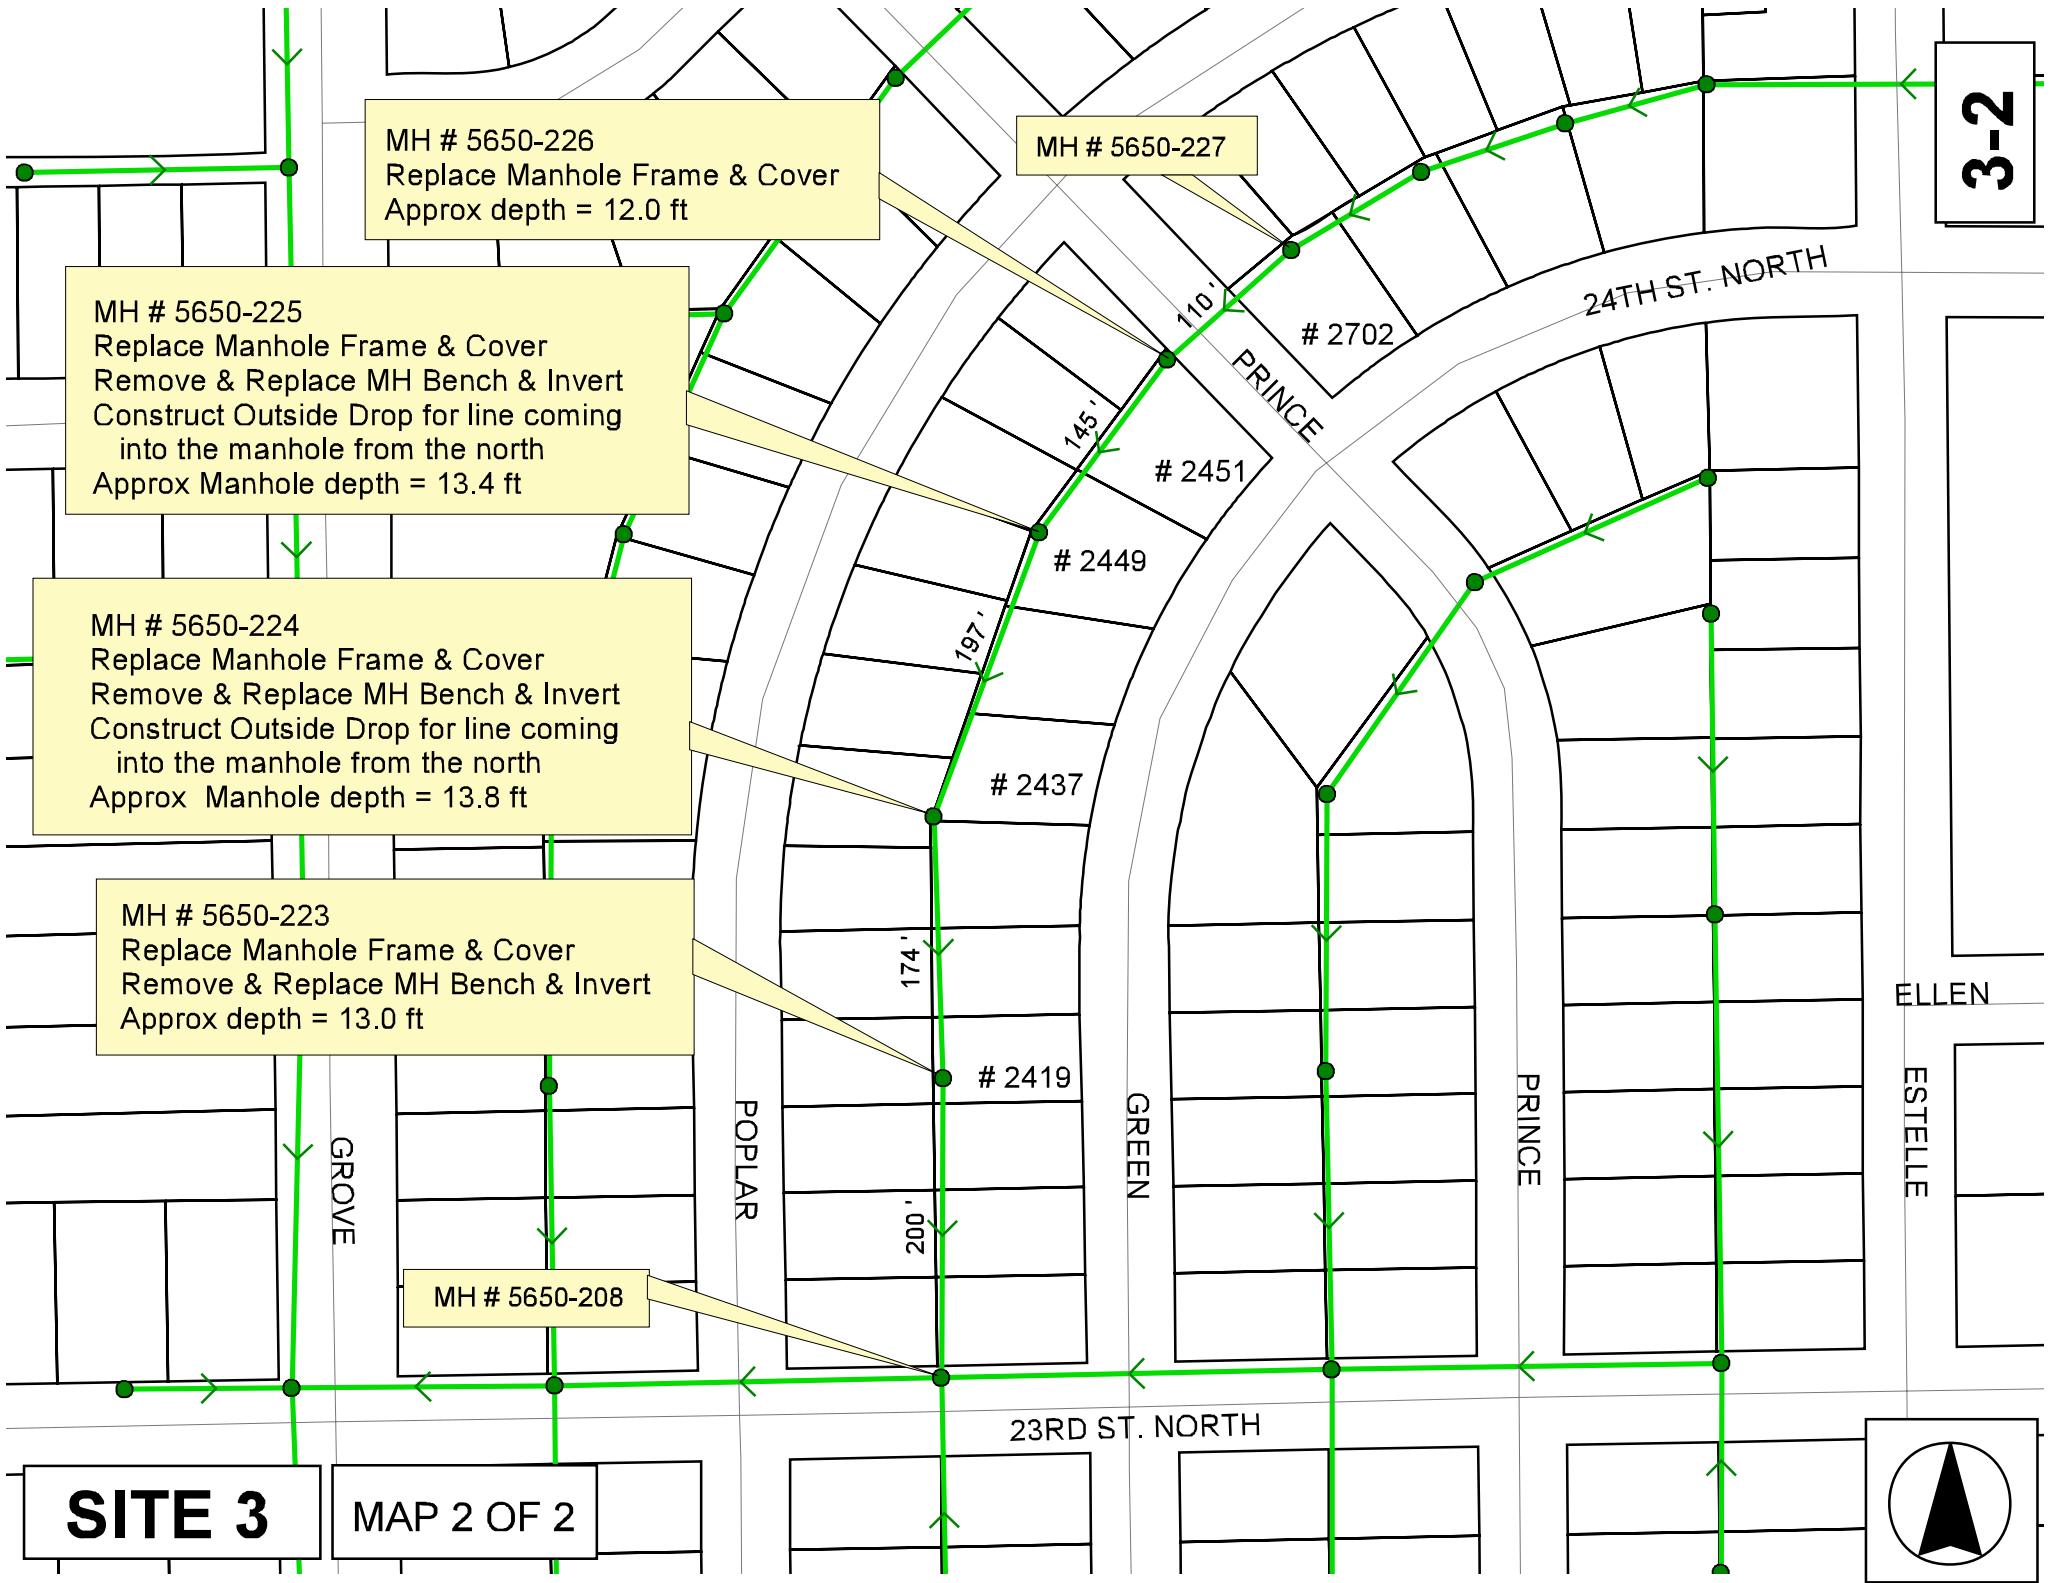
MH # 5650-226  
Replace Manhole Frame & Cover  
Approx depth = 12.0 ft

MH # 5650-225  
Replace Manhole Frame & Cover  
Remove & Replace MH Bench & Invert  
Construct Outside Drop for line coming  
into the manhole from the north  
Approx Manhole depth = 13.4 ft

MH # 5650-224  
Replace Manhole Frame & Cover  
Remove & Replace MH Bench & Invert  
Construct Outside Drop for line coming  
into the manhole from the north  
Approx Manhole depth = 13.8 ft

MH # 5650-223  
Replace Manhole Frame & Cover  
Remove & Replace MH Bench & Invert  
Approx depth = 13.0 ft
