**2010 Sanitary Sewer Reconstruction
Phase 3
OCA # 620562 / 468-84703**

Television Inspection Master Report

US Structure: 5349-160
DS Structure: 5348-135

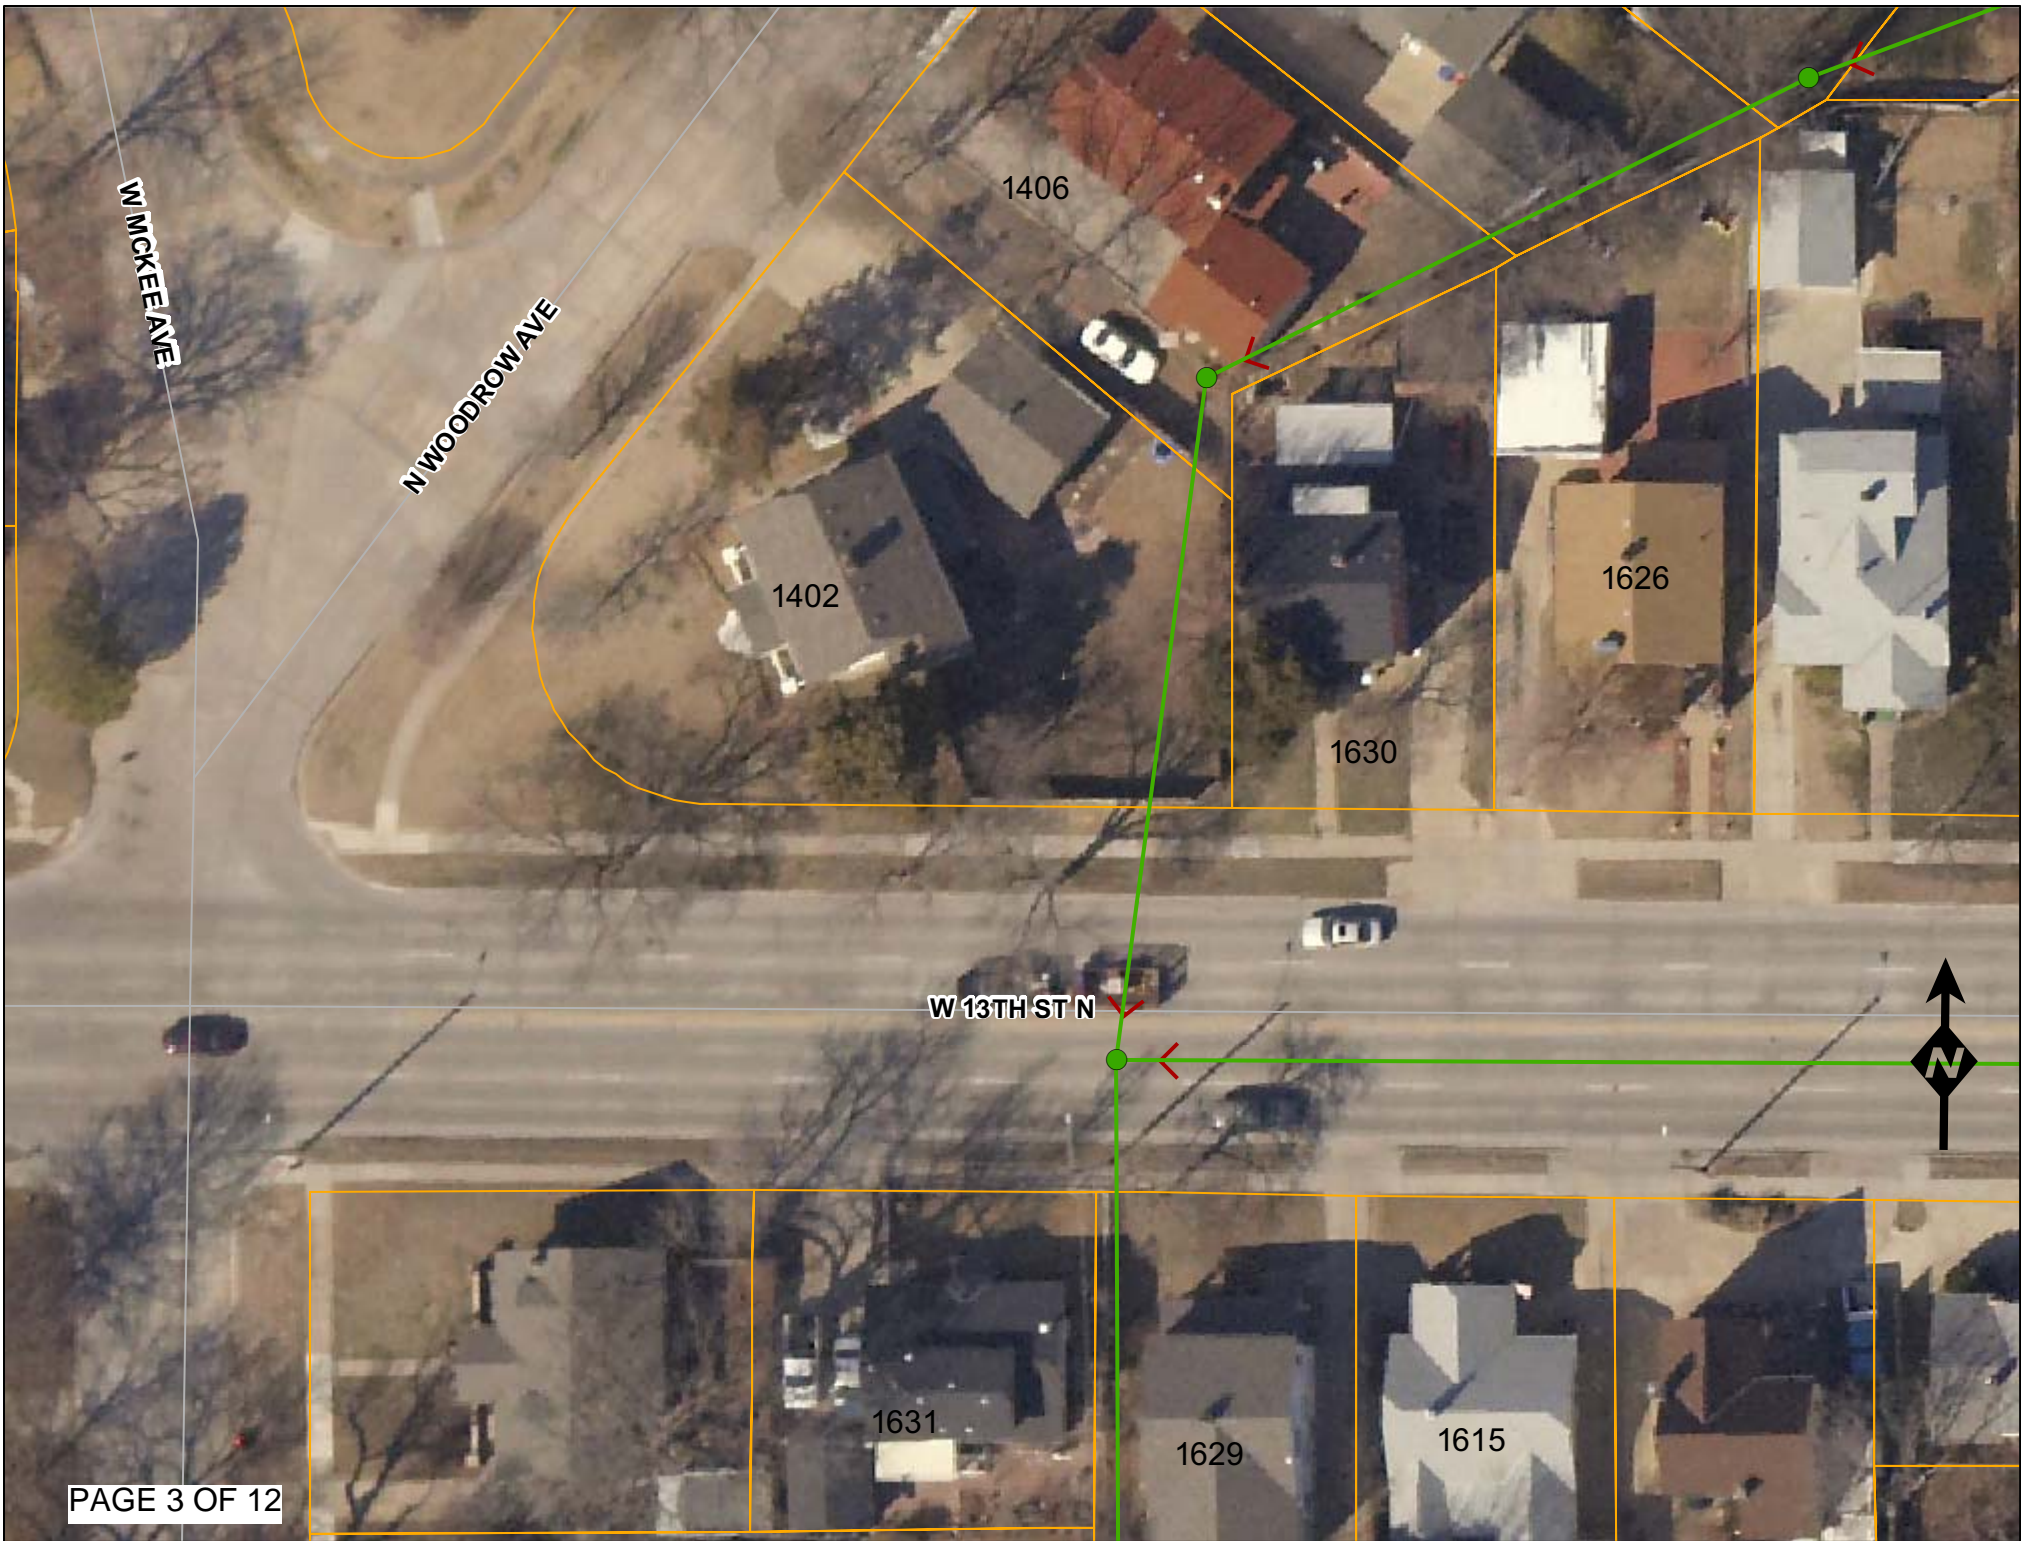
Obs. #	VTR Counter	Distance	Location	Description	Rating	Obsrvd (gpm)	Ratings			Remain (gpm)
							Est. (gpm)	Struct	Clean	
1		0.0		5349-160 / US Manhole						
2		3.2		Sealed Off Wye	1	0.000	0	0	0.000	
3		24.2	E	Break-In Conn	3	0.004	2	0	0.004	
1630 W 13TH ST N										
4		25.4		Crack-Radial	1	0.001	1	0	0.001	
5		35.8		Crack-Radial	1	0.001	1	0	0.001	
6		48.5		Crack-Radial	2	0.002	2	0	0.002	
7		49.8	W	Wye Service	1	0.000	0	0	0.000	
1402 N WOODROW										
8		56.9		Crack-Radial	1	0.001	1	0	0.001	
9		65.9	W / protrudes slightly	Sealed Off tap	5	0.000	0	0	0.000	
10		66.0	Hole in crown / pipe missing / patched	Broken Pipe	5	0.060	100	0	0.060	
11		80.6	Hole in crown / pipe missing / patched	Broken Pipe	5	0.060	100	0	0.060	
12		91.9	W / protrudes slightly	Sealed Off tap	3	0.000	0	0	0.000	
13		98.0	Hole in crown / pipe missing / patched	Broken Pipe	5	0.060	100	0	0.060	
13		105.0		Mat'l Chngs to Ductile Iron (corroded DIP)	2	0.000	0	0	0.000

15		107.6		Sag begins	5	0.000	25	0	0.000	
16		115.9		Mat'l Chngs back to VCP	1	0.000	0	0	0.000	
21		119.8	Joint / pipe angles downward	Offset Joint	5	0.060	100	0	0.060	
22		122.5	Joint / FULL TILE SAG	Offset	4	0.030	60	0	0.030	
18		123.7	Camera emerges from water	Sag ends	1	0.000	1	0	0.000	
19		132.8		Broken Pipe	2	0.008	44	0	0.008	
20		137.3		5348-135 / DS Manhole (manhole has not been inspected)

REPLACE FROM 102' TO MANHOLE WALL TO CORRECT GRADE AND REMOVE CORRODED DUCTILE IRON. (APPROX. 35 LF)
