# 2011 SANITARY SEWER RECONSTRUCTION PHASE 1

**OCA # 620571 / 468-84726**  
( North of Kellogg, East of Oliver )

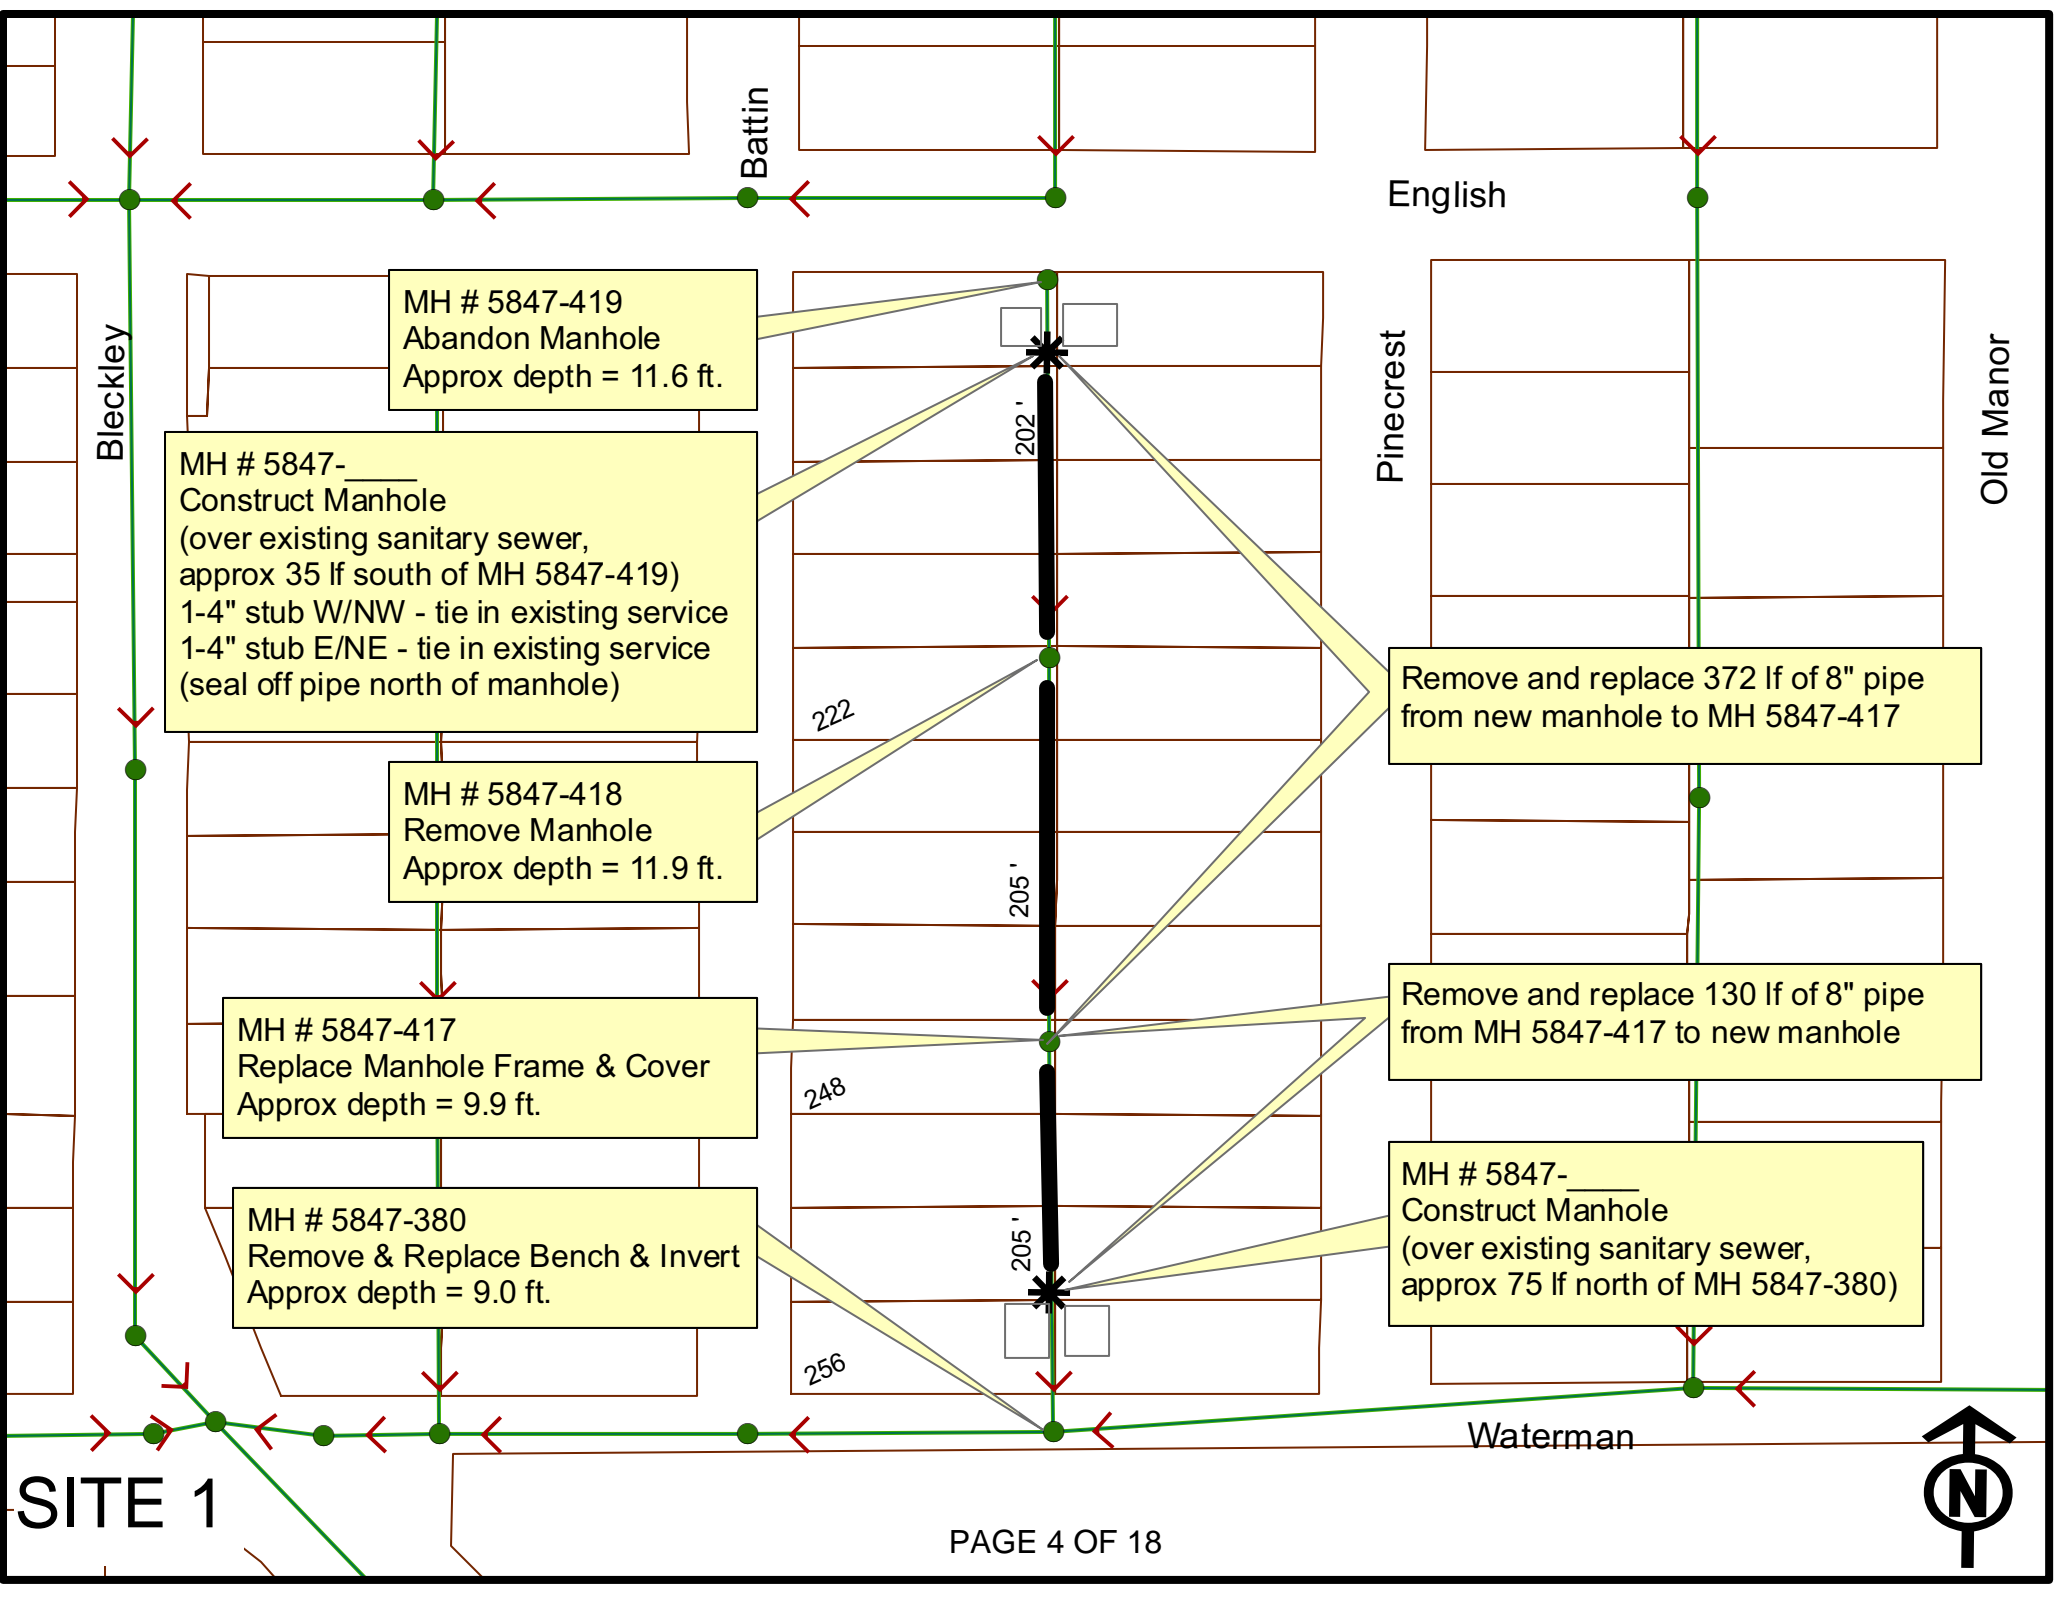
SITE 1

MH # 5847-419  
Abandon Manhole  
Approx depth = 11.6 ft.

MH # 5847-\_\_\_\_  
Construct Manhole  
(over existing sanitary sewer,  
approx 35 lf south of MH 5847-419)  
1-4" stub W/NW - tie in existing service  
1-4" stub E/NE - tie in existing service  
(seal off pipe north of manhole)

MH # 5847-418  
Remove Manhole  
Approx depth = 11.9 ft.

MH # 5847-417  
Replace Manhole Frame & Cover  
Approx depth = 9.9 ft.

MH # 5847-380  
Remove & Replace Bench & Invert  
Approx depth = 9.0 ft.

Remove and replace 372 lf of 8" pipe  
from new manhole to MH 5847-417

Remove and replace 130 lf of 8" pipe  
from MH 5847-417 to new manhole

MH # 5847-\_\_\_\_  
Construct Manhole  
(over existing sanitary sewer,  
approx 75 lf north of MH 5847-380)
