2012 Sanitary Sewer Reconstruction

Phase 6

OCA 620600 / 468-84842

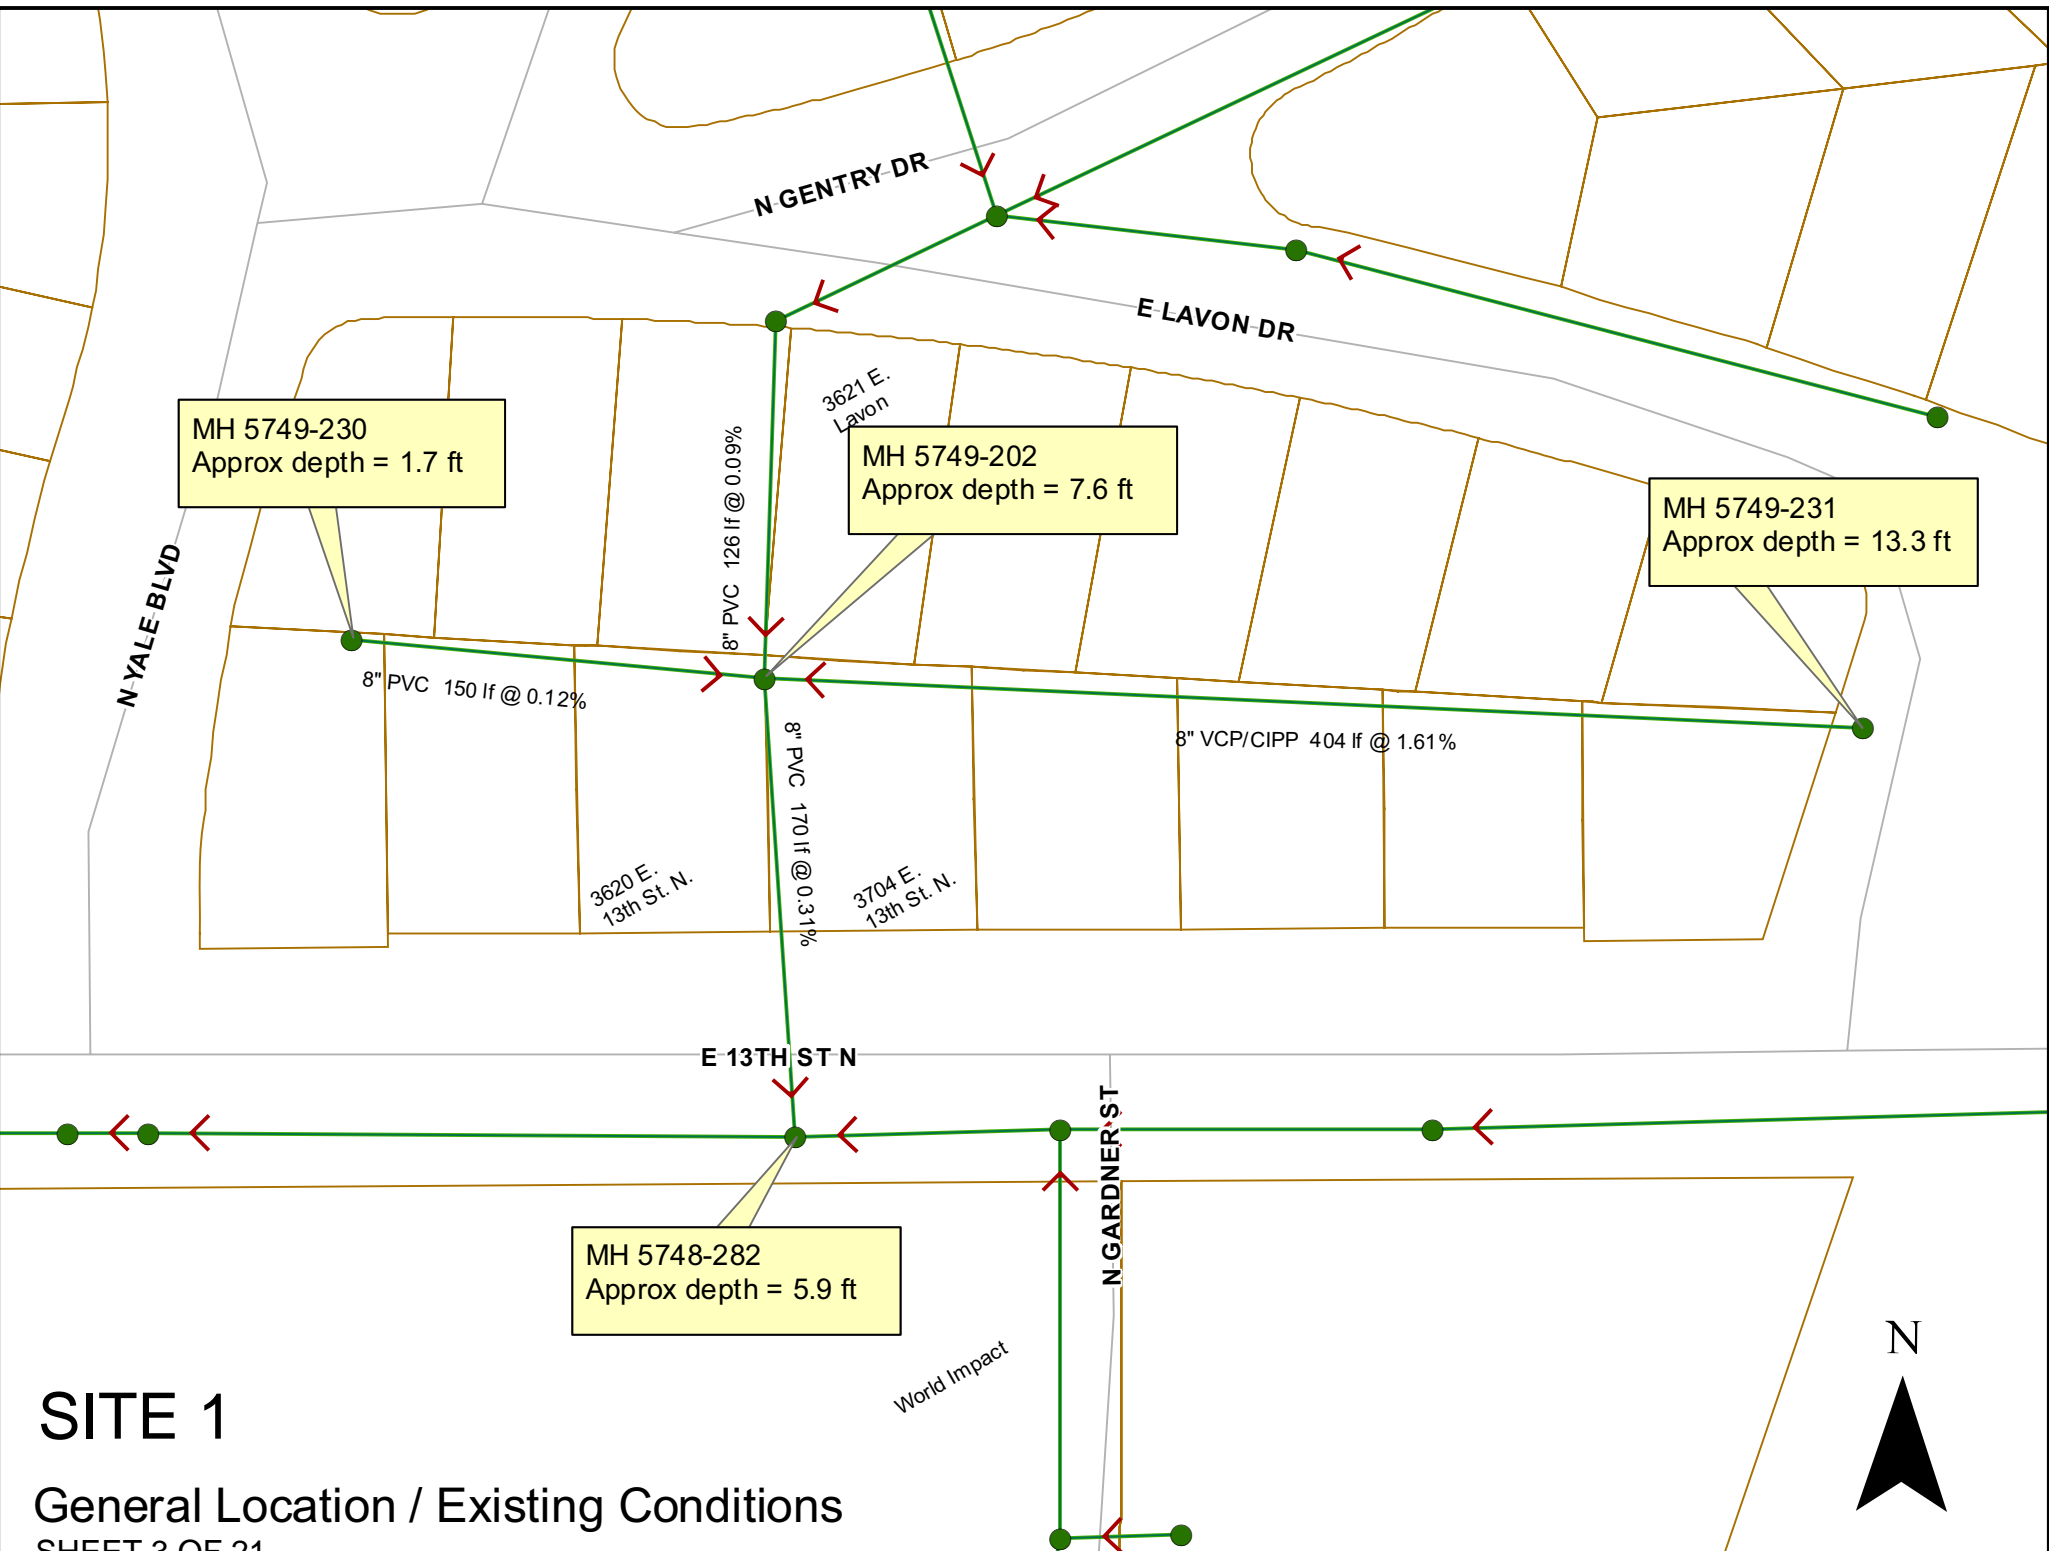
SITE 1

The homes west of MH 5749-202 experience backups, so the goal is to redirect flow and shape manhole inverts in a manner to correct that problem. MH 5749-140 is oversized to allow approx 18 inches between the two incoming pipes.
There is a 10' easement between 3620 and 3704 E. 13th Street, with 5 feet to either side of the property line. There is a 15' easement between 3704 E 13th and 3621 Lavon, with 7.5 feet to either side fo the property line.

MH 5749-202
Remove and Replace Manhole Bench & Invert
(reshape invert to better facilitate moving the flow
from the west through the manhole) (seal off the
pipe on east wall) Approx MH depth = 7.6 ft.

MH 5749-204
Construct Standard Manhole (4' dia) over existing sanitary
sewer (locate it as close as possible to MH 5749-202)
(remove line to the west between the manholes)

MH 5749-140
Construct Standard Manhole (5' dia) over existing sanitary
sewer (locate it 10' to 12' south of MH 5749-202)
(manhole does not need a special lining inside)

Install approx 12 lf of 8" pipe between
MH 5749-204 and MH 5749-140.

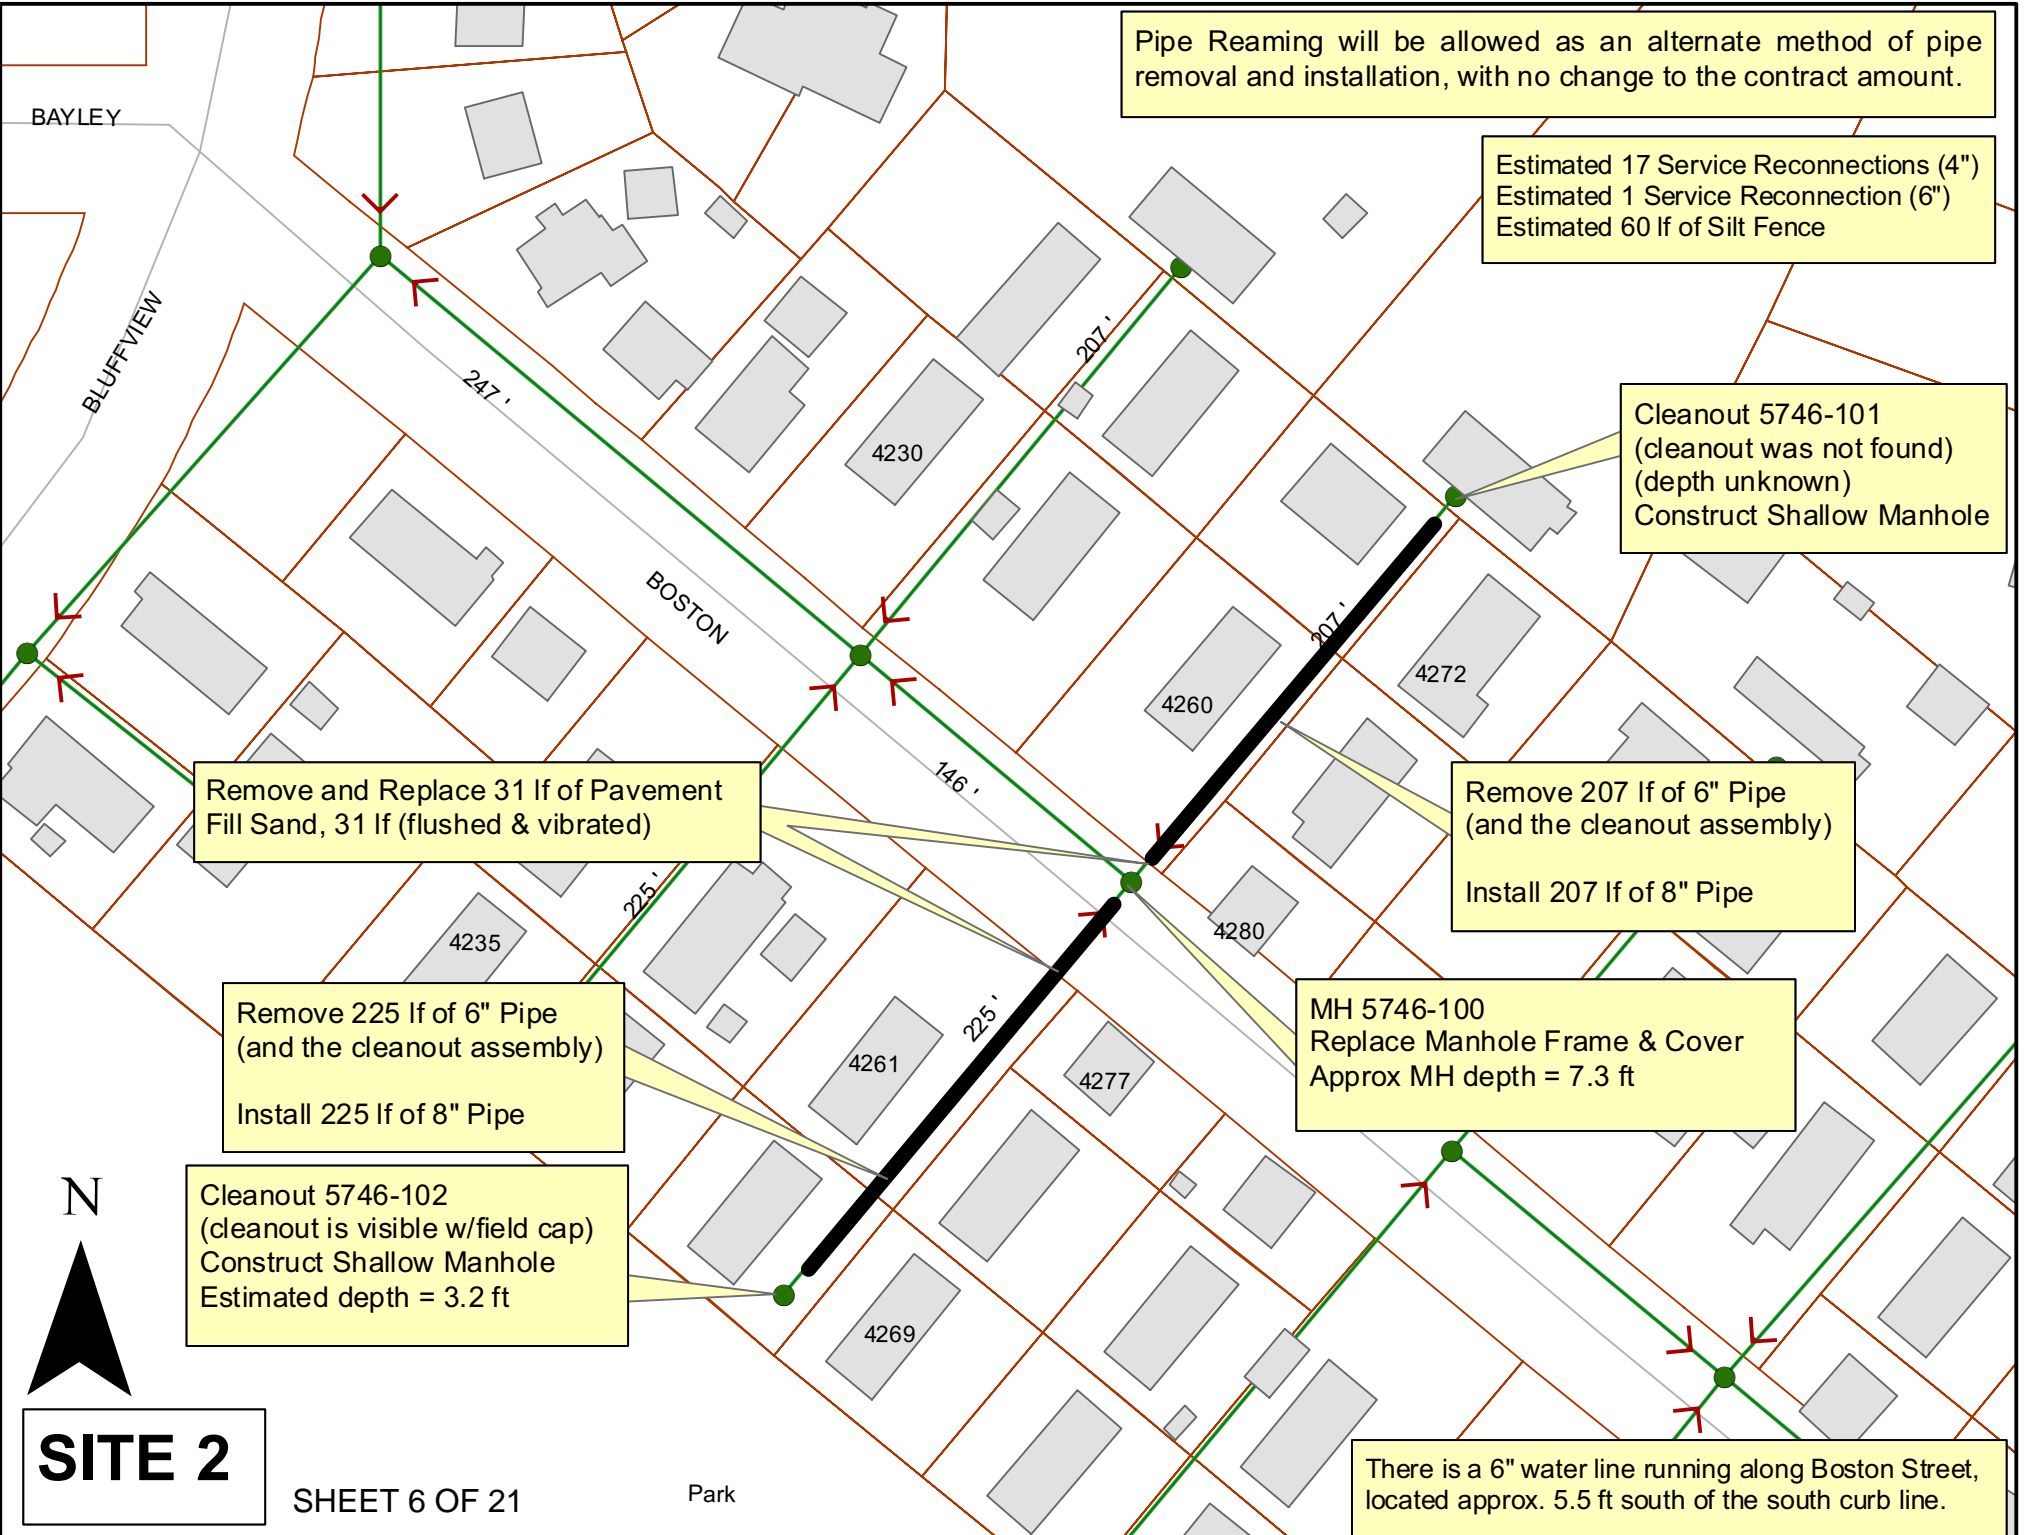
SITE 2

Cleanout 5746-101
(cleanout was not found)
(depth unknown)
Construct Shallow Manhole

Cleanout 5746-102
(cleanout is visible w/field cap)
Construct Shallow Manhole
Estimated depth = 3.2 ft

Remove 207 lf of 6" Pipe
(and the cleanout assembly)
Install 207 lf of 8" Pipe

MH 5746-100
Replace Manhole Frame & Cover
Approx MH depth = 7.3 ft

Remove 225 lf of 6" Pipe
(and the cleanout assembly)
Install 225 lf of 8" Pipe

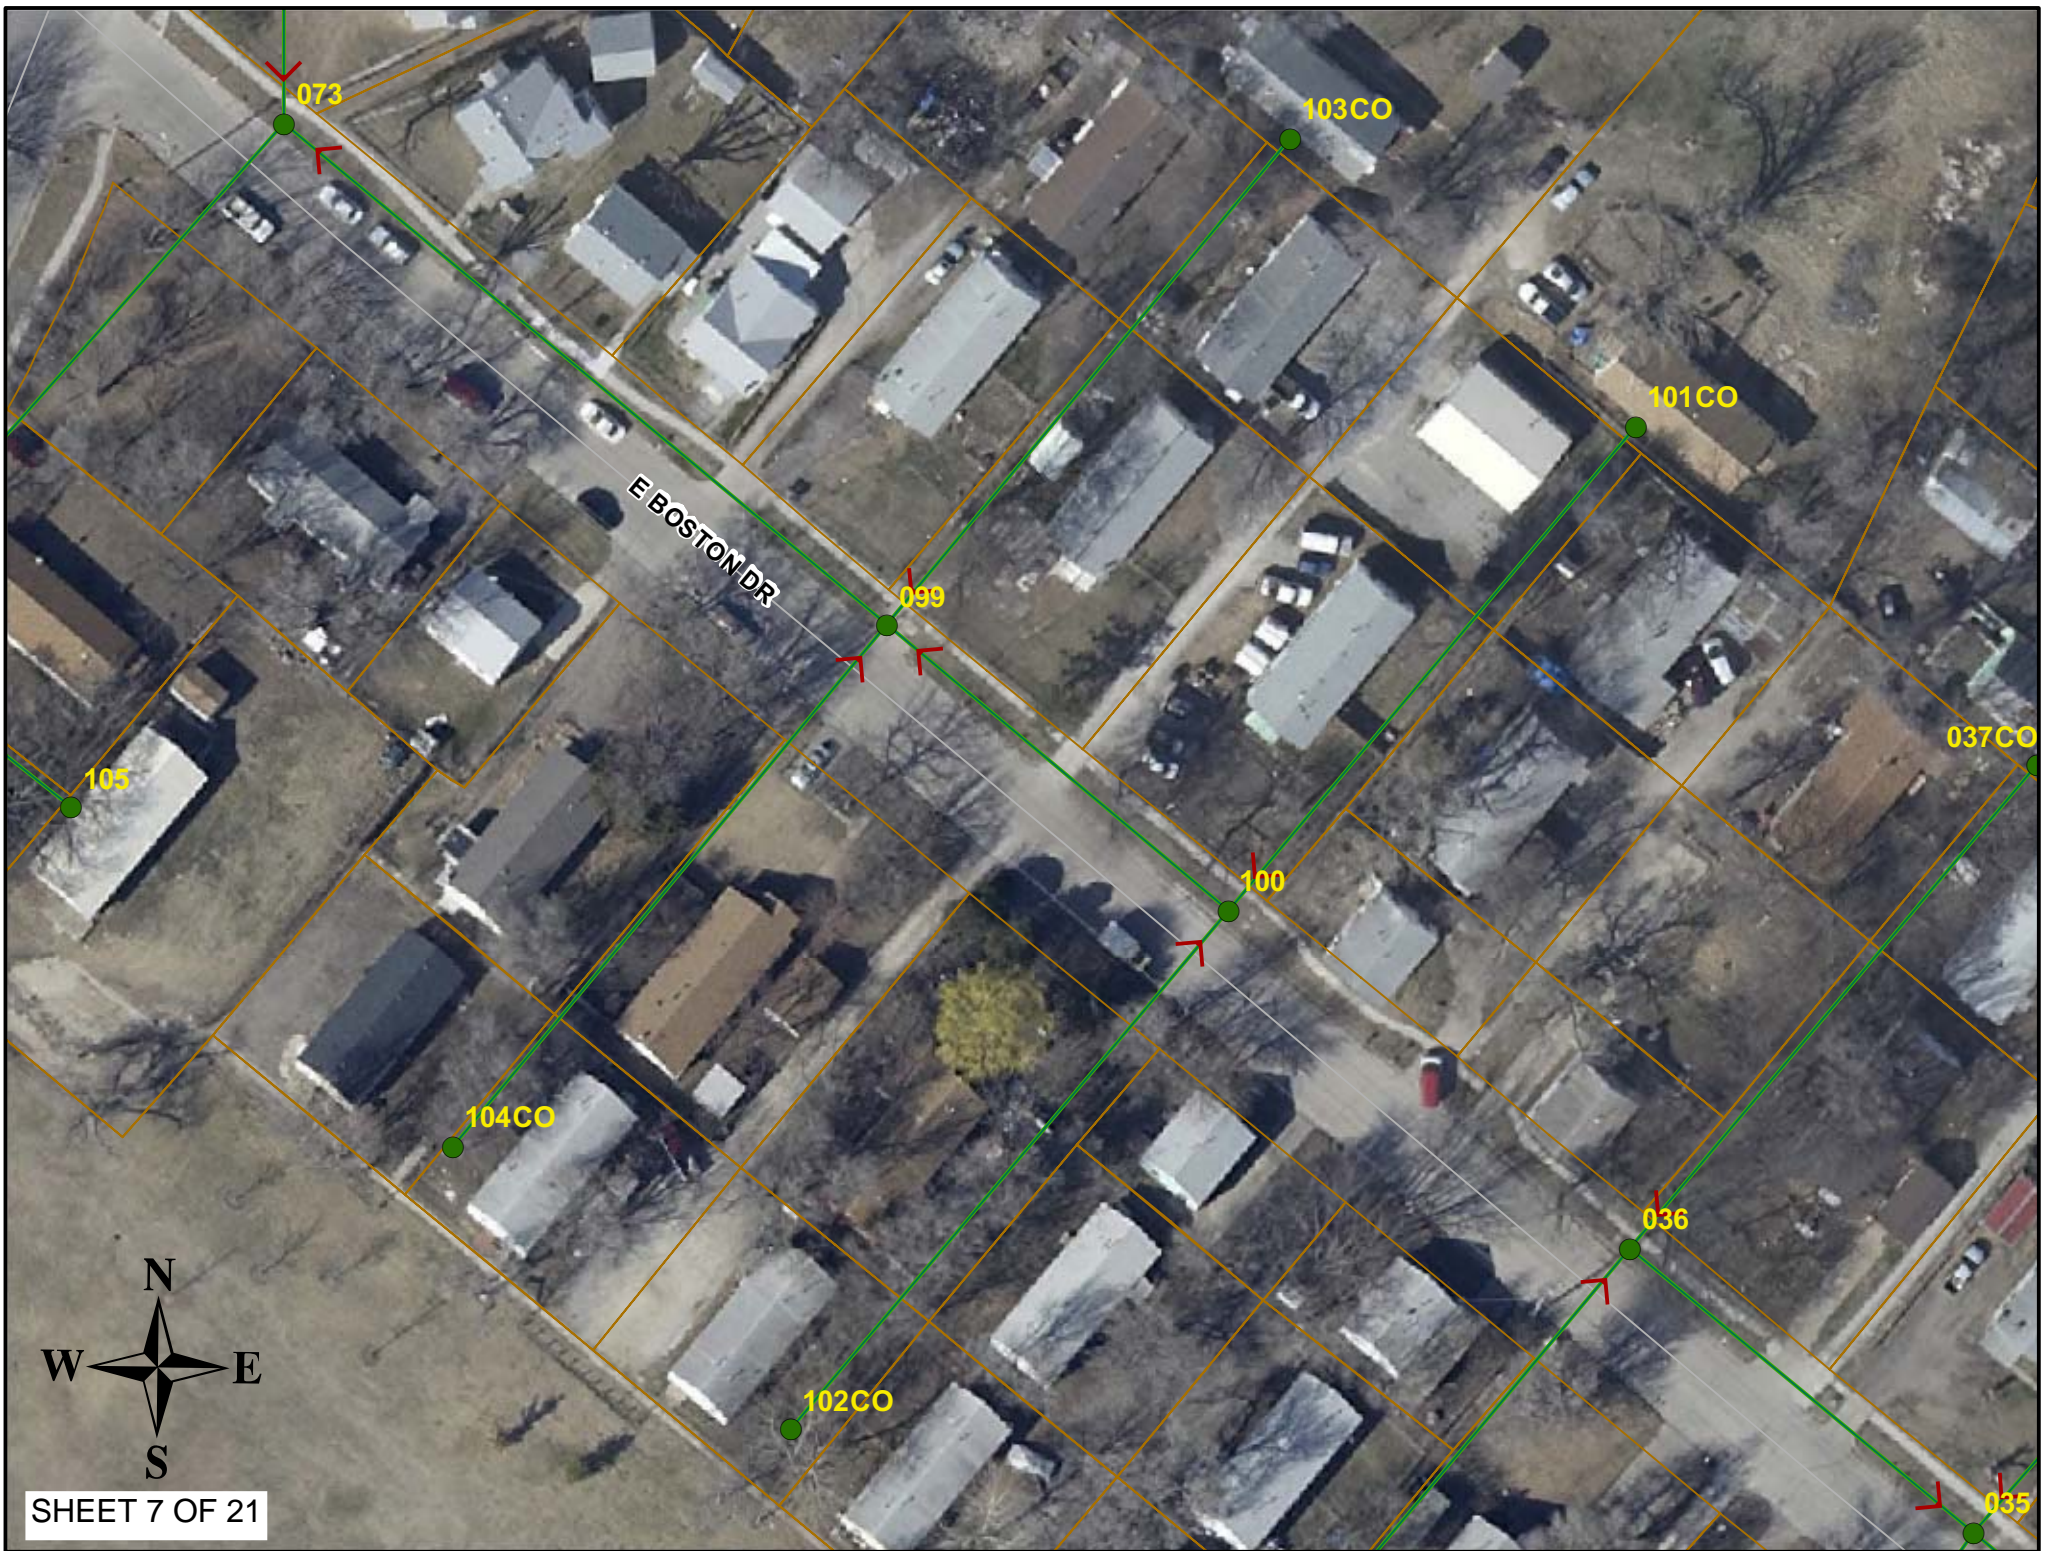
US Structure: **5746-101CO** 4268 E BOSTON CT Date Insp: 3/21/2012 Basin: EC01C
 DS Structure: **5746-100** 4260 E BOSTON ST Dir Televised: Downstream To Upstream

Obs. #	VTR Counter	Distance	Location	Description	Rating	Obsrvd (gpm)	Ratings		Remain (gpm)
							Est. (gpm)	Struct Clean	
1		0.0	4260 EAST BOSTON	DS Manhole 5746-100	1	(located in the grass)			
2		29.4	4280 EAST BOSTON	Wye Service	3				
3		71.8	4260 EAST BOSTON	Wye Service	4				
4		71.8	4276-78 EAST BOSTON	Wye Service	2				
5		106.3	4262 EAST BOSTON	Wye Service	3				
6		106.3	4276-78 EAST BOSTON	Wye Service	4				
7		111.5		Roots	3				
8		119.0		Roots	3				
9		124.2		Broken Pipe	3				
10		148.4	4264-66 EAST BOSTON	Wye Service	4				
11		148.6	4272-74 EAST BOSTON	Wye Service	2				
12		156.9	Offset Joint & Pipe Missing		3				
13		157.5	Camera cannot pass offset	Stopped Inspection	3

Pipe needs upsized to 8"

All wyes are full of roots

At this point, the pipe defects upward at a slope too great for the camera to crawl up the pipe.

Incomplete televising.

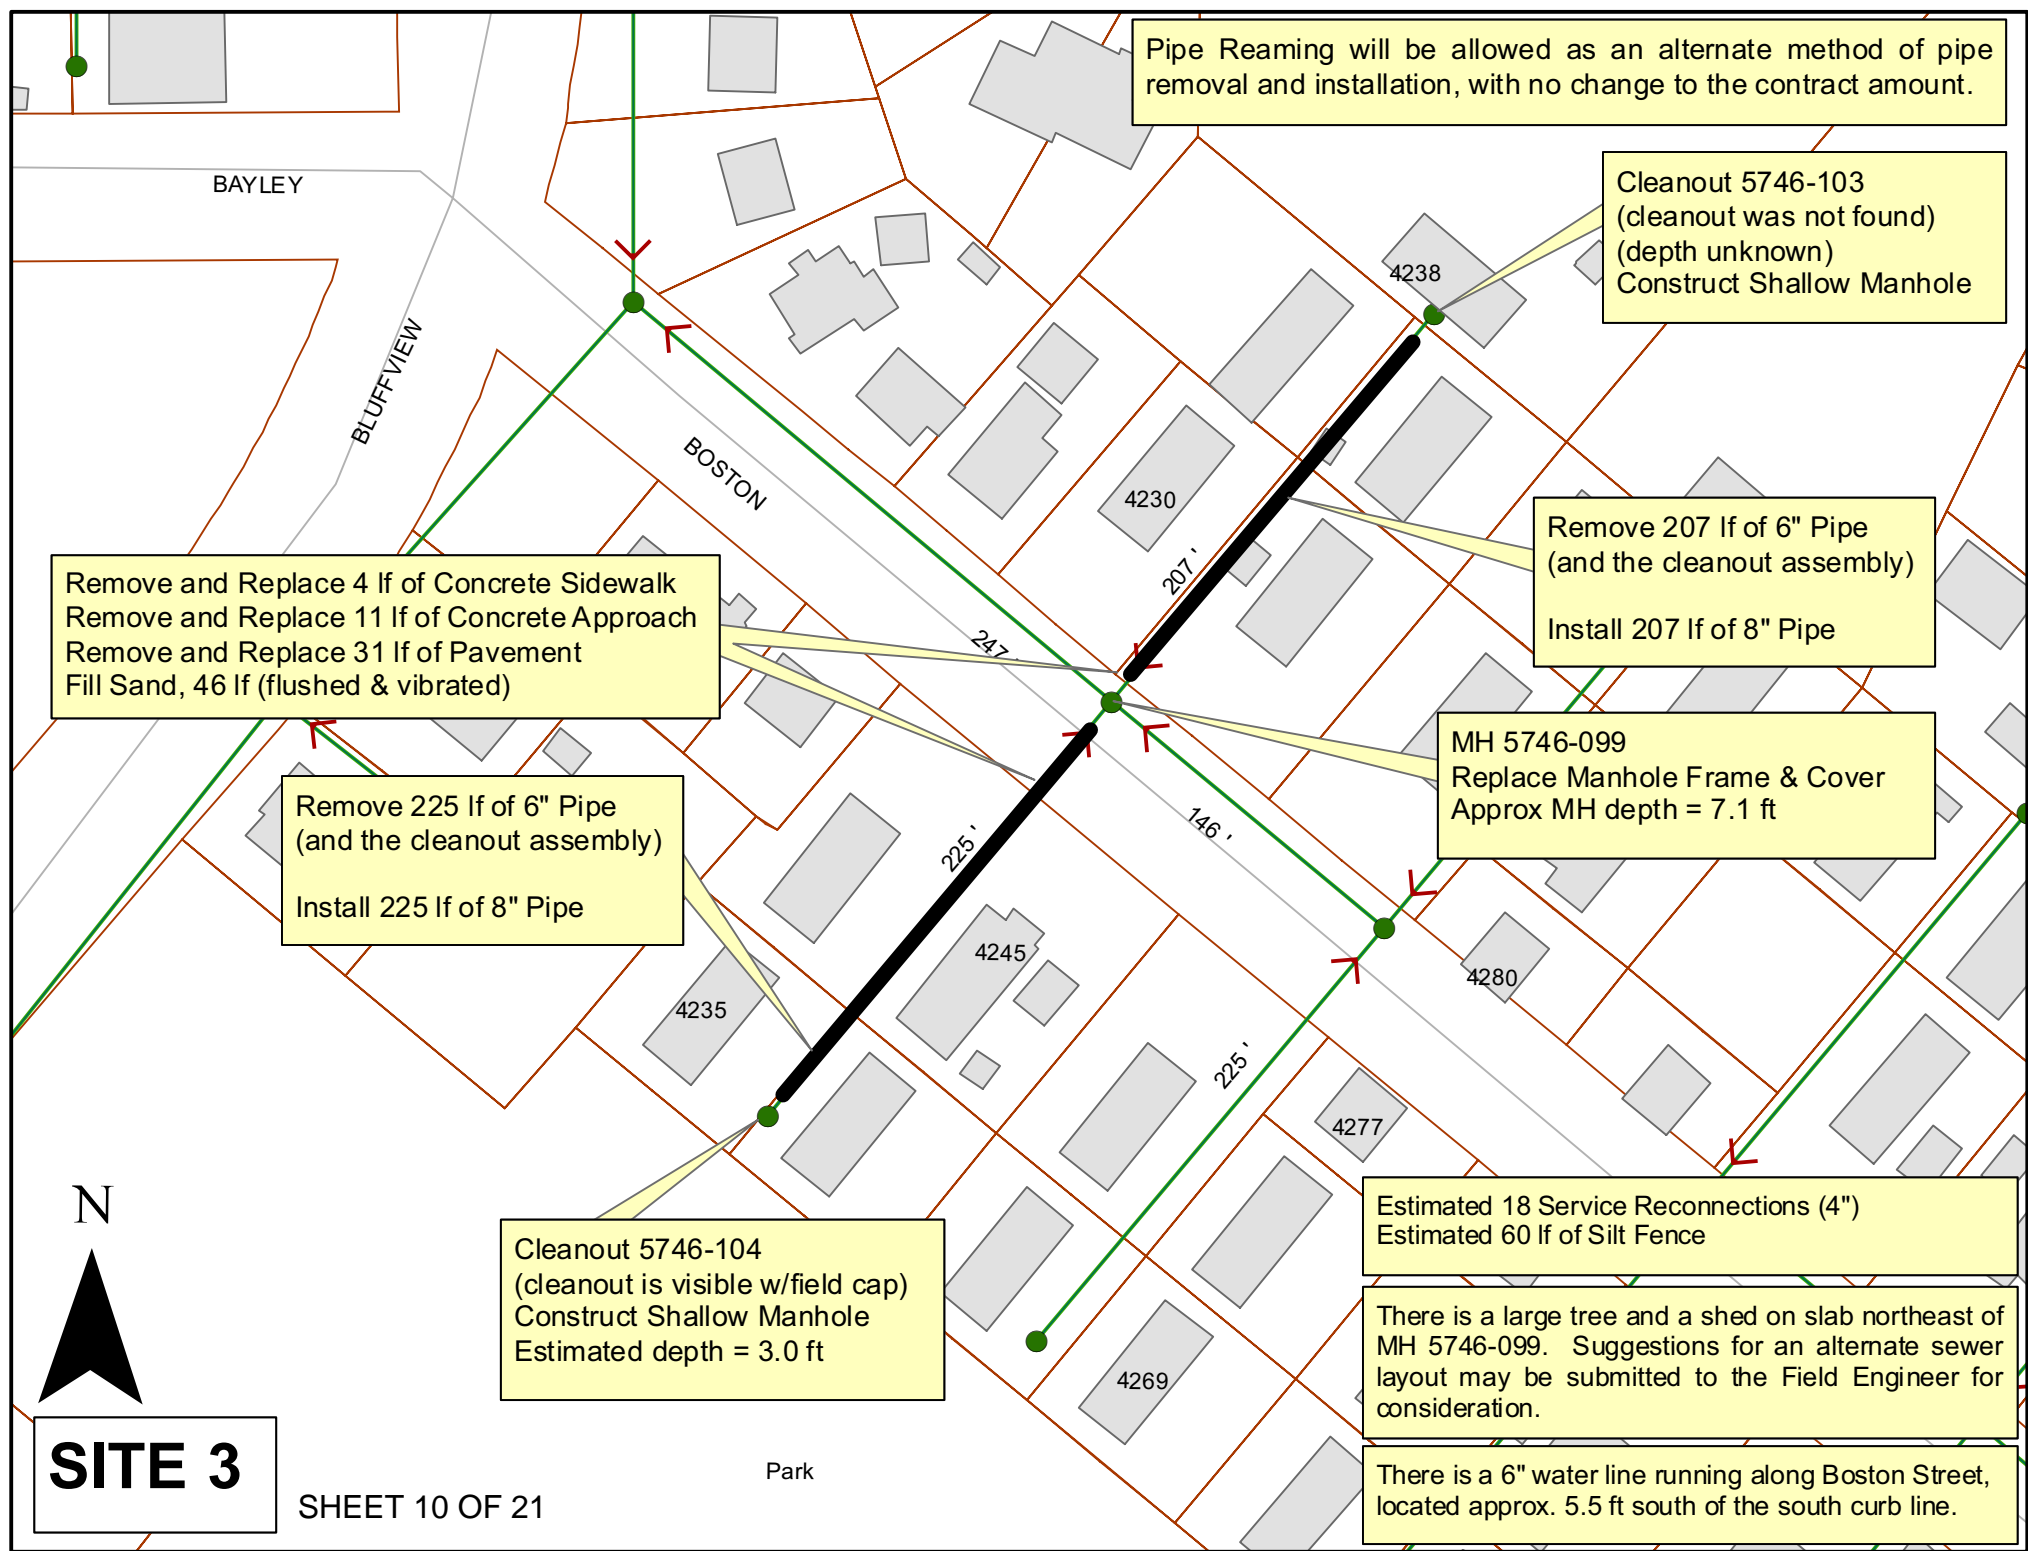
N
SITE 3

Cleanout 5746-103
(cleanout was not found)
(depth unknown)
Construct Shallow Manhole

There is a large tree and a shed on slab northeast of MH 5746-099. Suggestions for an alternate sewer layout may be submitted to the Field Engineer for consideration.

Cleanout 5746-104
(cleanout is visible w/field cap)
Construct Shallow Manhole
Estimated depth = 3.0 ft

Remove 207 lf of 6" Pipe
(and the cleanout assembly)
Install 207 lf of 8" Pipe

MH 5746-099
Replace Manhole Frame & Cover
Approx MH depth = 7.1 ft

Remove 225 lf of 6" Pipe
(and the cleanout assembly)
Install 225 lf of 8" Pipe

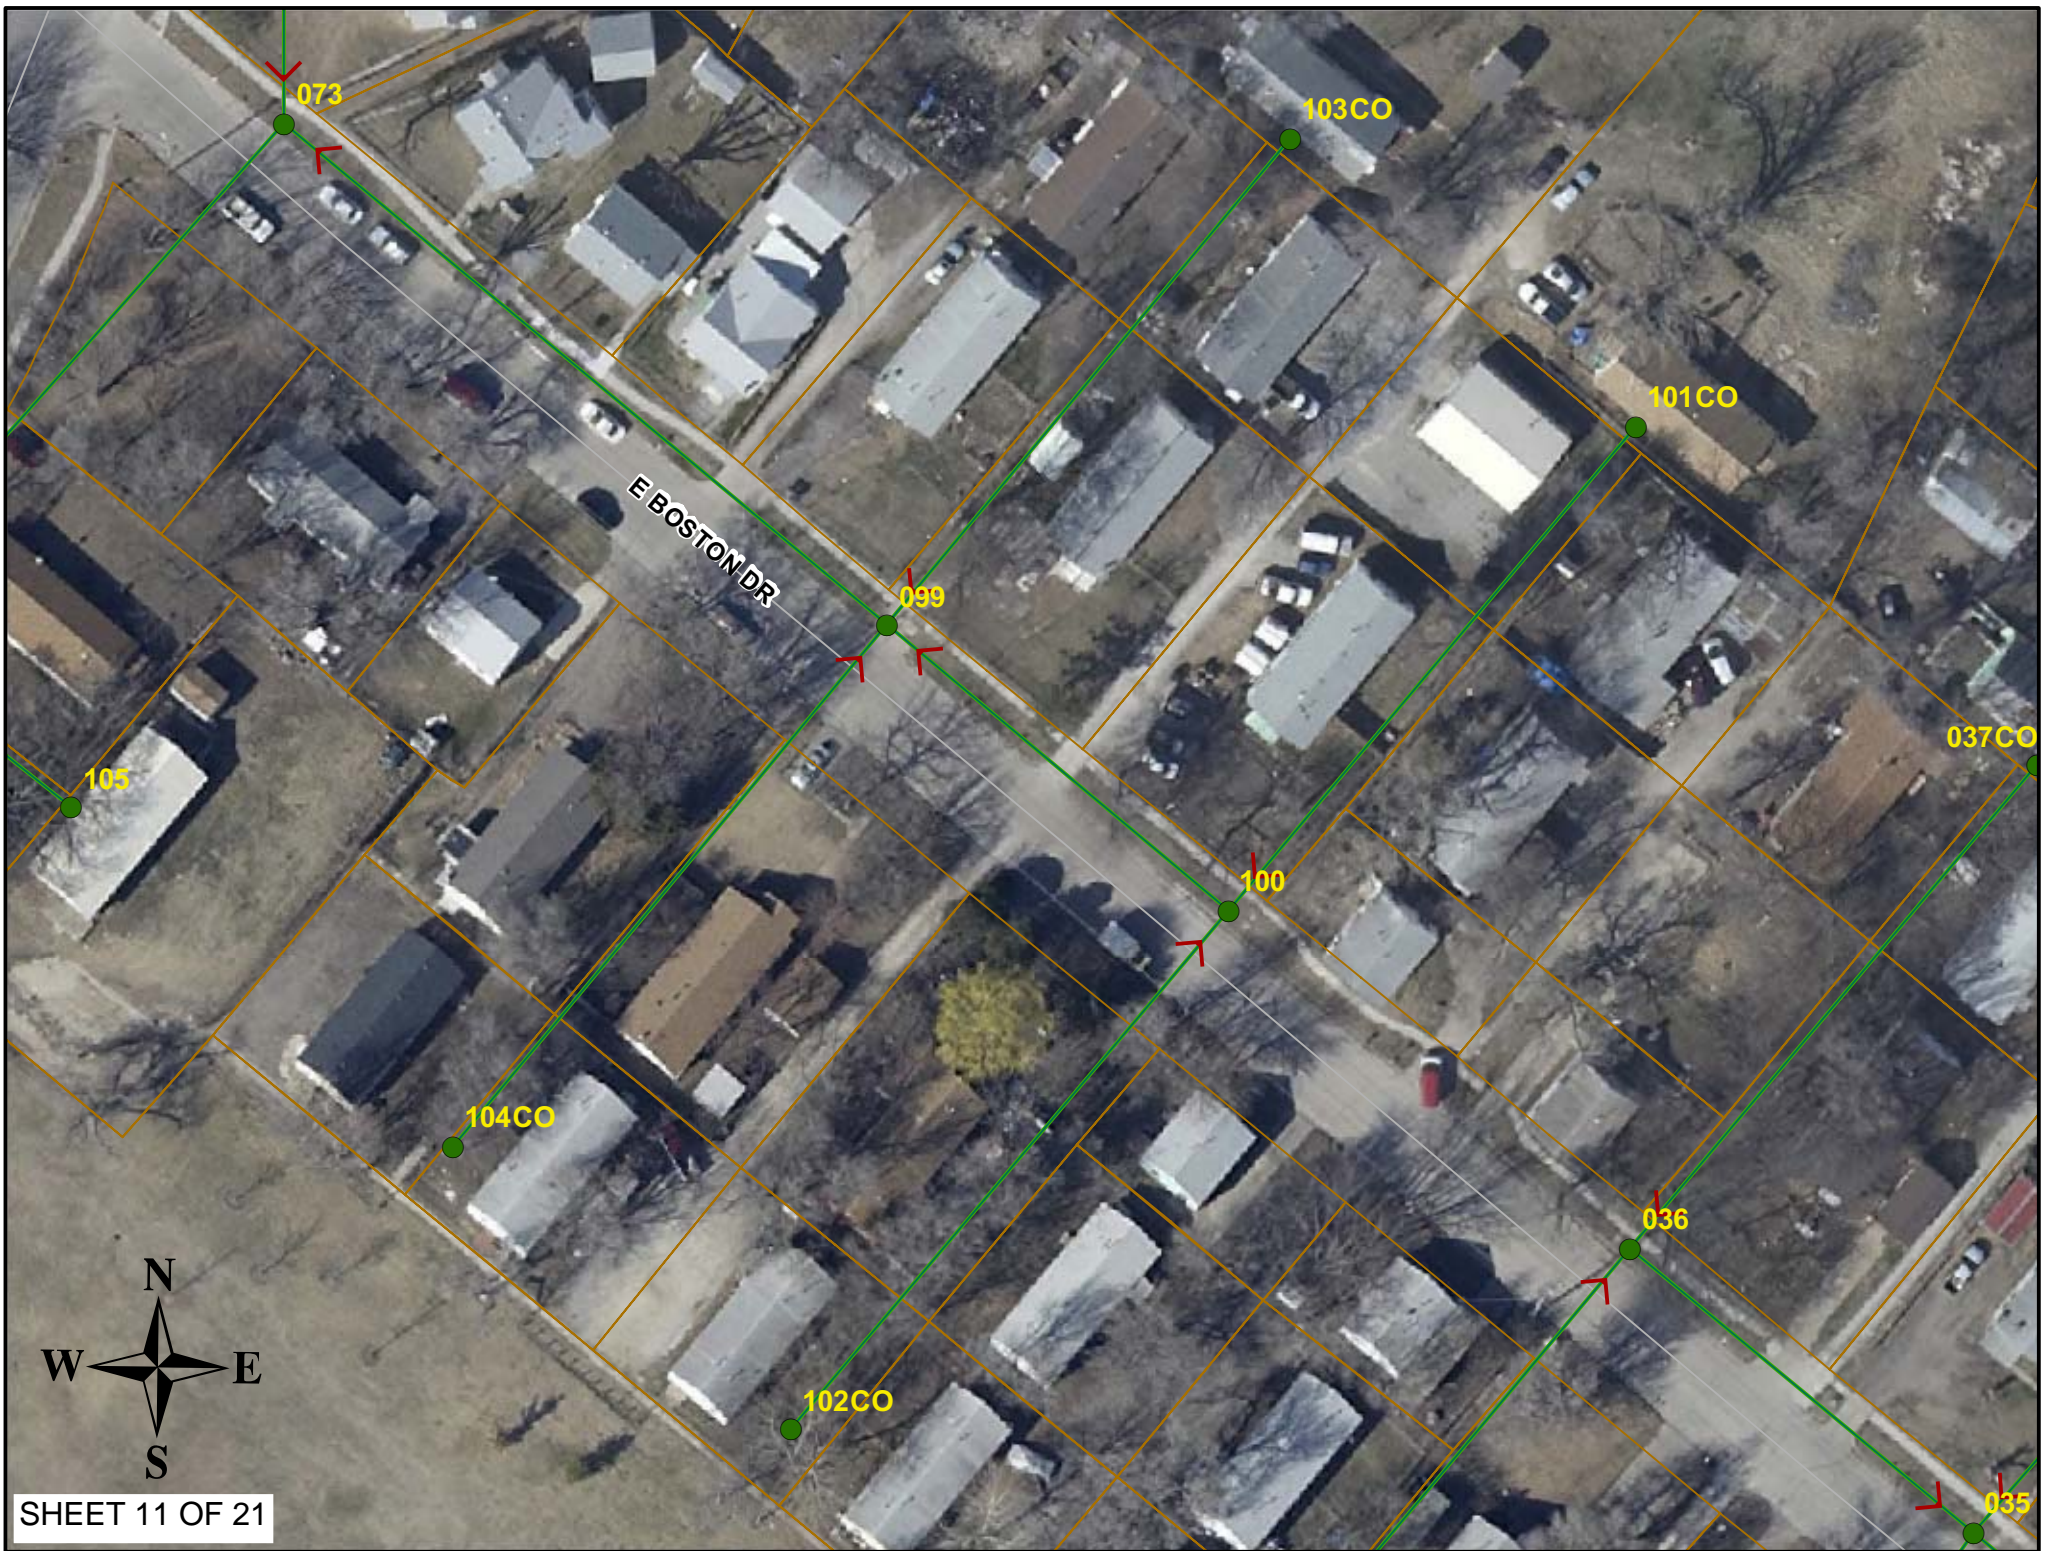
US Structure: 5746-103CO 4240 E BOSTON CT Date Insp: 3/22/2012 Basin: EC01C
 DS Structure: 5746-099 4248 E BOSTON ST Dir Televised: Downstream To Upstream

Obs. #	VTR Counter	Distance	Location	Description	Rating	Obsrvd (gpm)	Ratings		Remain (gpm)
							Est. (gpm)	Struct Clean	
1		0.0		5746-099 DS Manhole	1				
2		9.3		Roots	4				
3		11.2		Roots	3				
4		21.2		Roots	3				
5		41.6		Roots	4				
6		46.1		Roots	3				
7		49.0		Roots	3				
8		51.3		Roots	3				
9		53.6		Roots	3				
10		61.3		Roots	3				
11		64.1		Roots	3				
12		68.0		Other	0				
13		72.1	4230 EAST BOSTON	Wye Service	4				
14		72.1	4246 EAST BOSTON	Wye Service	4				
15		106.5	4232 EAST BOSTON	Wye Service	3				
16		106.5	4248 EAST BOSTON	Wye Service	2				
17		132.7		Broken Pipe	2				
18		148.8	4244 EAST BOSTON	Wye Service	1				
19		149.0	4234 EAST BOSTON	Wye Service	4				
20		158.2		Stopped Inspection	5				Camera slipping, can't continue

Incomplete televising

All wyes are full of roots

Obs. #	VTR Counter	Distance	Location	Description	Rating	Ratings			
						Obsrvd (gpm)	Est. (gpm)	Struct Clean	Remain (gpm)
1		11.6		5746-099 DS Manhole	1	(pipe gone at manhole wall?)			
2		6.0		Broken Pipe	3				
3		20.1		Broken Pipe	3				
4		70.5		Broken Pipe	3				
5		72.0	pipe missing in all quadrants	Broken Pipe	5				
6		90.9		Crack-Radial	3				
7		113.0	4243-45 EAST BOSTON	Wye Service	3				
8		113.0	4231-33 EAST BOSTON	Wye Service	4				
9		135.4		Broken Pipe	3				
10		149.4	4243 EAST BOSTON	Wye Service	3				
11		149.4	4233 EAST BOSTON	Wye Service	3				
12		190.8	4235 EAST BOSTON	Wye Service	3				
13		191.0	4241 EAST BOSTON	Wye Service	3				
14		217.8		Broken Pipe	3				
15		222.2		Broken Pipe	3				
16		224.7	4237 EAST BOSTON	Wye Service	4				
17		224.7	4241 EAST BOSTON	Wye Service	5				
18		225.3	HUGE BALL OF ROOTS/	US Cleanout 5746-104CO	1

Pipe has poor grade / needs upsized to 8"

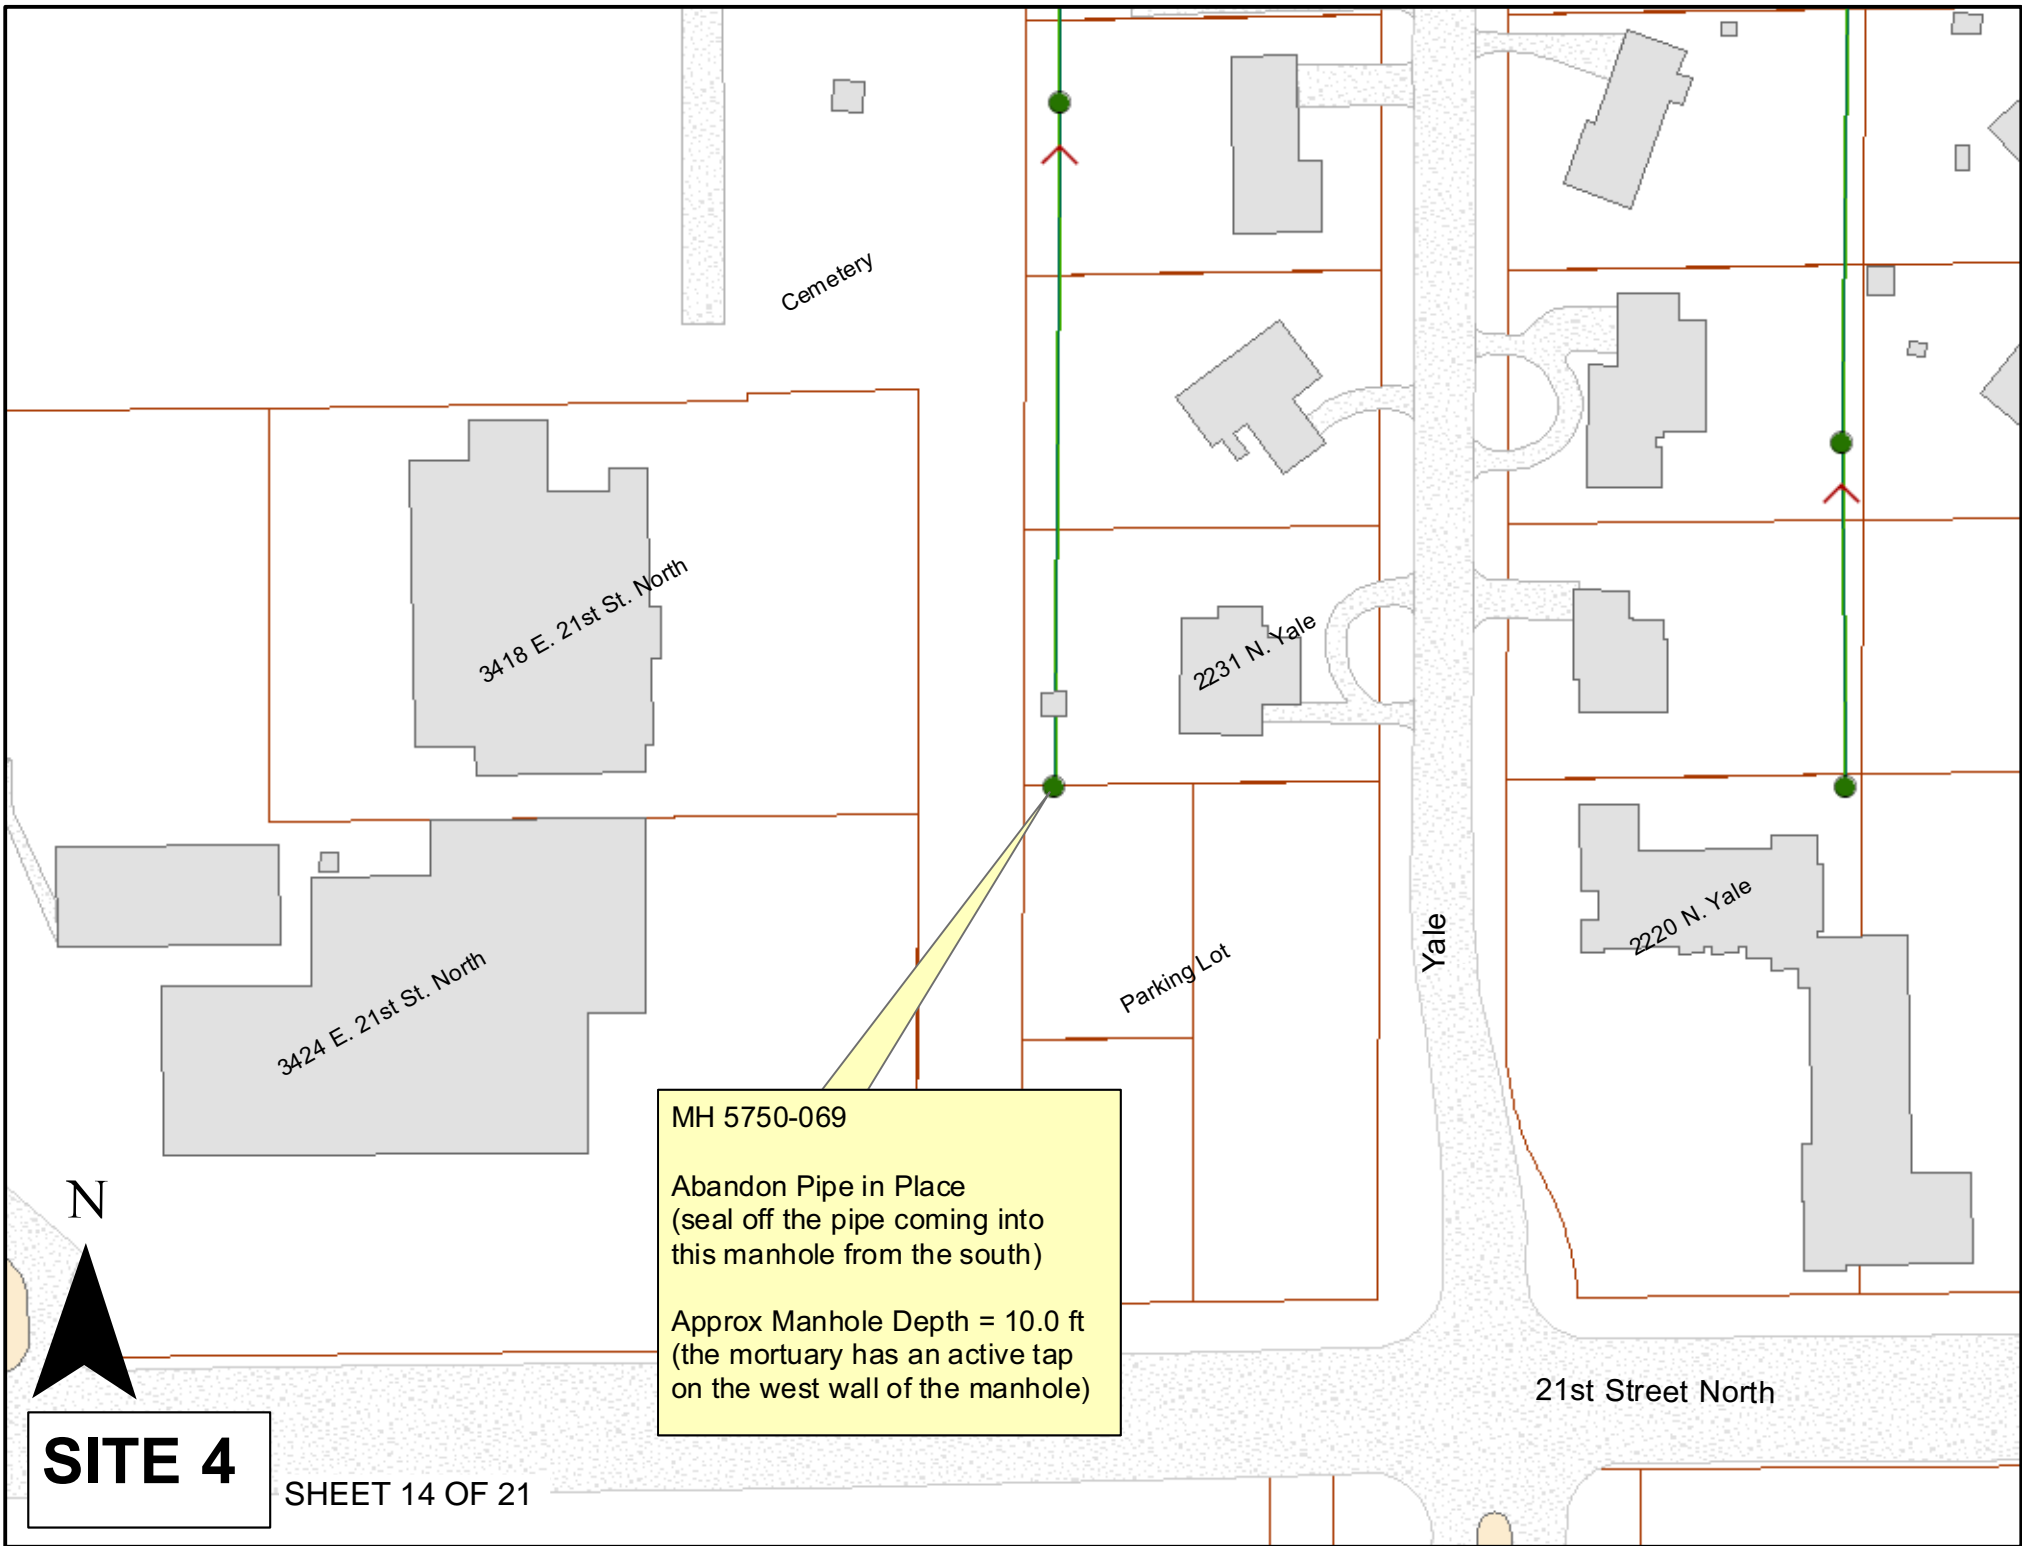
SITE 4

Approx Manhole Depth = 10.0 ft
(the mortuary has an active tap
on the west wall of the manhole)

MH 5750-069
Abandon Pipe in Place
(seal off the pipe coming into
this manhole from the south)
