### Defect Listing Plot

Image Report 1/Page

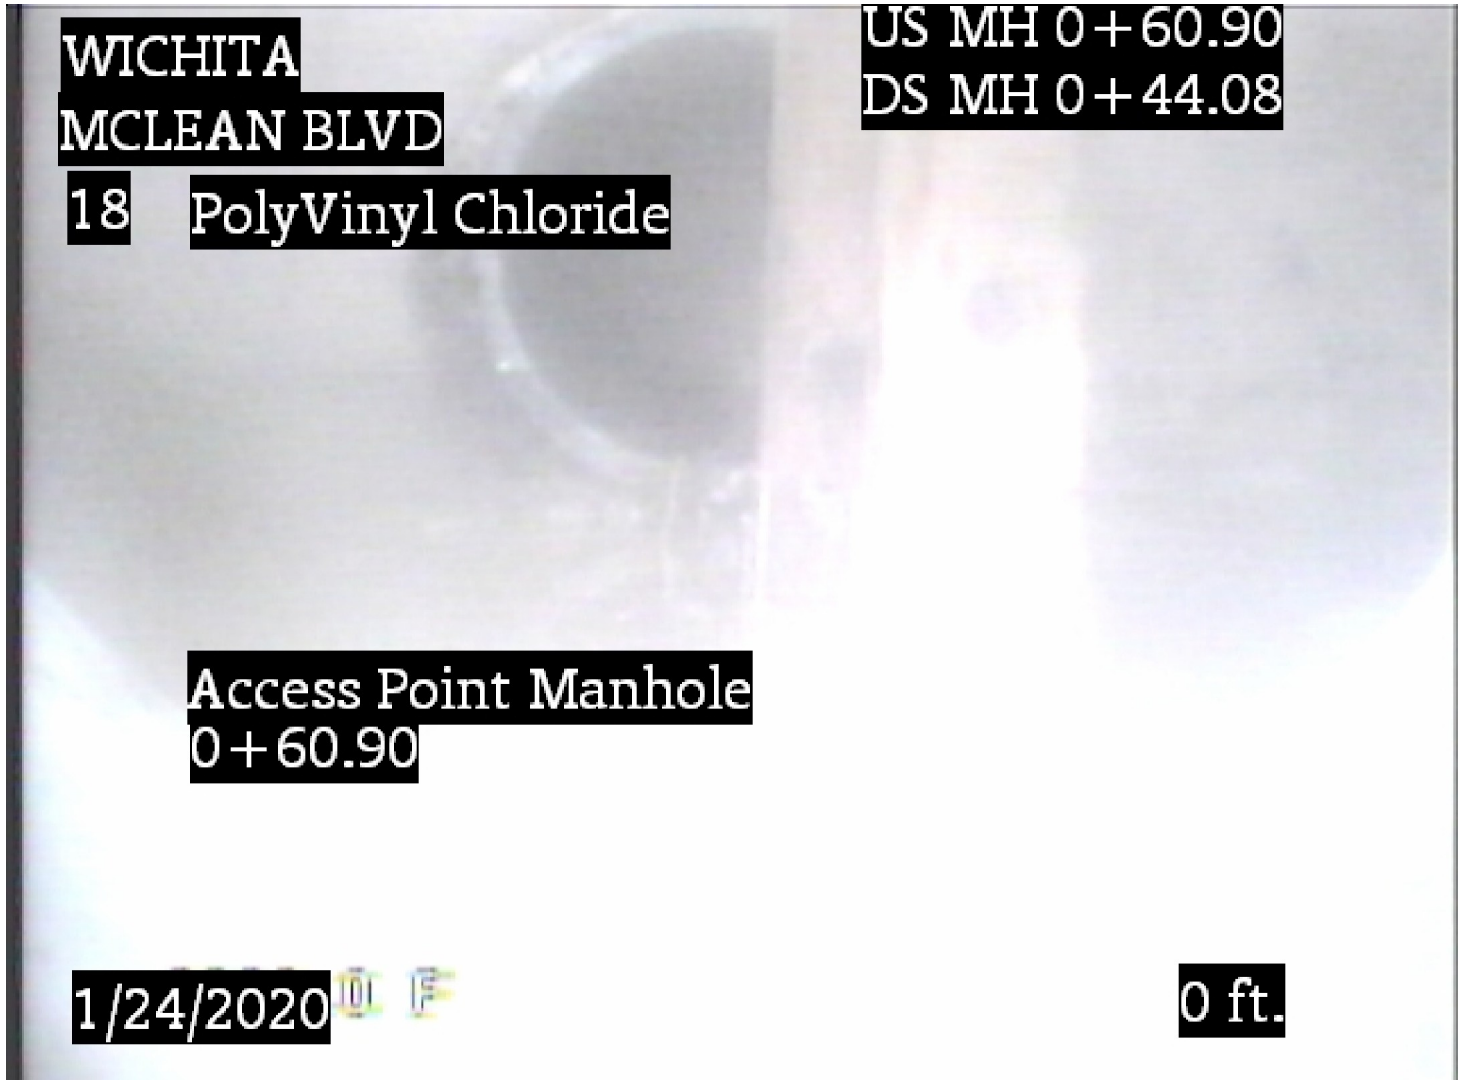
Distance:	0.0 ft.
Condition:	Access Point Manhole
Grade:	0
Remarks:	0+60.90

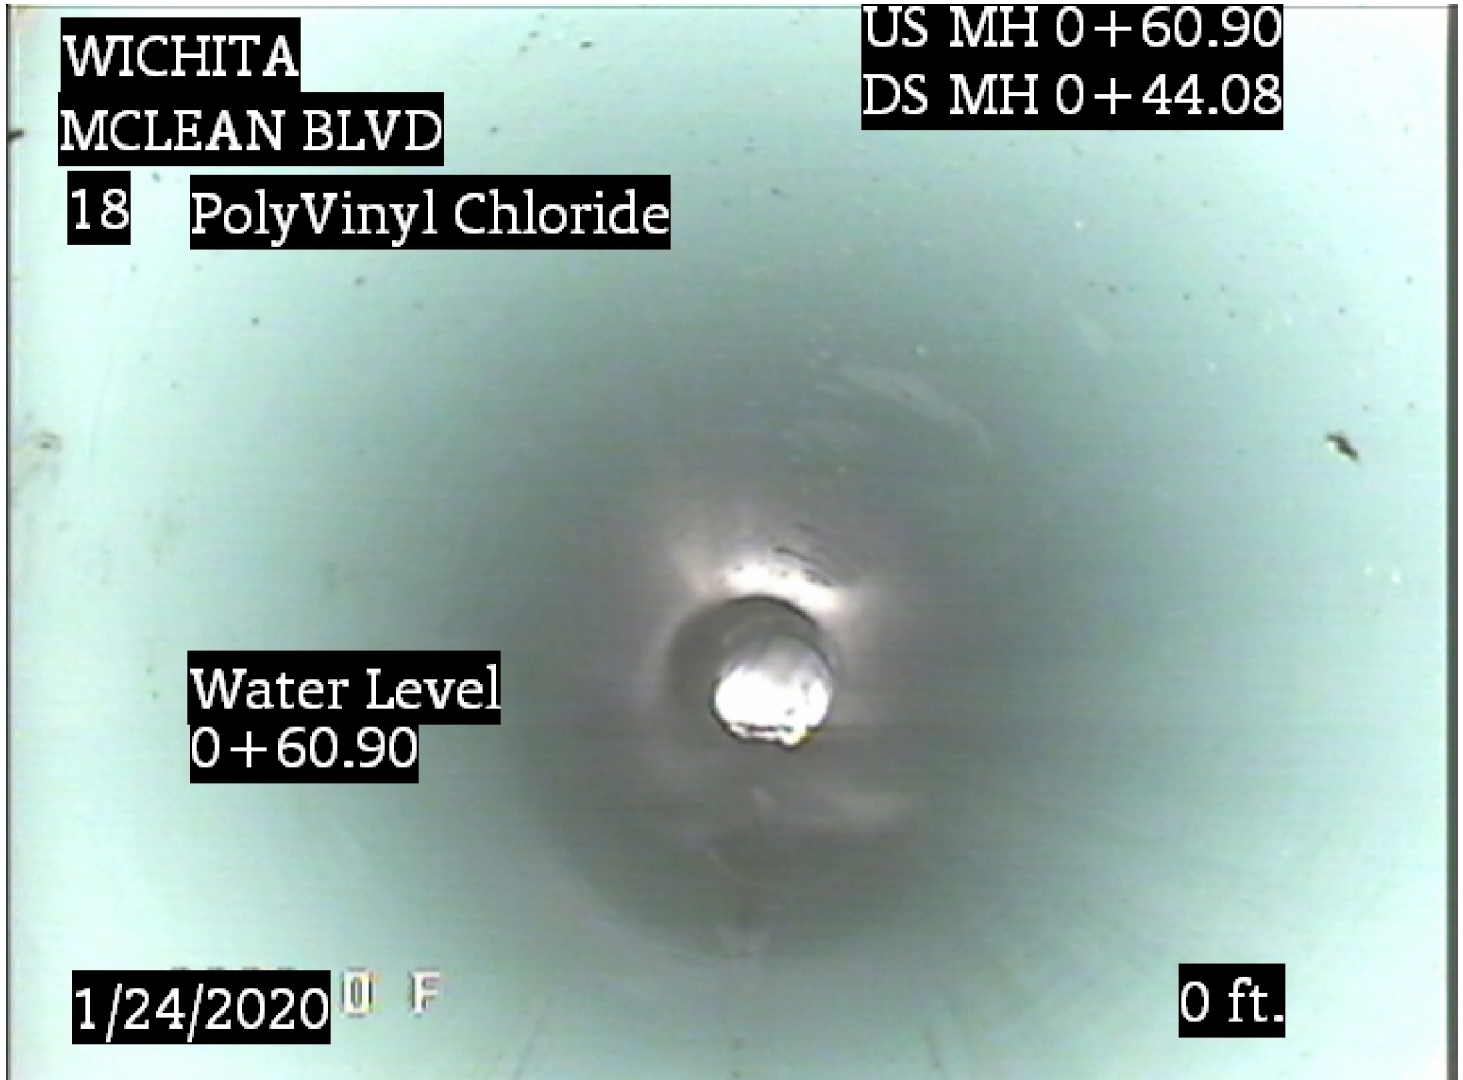
Distance:	0.0 ft.
Condition:	Water Level
Grade:	0
Remarks:	N/A

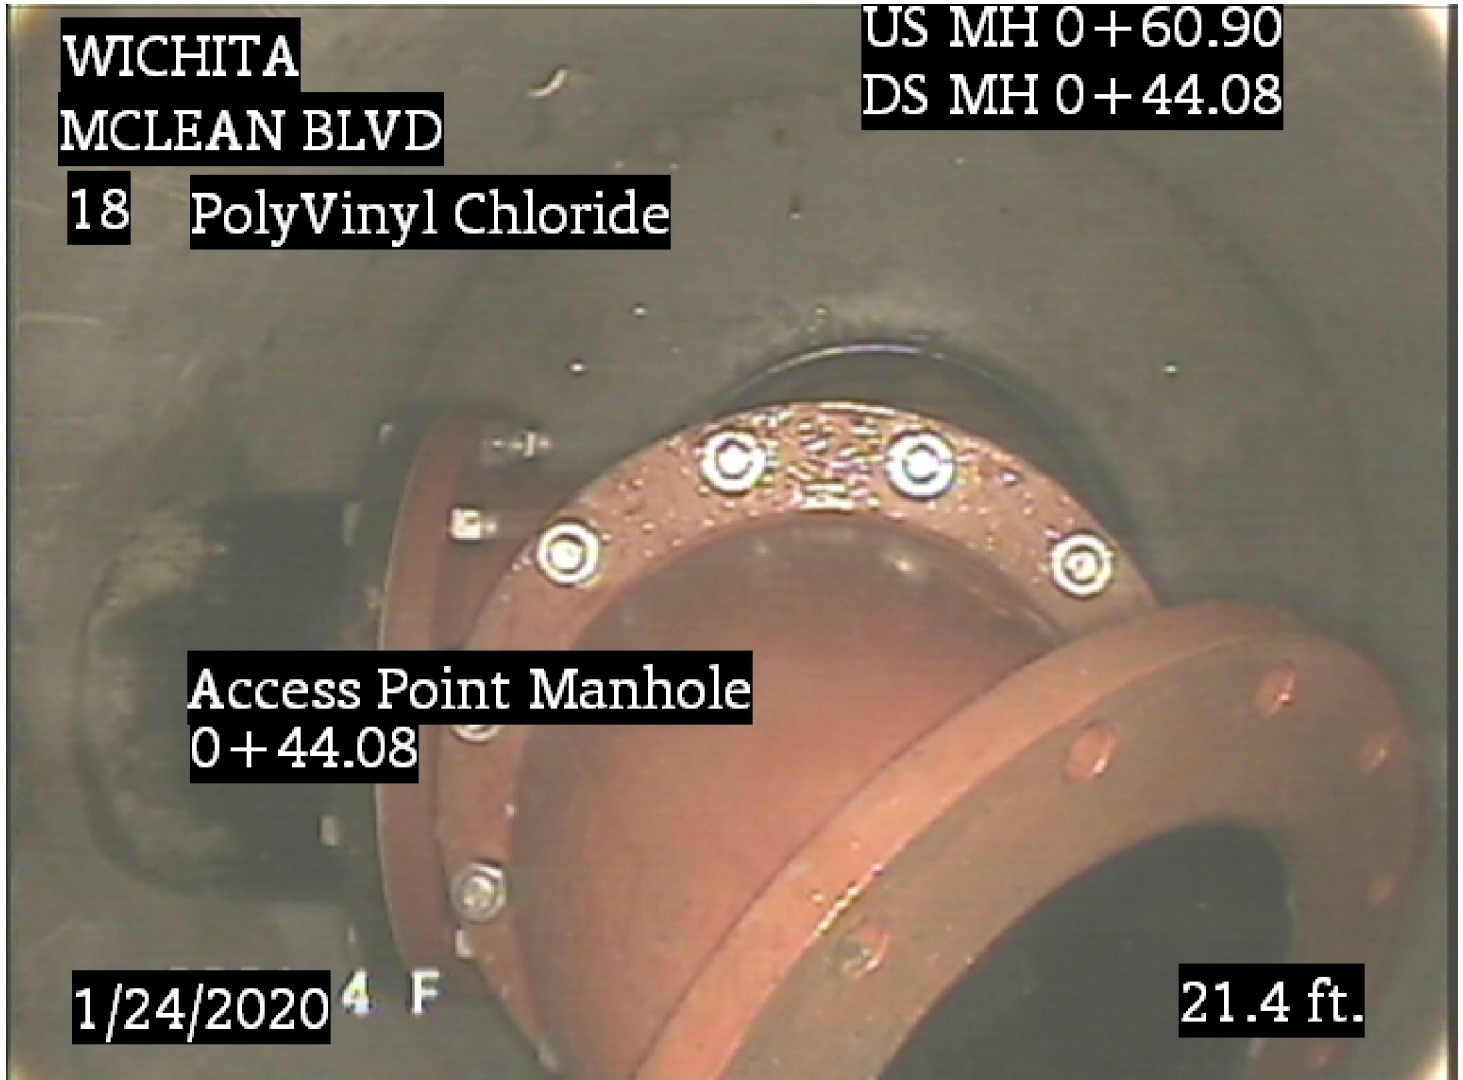
Distance:	21.4 ft.
Condition:	Access Point Manhole
Grade:	0
Remarks:	0+44.08
