2021 Sanitary Sewer Reconstruction

Phase 3

Project # 468-2021-025361

Munis # S1006 / Org #53200021

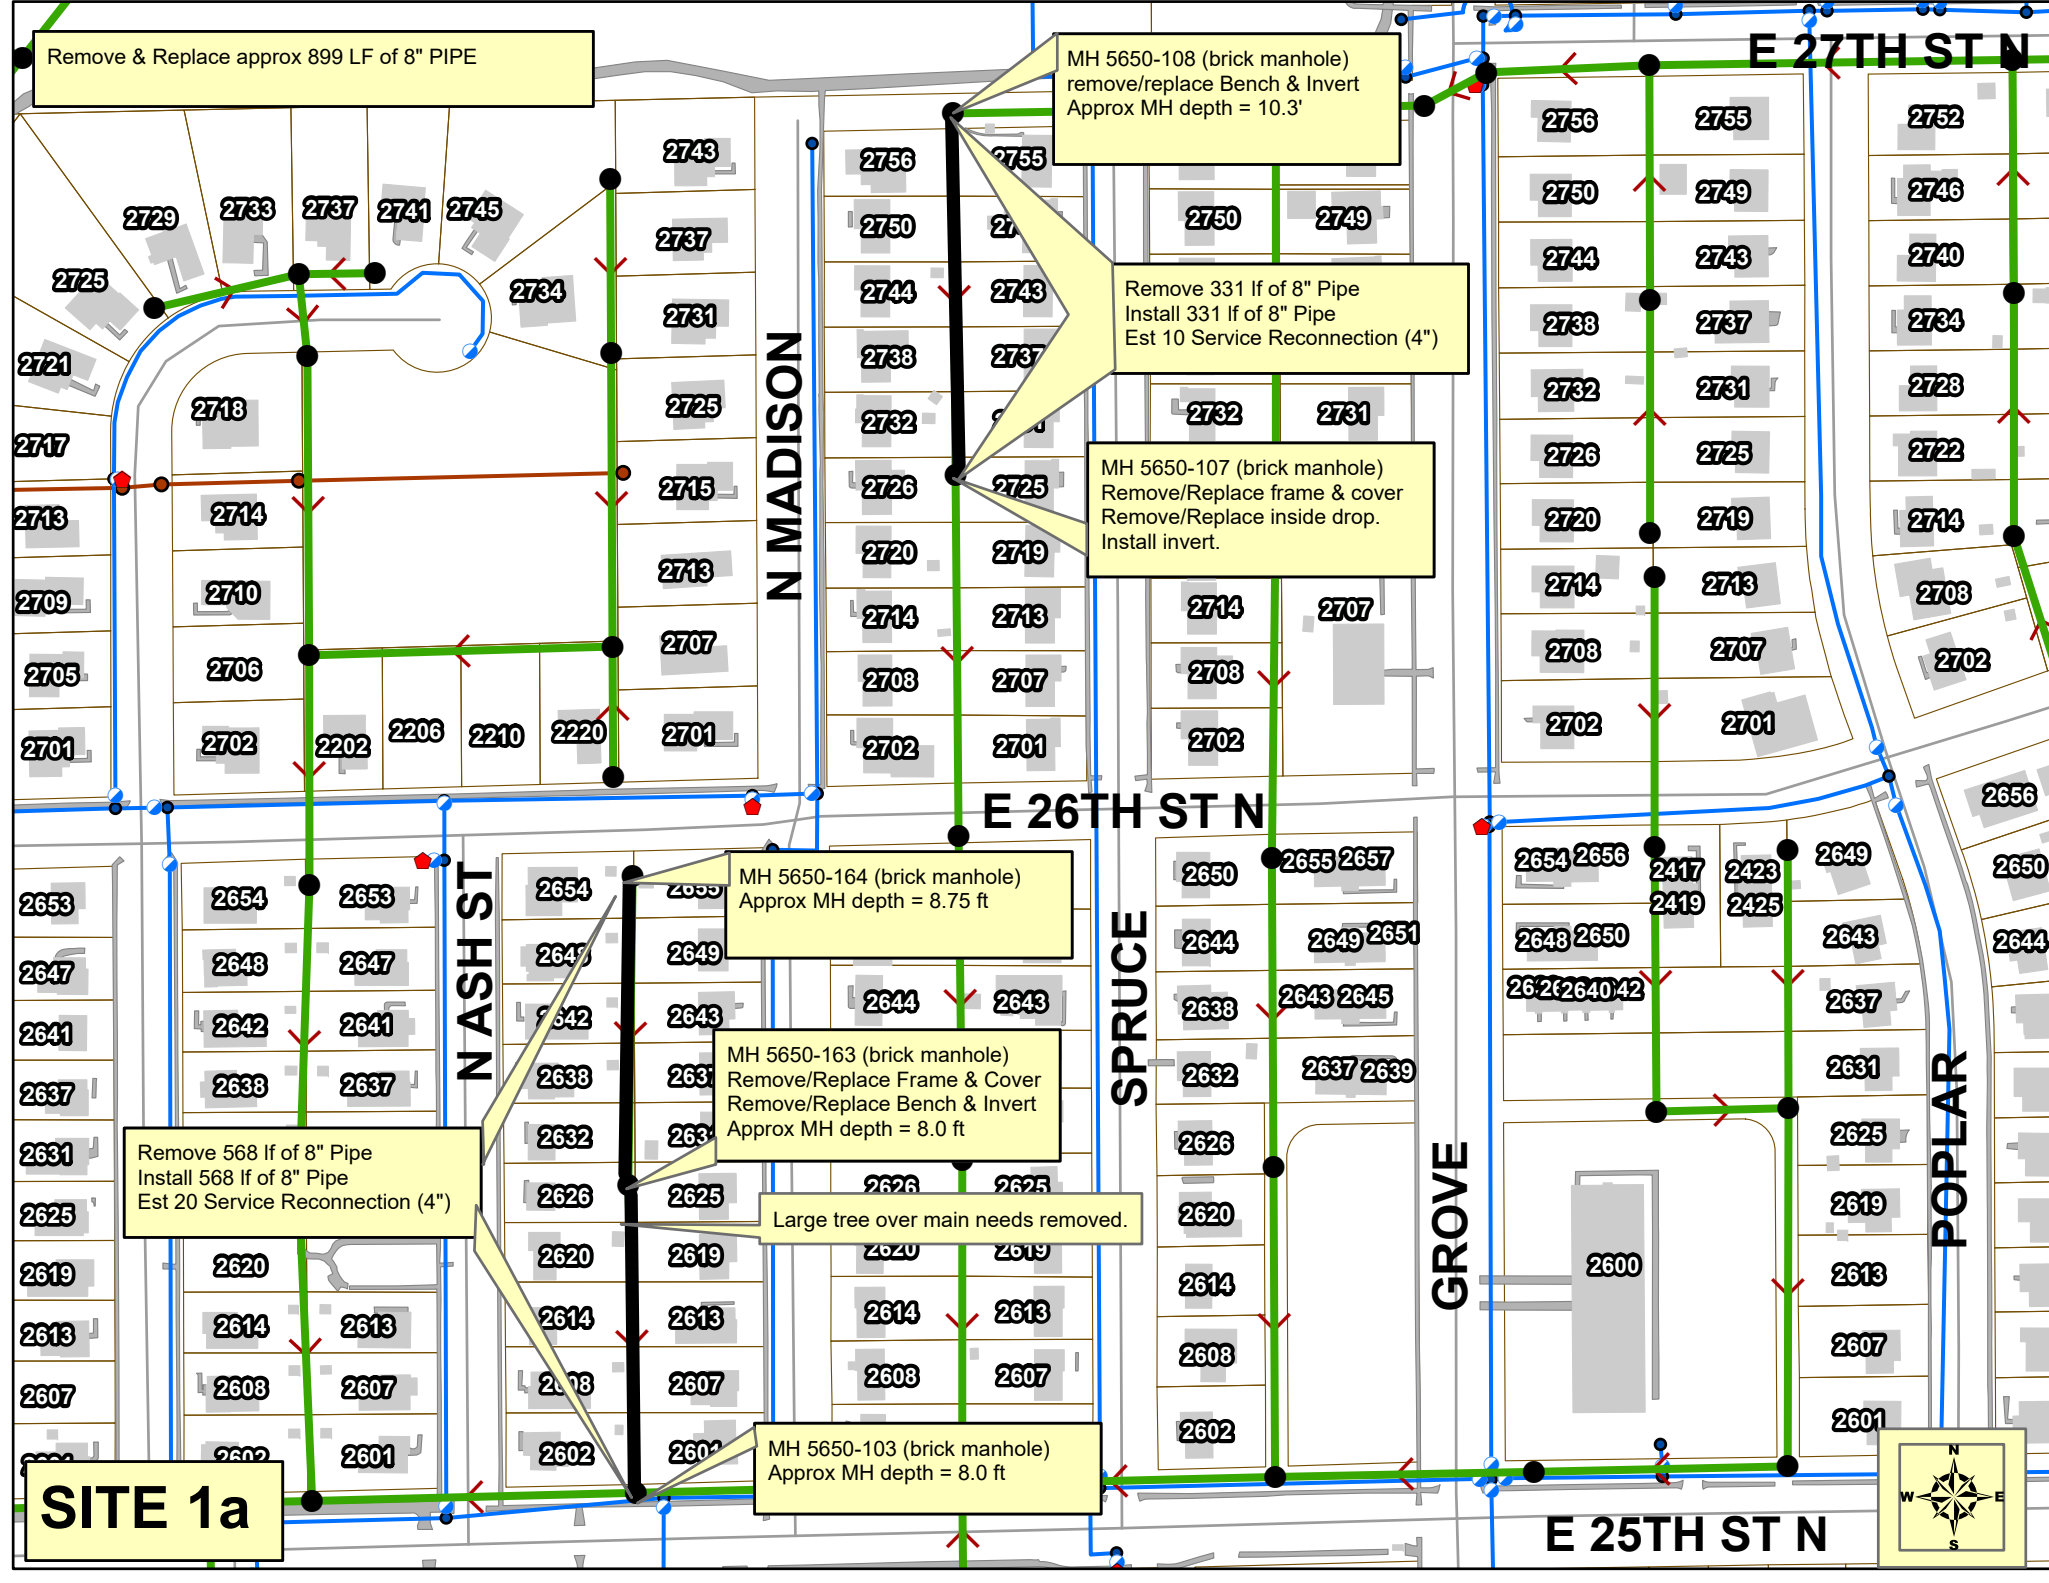
SITE 1a

MH 5650-108 (brick manhole)
remove/replace Bench & Invert
Approx MH depth = 10.3'

MH 5650-107 (brick manhole)
Remove/Replace frame & cover
Remove/Replace inside drop.
Install invert.

MH 5650-164 (brick manhole)
Approx MH depth = 8.75 ft

MH 5650-163 (brick manhole)
Remove/Replace Frame & Cover
Remove/Replace Bench & Invert
Approx MH depth = 8.0 ft

Large tree over main needs removed.

MH 5650-103 (brick manhole)
Approx MH depth = 8.0 ft

Remove & Replace approx 899 LF of 8" PIPE

Remove 331 lf of 8" Pipe
Install 331 lf of 8" Pipe
Est 10 Service Reconnection (4")

Remove 568 lf of 8" Pipe
Install 568 lf of 8" Pipe
Est 20 Service Reconnection (4")

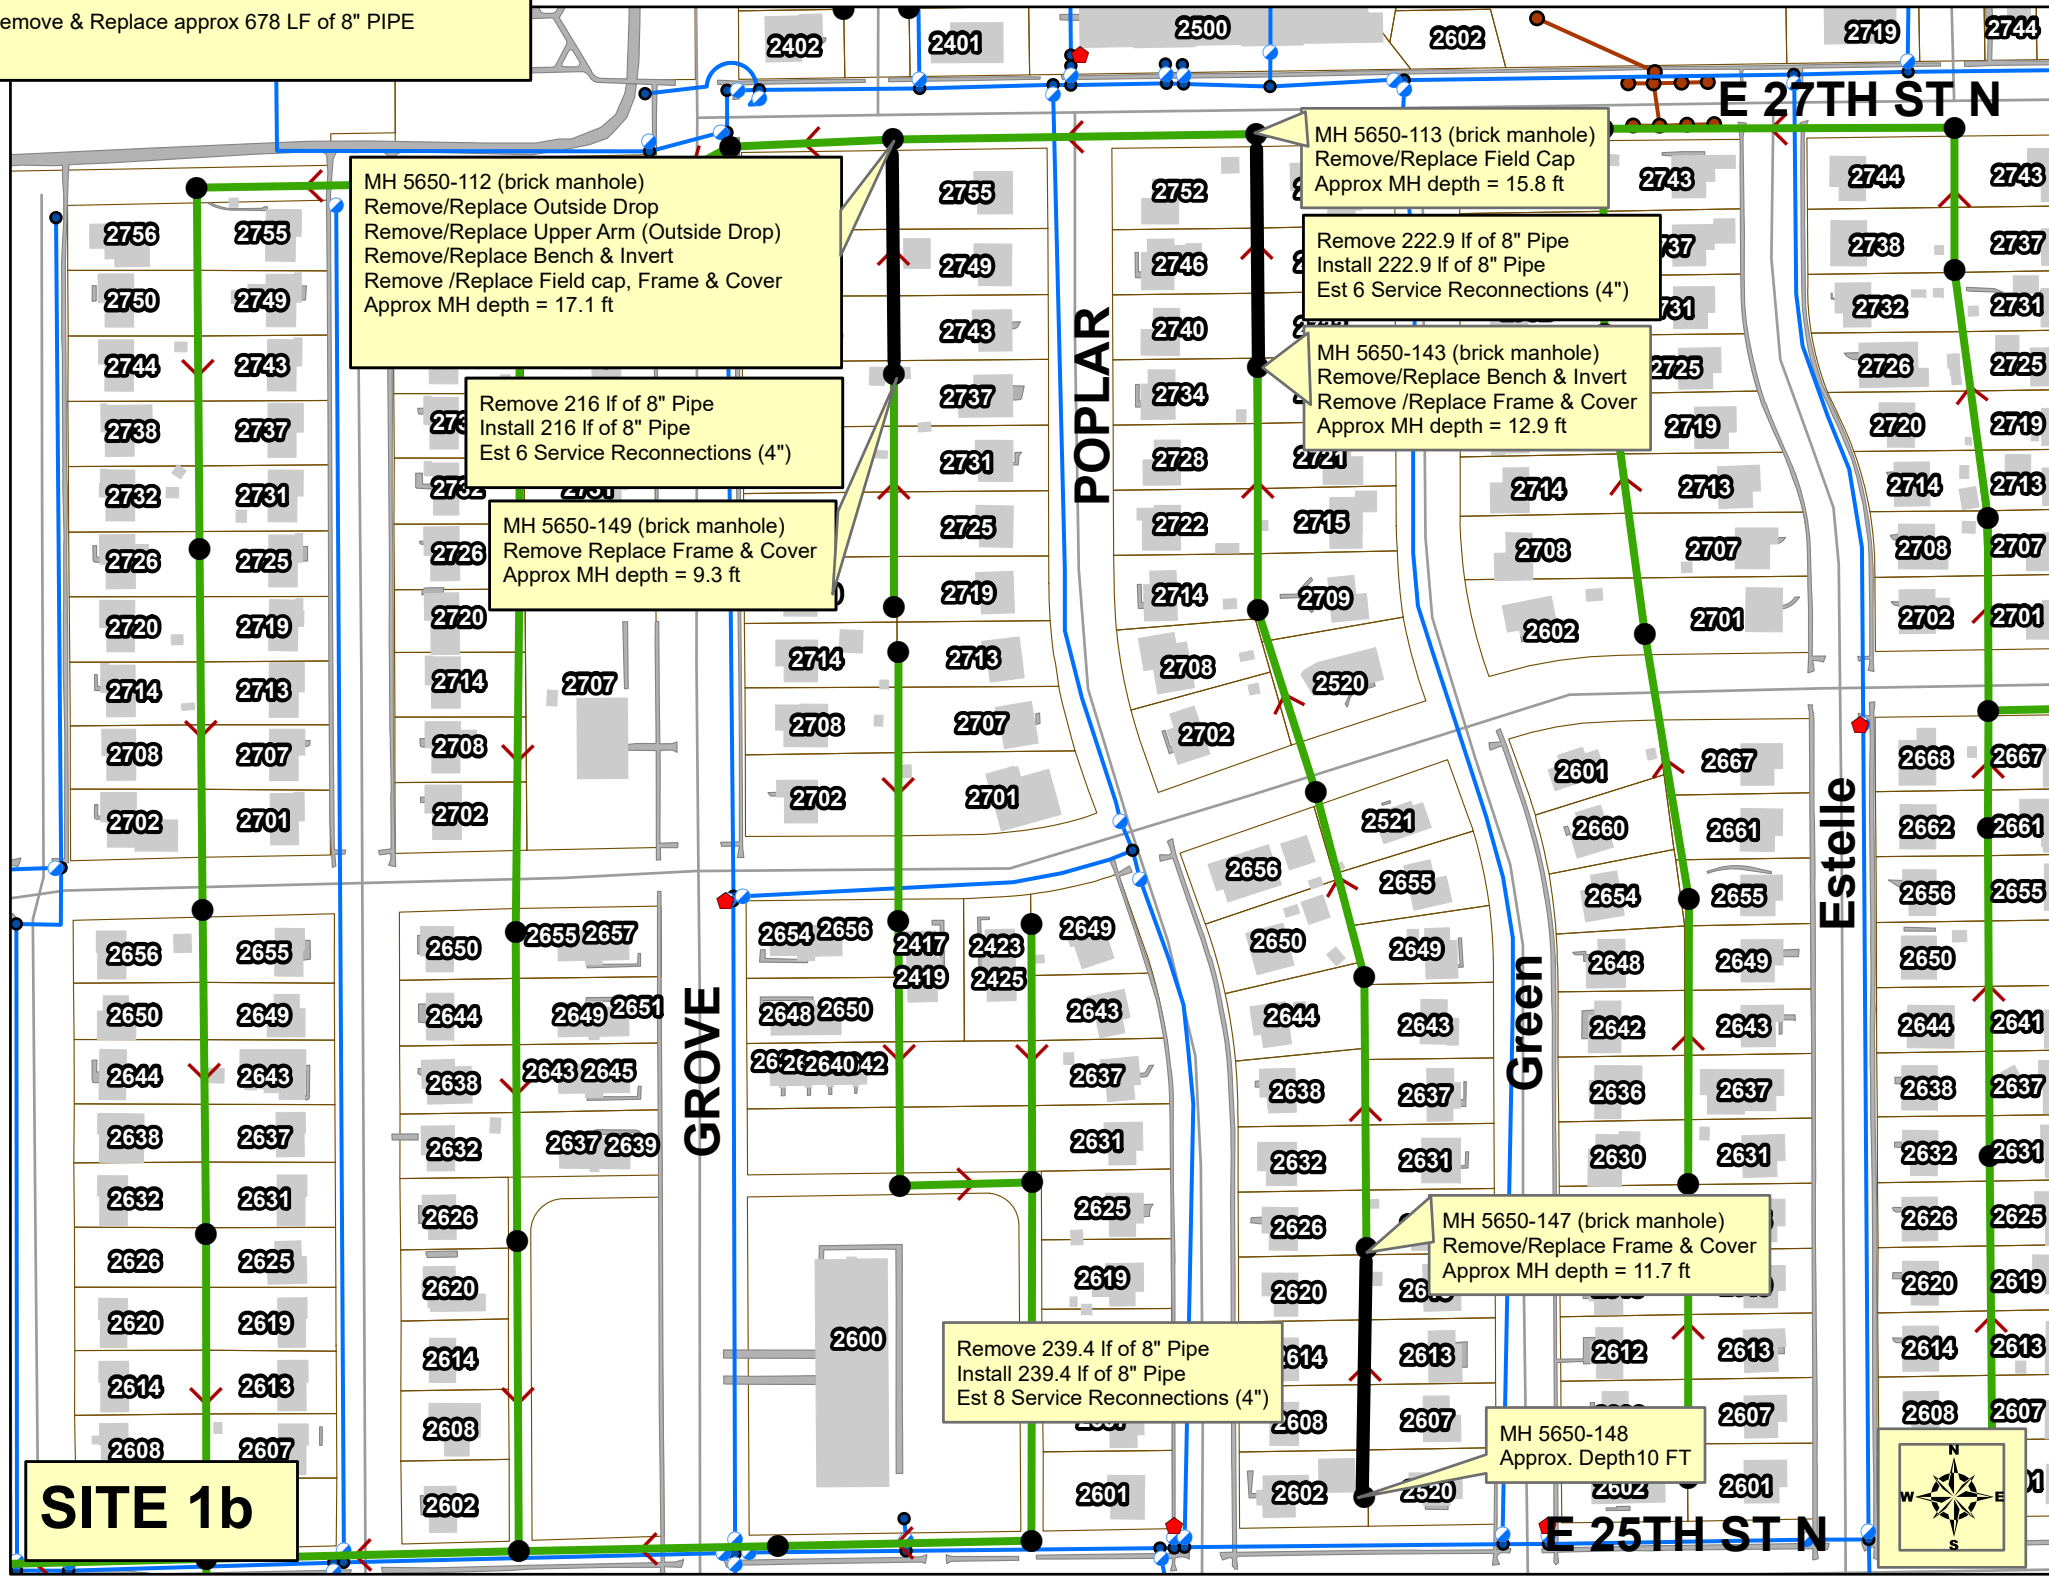
SITE 1b

MH 5650-112 (brick manhole)
Remove/Replace Outside Drop
Remove/Replace Upper Arm (Outside Drop)
Remove/Replace Bench & Invert
Remove /Replace Field cap, Frame & Cover
Approx MH depth = 17.1 ft

MH 5650-149 (brick manhole)
Remove Replace Frame & Cover
Approx MH depth = 9.3 ft

MH 5650-113 (brick manhole)
Remove/Replace Field Cap
Approx MH depth = 15.8 ft

MH 5650-143 (brick manhole)
Remove/Replace Bench & Invert
Remove /Replace Frame & Cover
Approx MH depth = 12.9 ft

MH 5650-147 (brick manhole)
Remove/Replace Frame & Cover
Approx MH depth = 11.7 ft

MH 5650-148
Approx. Depth 10 FT

Remove & Replace approx 678 LF of 8" PIPE

Remove 216 lf of 8" Pipe
Install 216 lf of 8" Pipe
Est 6 Service Reconnections (4")

Remove 222.9 lf of 8" Pipe
Install 222.9 lf of 8" Pipe
Est 6 Service Reconnections (4")

Remove 239.4 lf of 8" Pipe
Install 239.4 lf of 8" Pipe
Est 8 Service Reconnections (4")

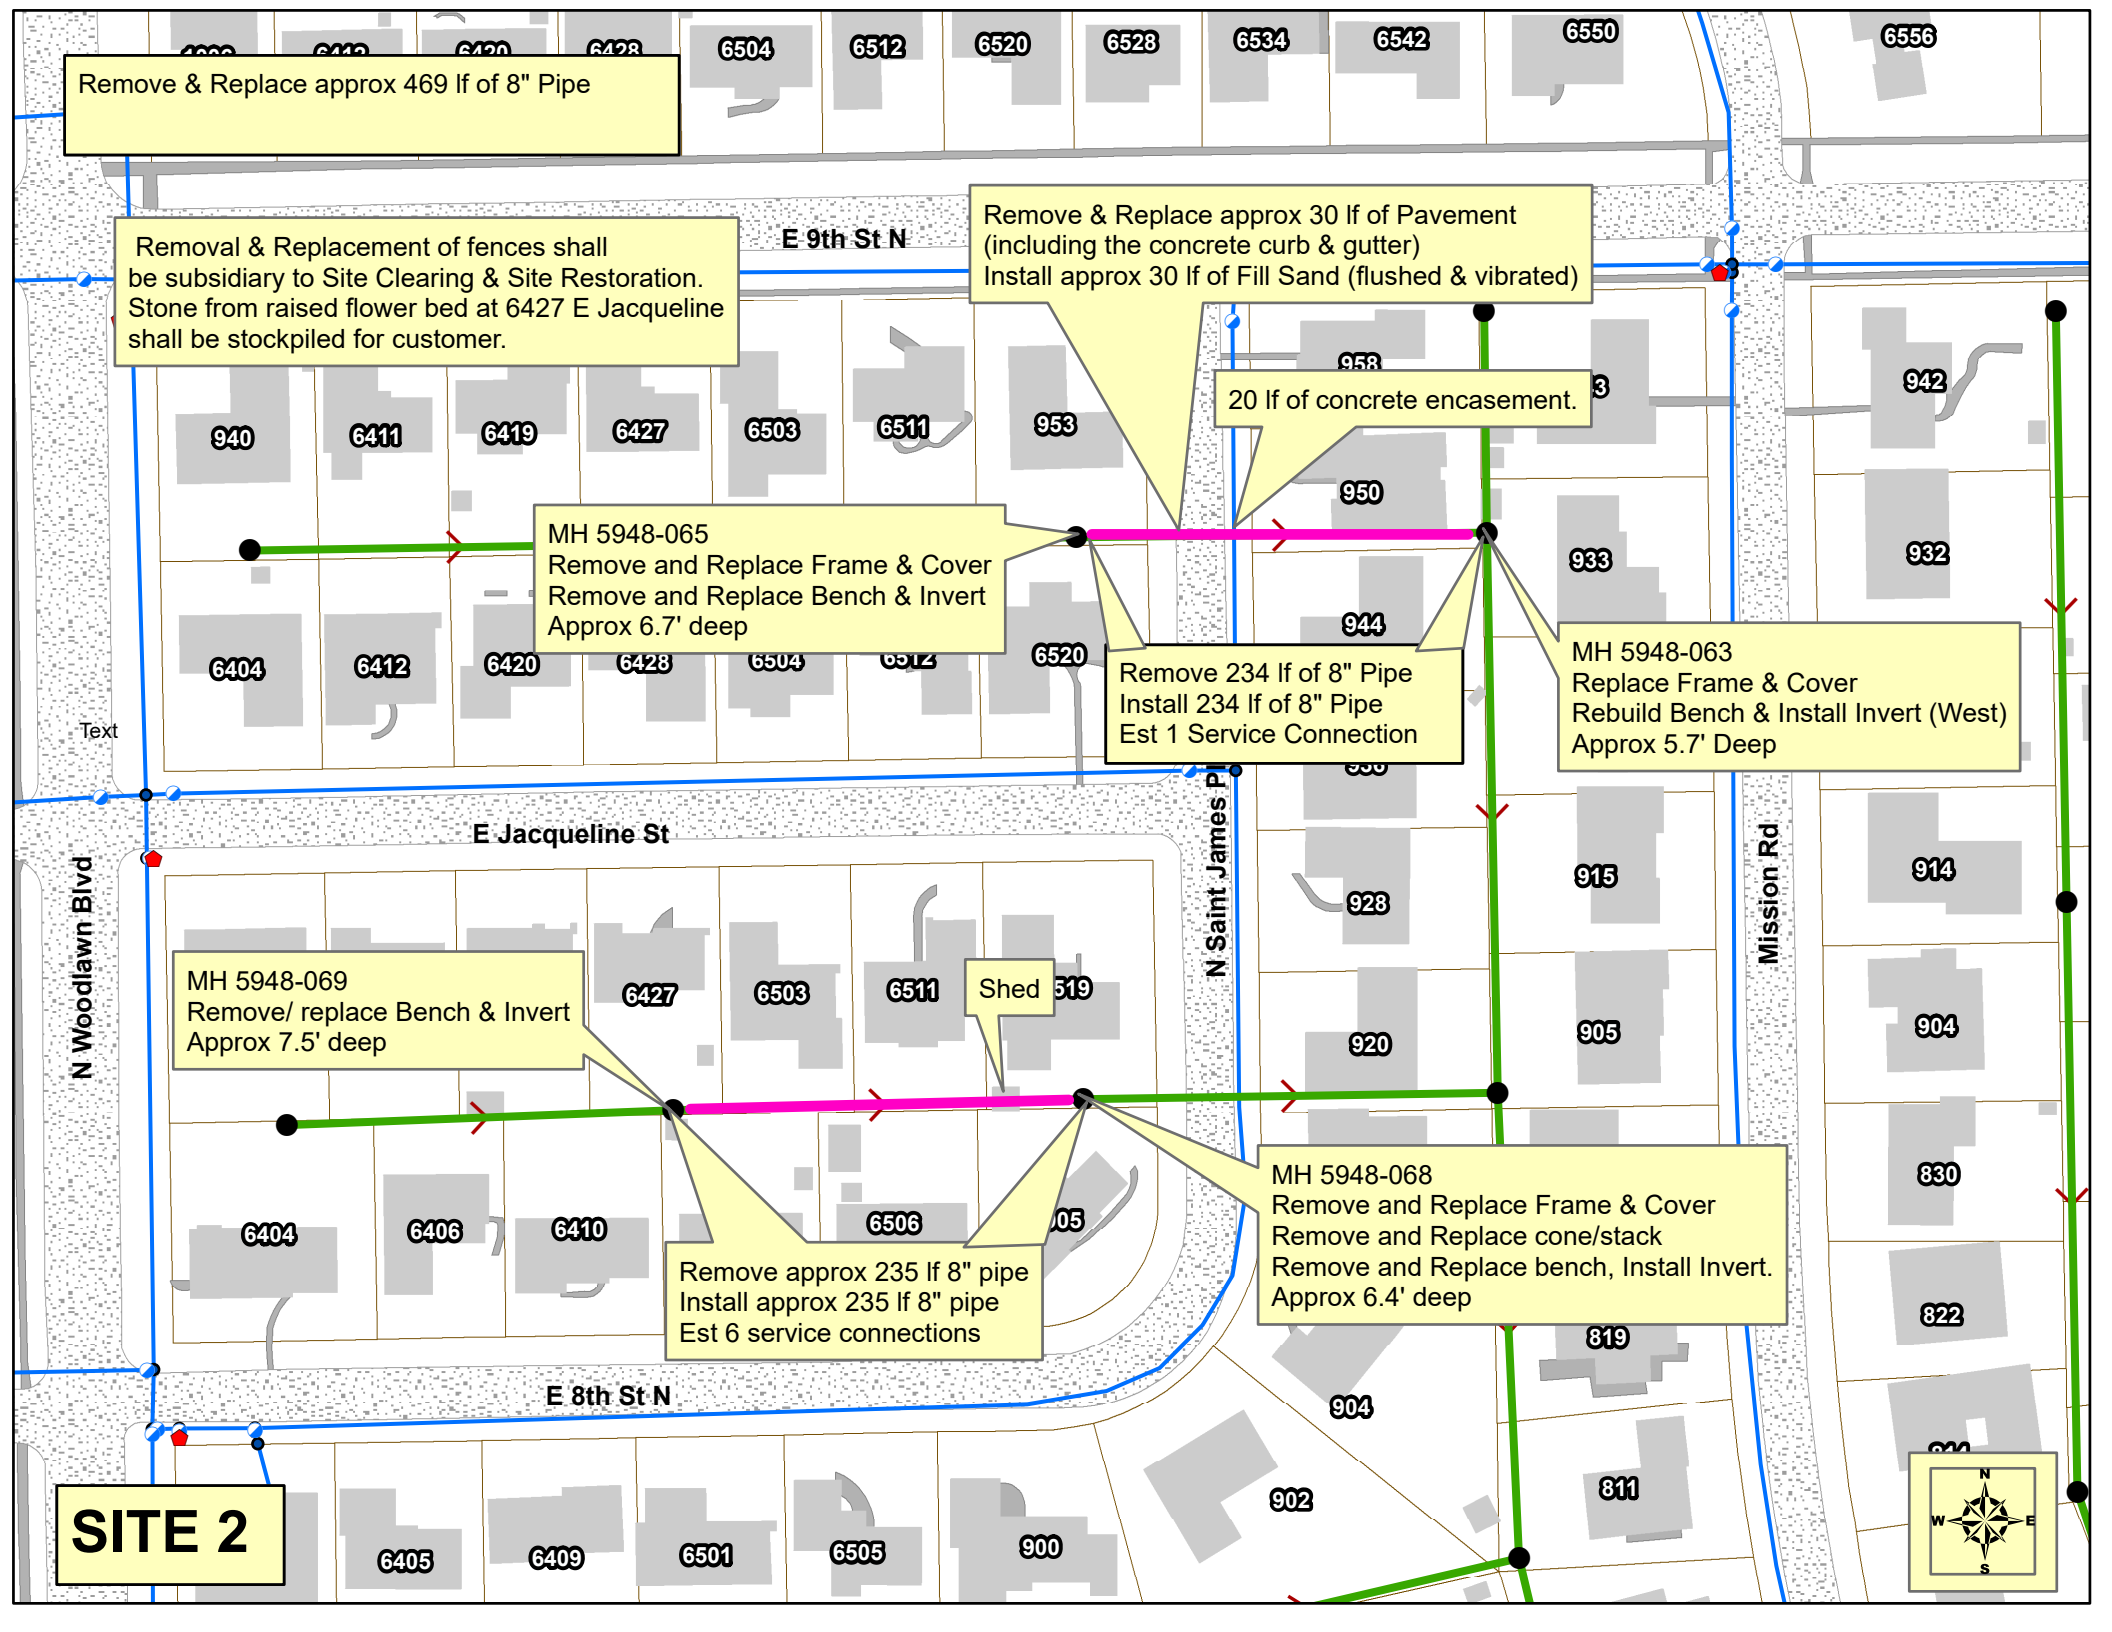
SITE 2

MH 5948-065
Remove and Replace Frame & Cover
Remove and Replace Bench & Invert
Approx 6.7' deep

MH 5948-063
Replace Frame & Cover
Rebuild Bench & Install Invert (West)
Approx 5.7' Deep

MH 5948-069
Remove/ replace Bench & Invert
Approx 7.5' deep

MH 5948-068
Remove and Replace Frame & Cover
Remove and Replace cone/stack
Remove and Replace bench, Install Invert.
Approx 6.4' deep

Sequence:	Recommendation:	Priority:	Assigned to:	Completed:
1	Line Rehabilitation REC CIPP LINER OR COMPLETE REPLACMENT. MAIN IS IN HORRIBLE SHAPE, LOTS OF CRACKS AND FRACTURES.	Rehab Priority High	Systems & Planning	No

226.30	CM	Crack Multiple	9	3			
232.60	AMH	Manhole					5948-063/ LINE SEGMENT LOOKED OKAY,SOME CRACKED SOME ROOTBALLS AT THE JOINTS.NEED KNIFE & CLEAN.

Sequence:	Recommendation:	Priority:	Assigned to:	Completed:
1	Line Rehabilitation REC CIPP LINER DUE TO CRACKS FRACTURES AND HOLES. MAY WANT TO DO A FULL REPLACMENT OF THE LINE	Rehab Priority Med High	Systems & Planning	No

235.60	AMH	Manhole					5948-068/ LINE SEGMENT LOOKED OKAY,SOME ROOTBALLS & CRACKED IN THE SEWER MAIN,NEED KNIFE & CLEAN.

Remove & Replace approx 469 lf of 8" Pipe

Removal & Replacement of fences shall be subsidiary to Site Clearing & Site Restoration. Stone from raised flower bed at 6427 E Jacqueline shall be stockpiled for customer.

Remove & Replace approx 30 lf of Pavement (including the concrete curb & gutter)
Install approx 30 lf of Fill Sand (flushed & vibrated)

20 lf of concrete encasement.

Remove 234 lf of 8" Pipe
Install 234 lf of 8" Pipe
Est 1 Service Connection

Remove approx 235 lf 8" pipe
Install approx 235 lf 8" pipe
Est 6 service connections
