Planeview Area Sanitary Sewer Improvements
Sewer Reconstruction Phase 2
OCA 624101 / 468-84838

Bid Items by Site Reference

Planeview Area Sanitary Sewer Improvements / Sewer Reconstruction Phase 2

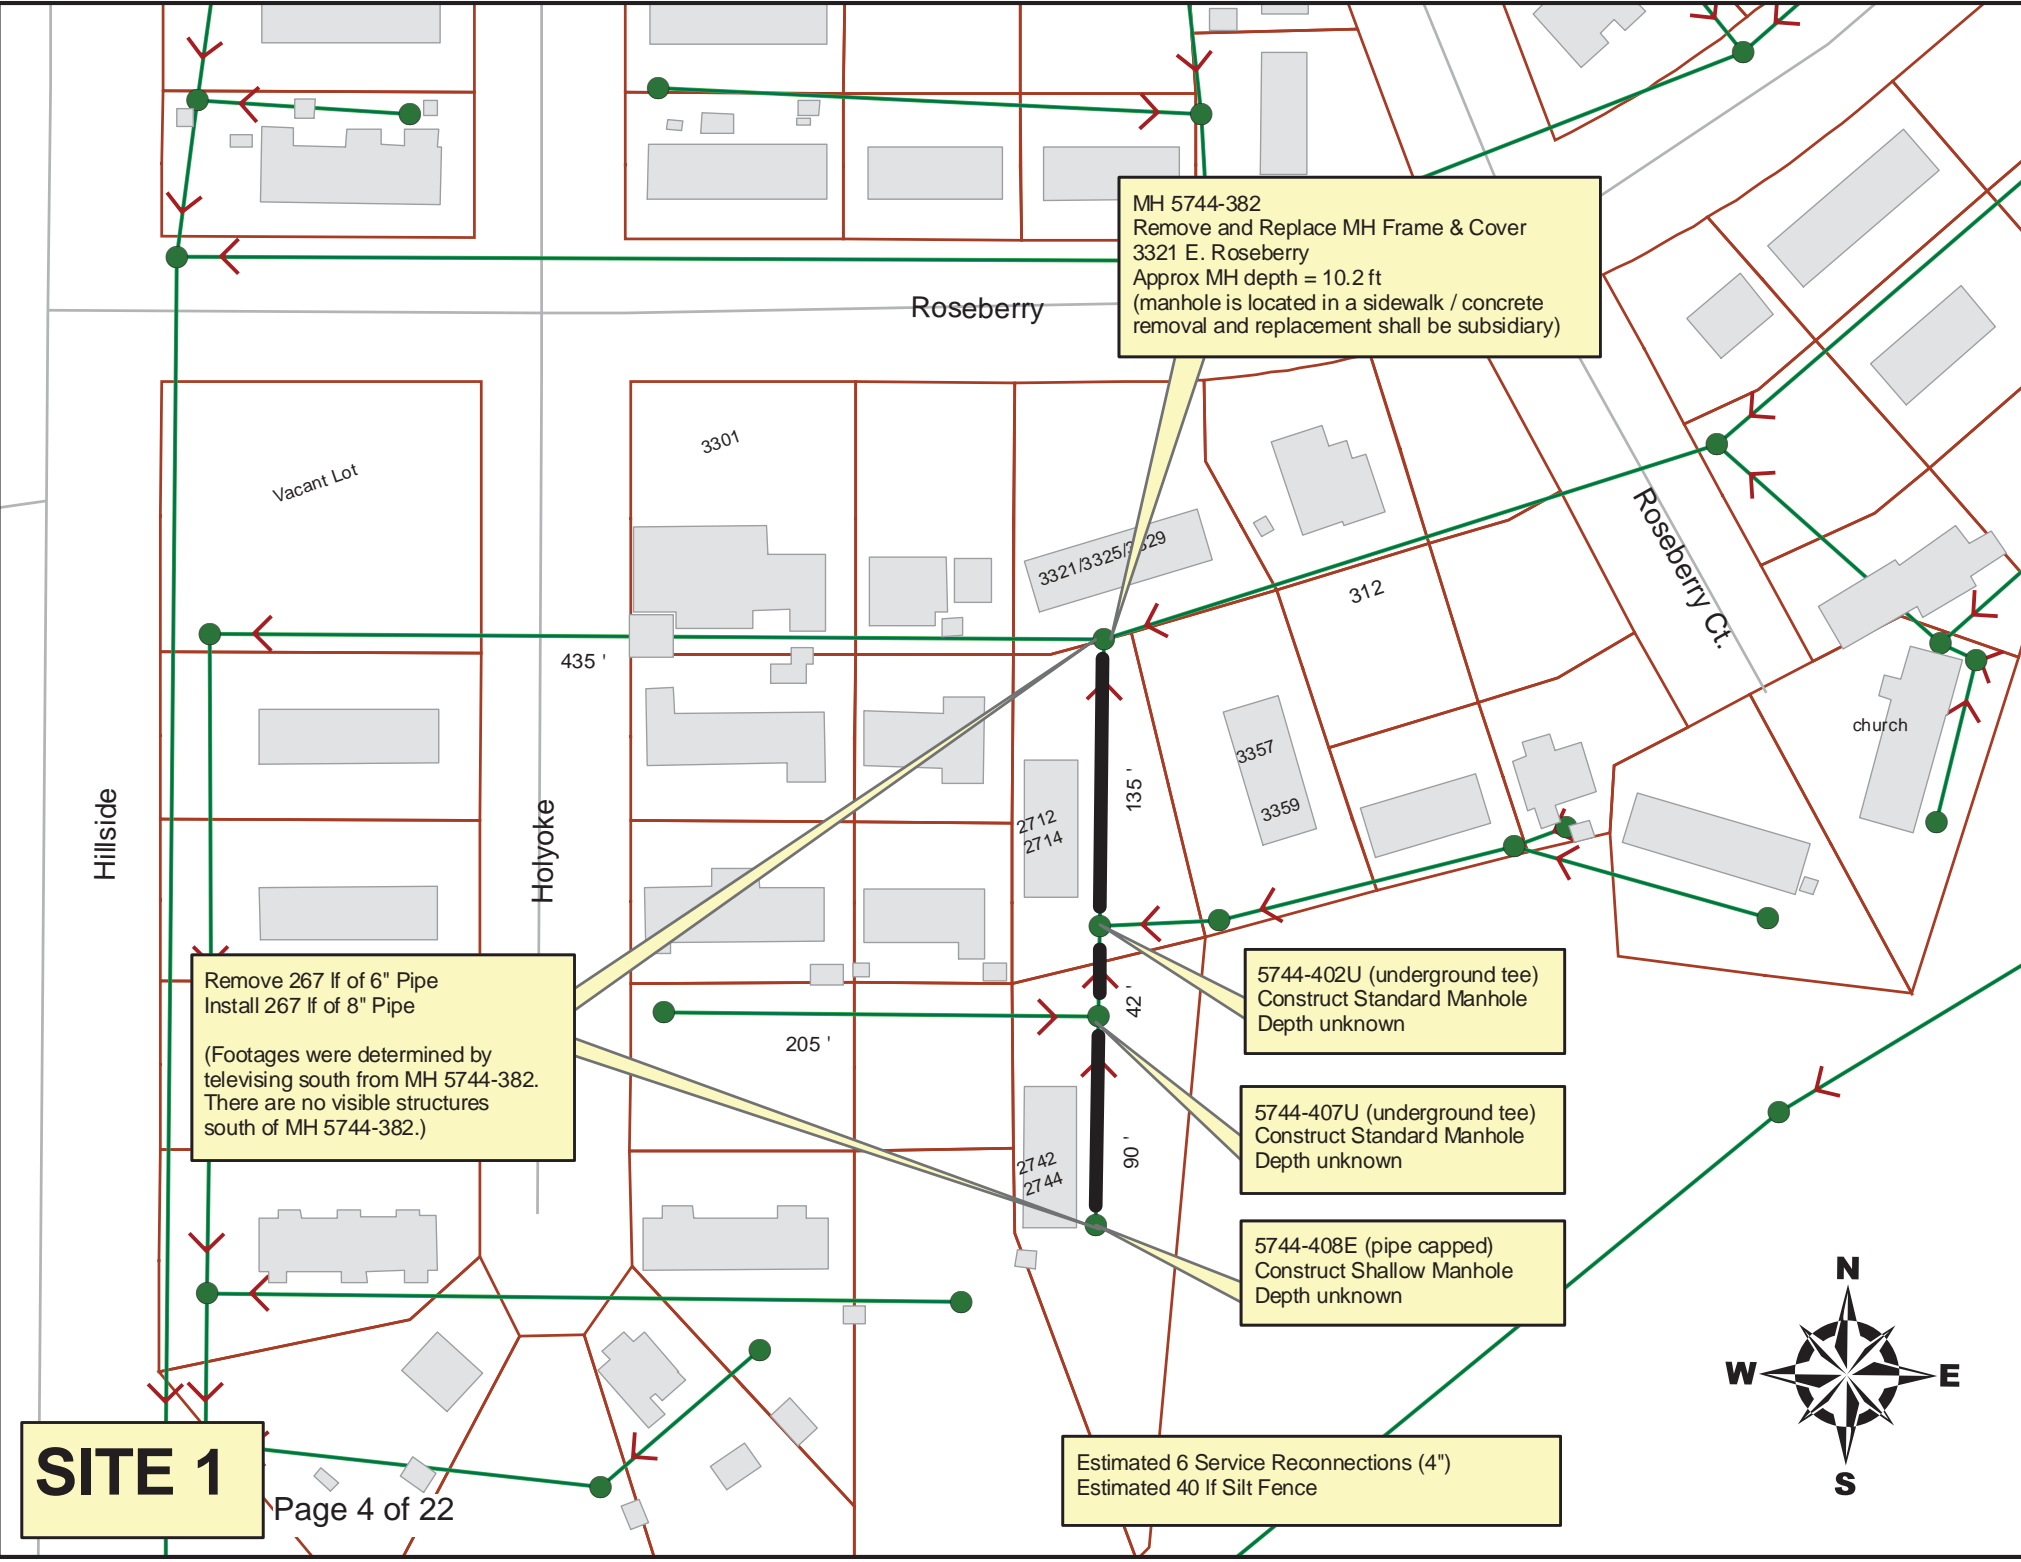
SITE 1

MH 5744-382
Remove and Replace MH Frame & Cover
3321 E. Roseberry
Approx MH depth = 10.2 ft
(manhole is located in a sidewalk / concrete removal and replacement shall be subsidiary)

Remove 267 lf of 6" Pipe
Install 267 lf of 8" Pipe

(Footages were determined by televising south from MH 5744-382. There are no visible structures south of MH 5744-382.)

5744-402U (underground tee)
Construct Standard Manhole
Depth unknown

5744-407U (underground tee)
Construct Standard Manhole
Depth unknown

5744-408E (pipe capped)
Construct Shallow Manhole
Depth unknown

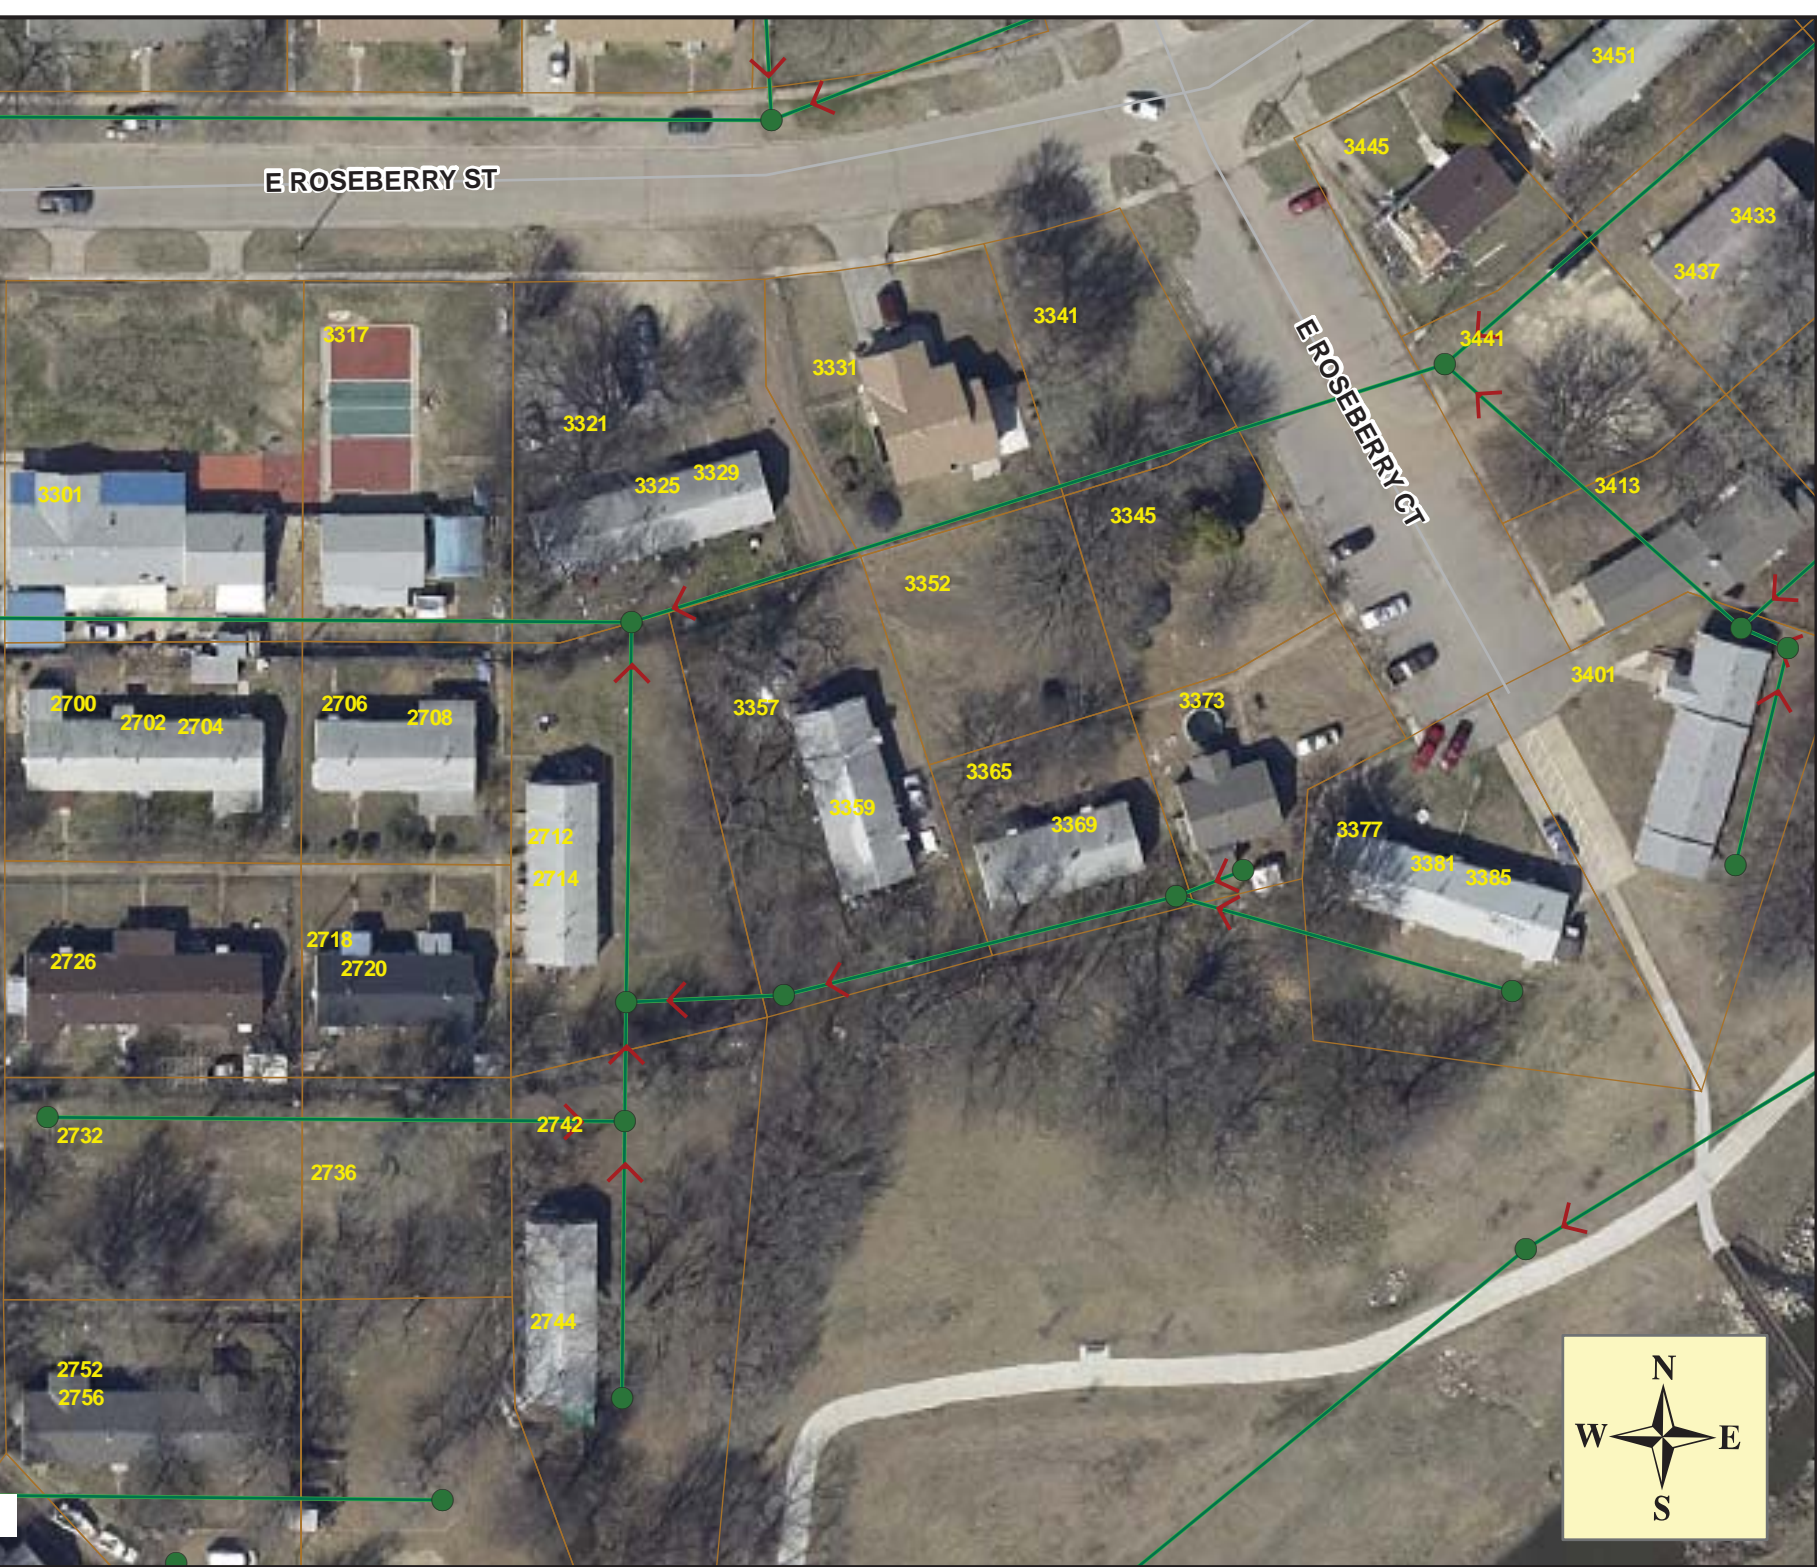
Video Inspection Master Report

US Structure: 5744-408E (capped end-pipe) **Date Insp:** 6/25/2012 **Basin:** C01A
DS Structure: 5744-407U (union) **Dir Televised:** Downstream to Upstream

Obs. #	VTR Counter	Distance	Location	Description	Rating	Obsrvd (gpm)	Est. (gpm)	Ratings		
								Struct	Clean	Remain (gpm)
		0.0		5744-407 U / Underground Tee (6") TV AGAINST THE FLOW	1		No structure at the surface Dia: 6"			VCP
		52.6		West wye / 2742-44 S. Holyoke (4")						
		87.4		West wye / 2742-44 S. Holyoke (4")			Heavy roots in service			
		90.0		5744-408E / Capped End of Pipe Line has roots	1		No structure at the surface

US Structure: 5744-407U **Date Insp:** 6/25/2012 **Basin:** C01A
DS Structure: 5744-402U **Dir Televised:** Downstream to Upstream

Obs. #	VTR Counter	Distance	Location	Description	Rating	Obsrvd (gpm)	Est. (gpm)	Ratings		
								Struct	Clean	Remain (gpm)
		0.0		5744-402 U / Underground Tee (6") TV AGAINST THE FLOW	1		No structure at the surface Dia: 6"			VCP
		42.2		5744-407U / Underground Tee (6") <u>NO TAPS</u>	1		No structure at the surface

US Structure: 5744-402U **Date Insp:** 6/25/2012 **Basin:** C01A
DS Structure: 5744-382 **Dir Televised:** Downstream to Upstream

Obs. #	VTR Counter	Distance	Location	Description	Rating	Obsrvd (gpm)	Est. (gpm)	Ratings		
								Struct	Clean	Remain (gpm)
		0.0		Downstream Manhole 5744-382 TV AGAINST THE FLOW			(manhole is visible) Dia: 6"			VCP
		62.0		East wye / 3357-59 Roseberry Ct. (4")						
		69.5		West wye / 2712-14 S. Holyoke (4")						
		100.8		East wye / 3357-59 Roseberry Ct. (4")						
		106.2		West wye / 2712-14 S. Holyoke (4")			Full of roots			
		135.0		5744-402U / Underground Tee (6")			No structure at the surface

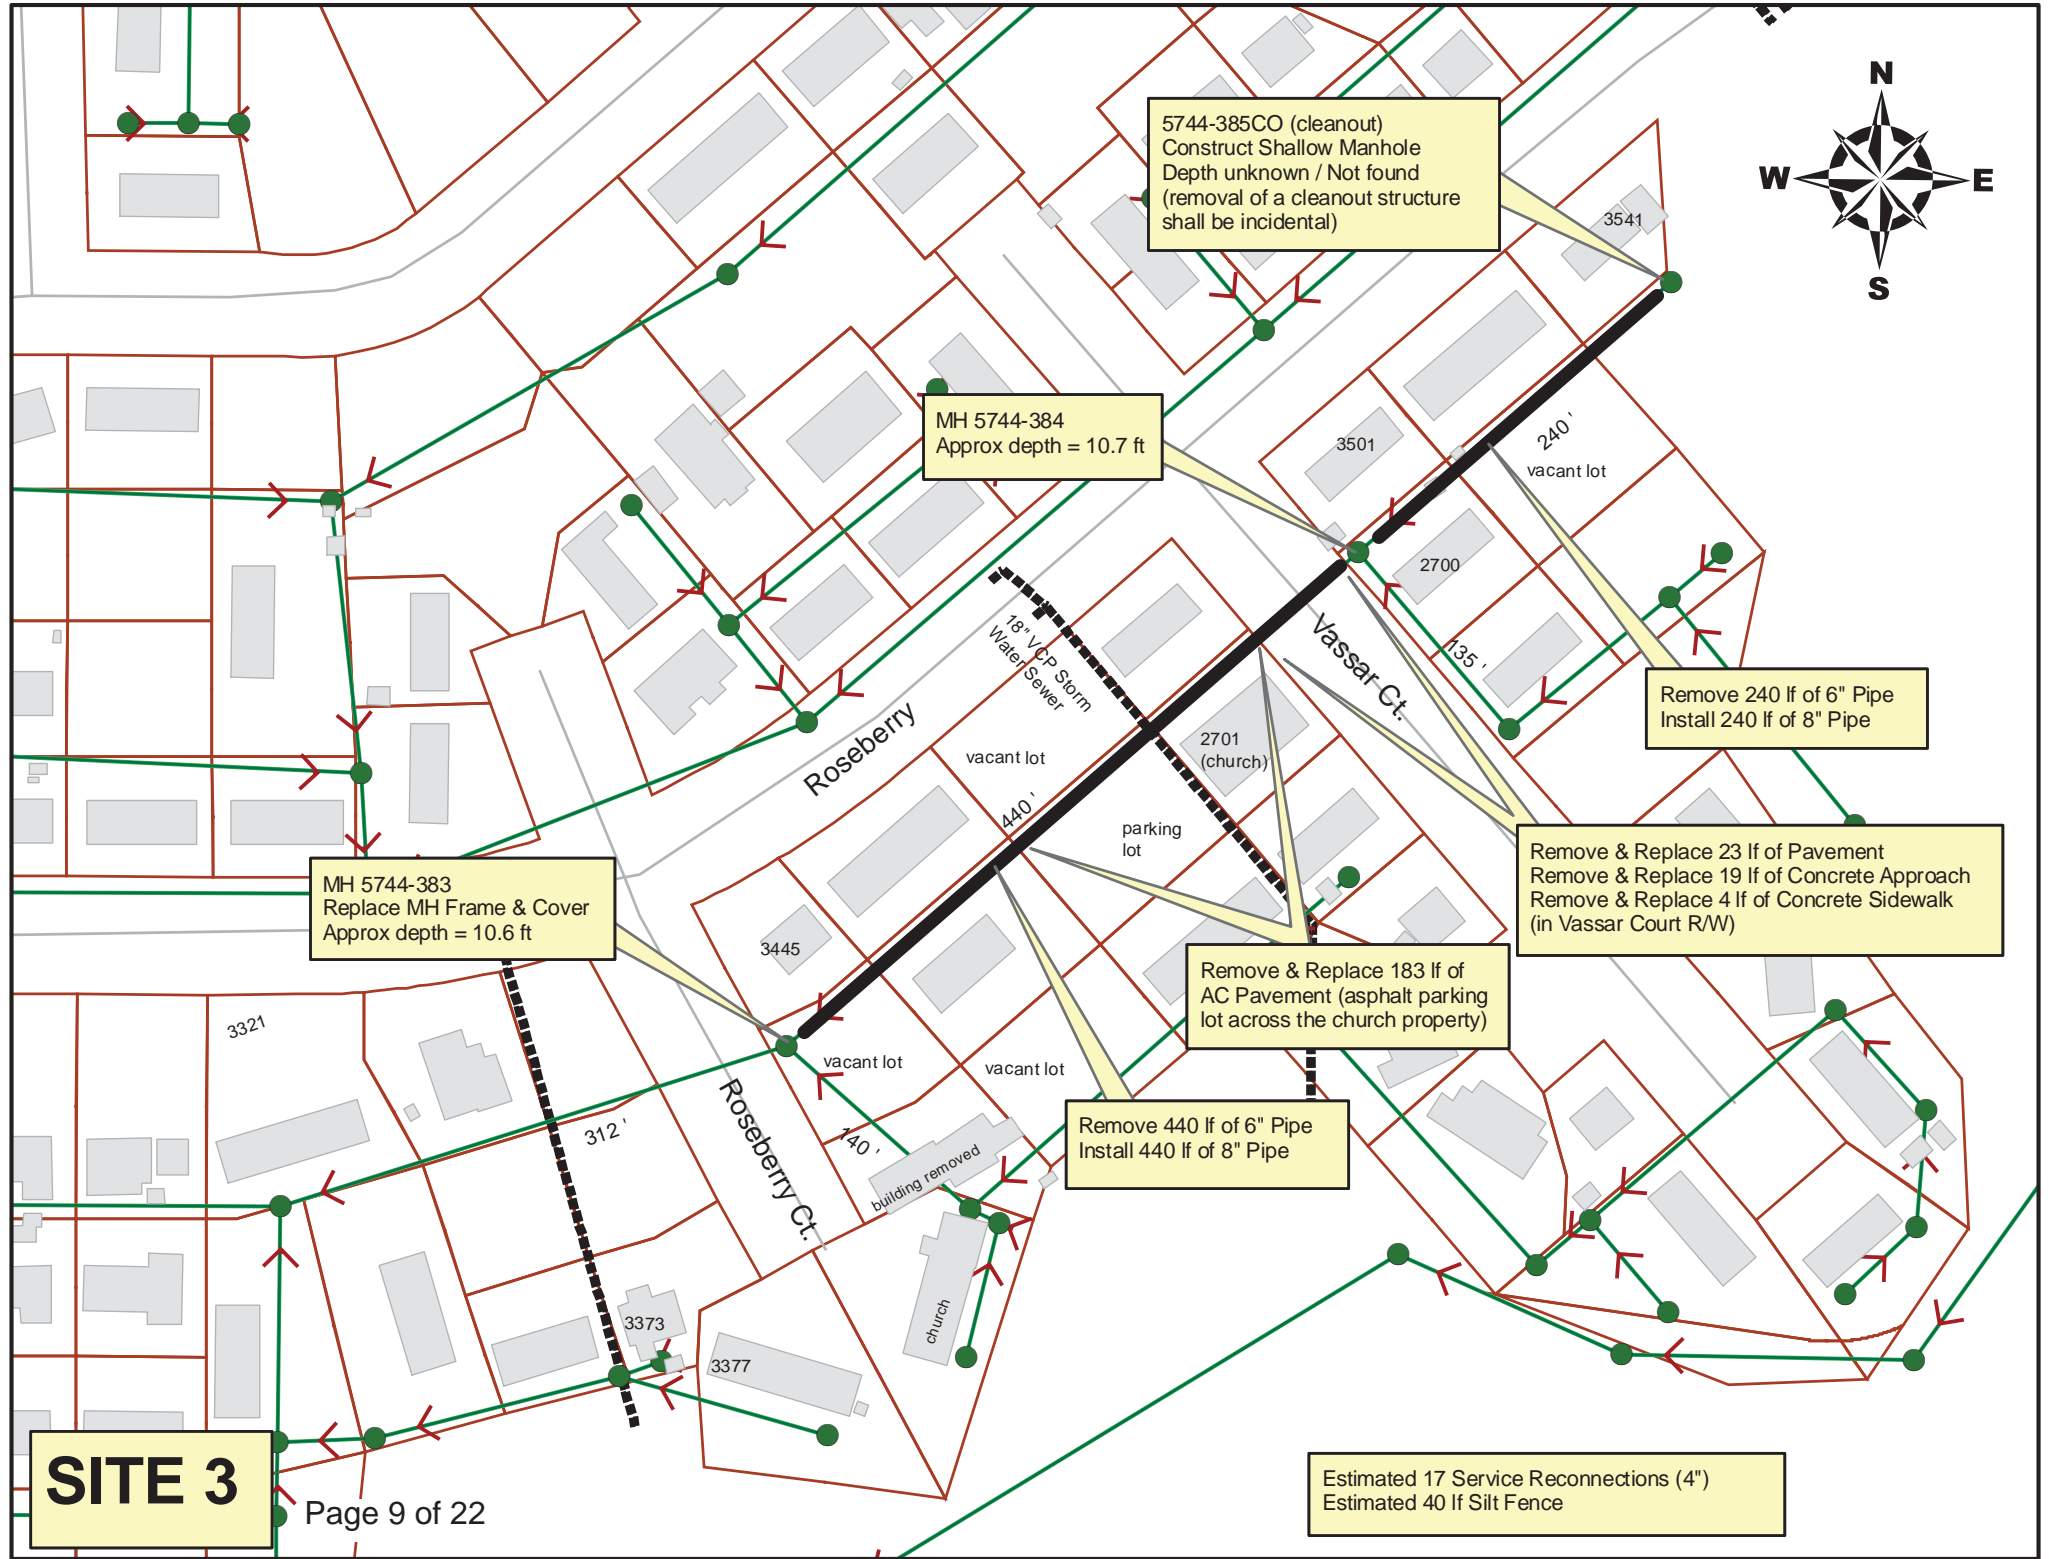
SITE 3

5744-385CO (cleanout)
Construct Shallow Manhole
Depth unknown / Not found
(removal of a cleanout structure shall be incidental)

MH 5744-384
Approx depth = 10.7 ft

Remove 240 lf of 6" Pipe
Install 240 lf of 8" Pipe

Remove & Replace 23 lf of Pavement
Remove & Replace 19 lf of Concrete Approach
Remove & Replace 4 lf of Concrete Sidewalk
(in Vassar Court R/W)

Remove & Replace 183 lf of
AC Pavement (asphalt parking
lot across the church property)

Remove 440 lf of 6" Pipe
Install 440 lf of 8" Pipe

MH 5744-383
Replace MH Frame & Cover
Approx depth = 10.6 ft

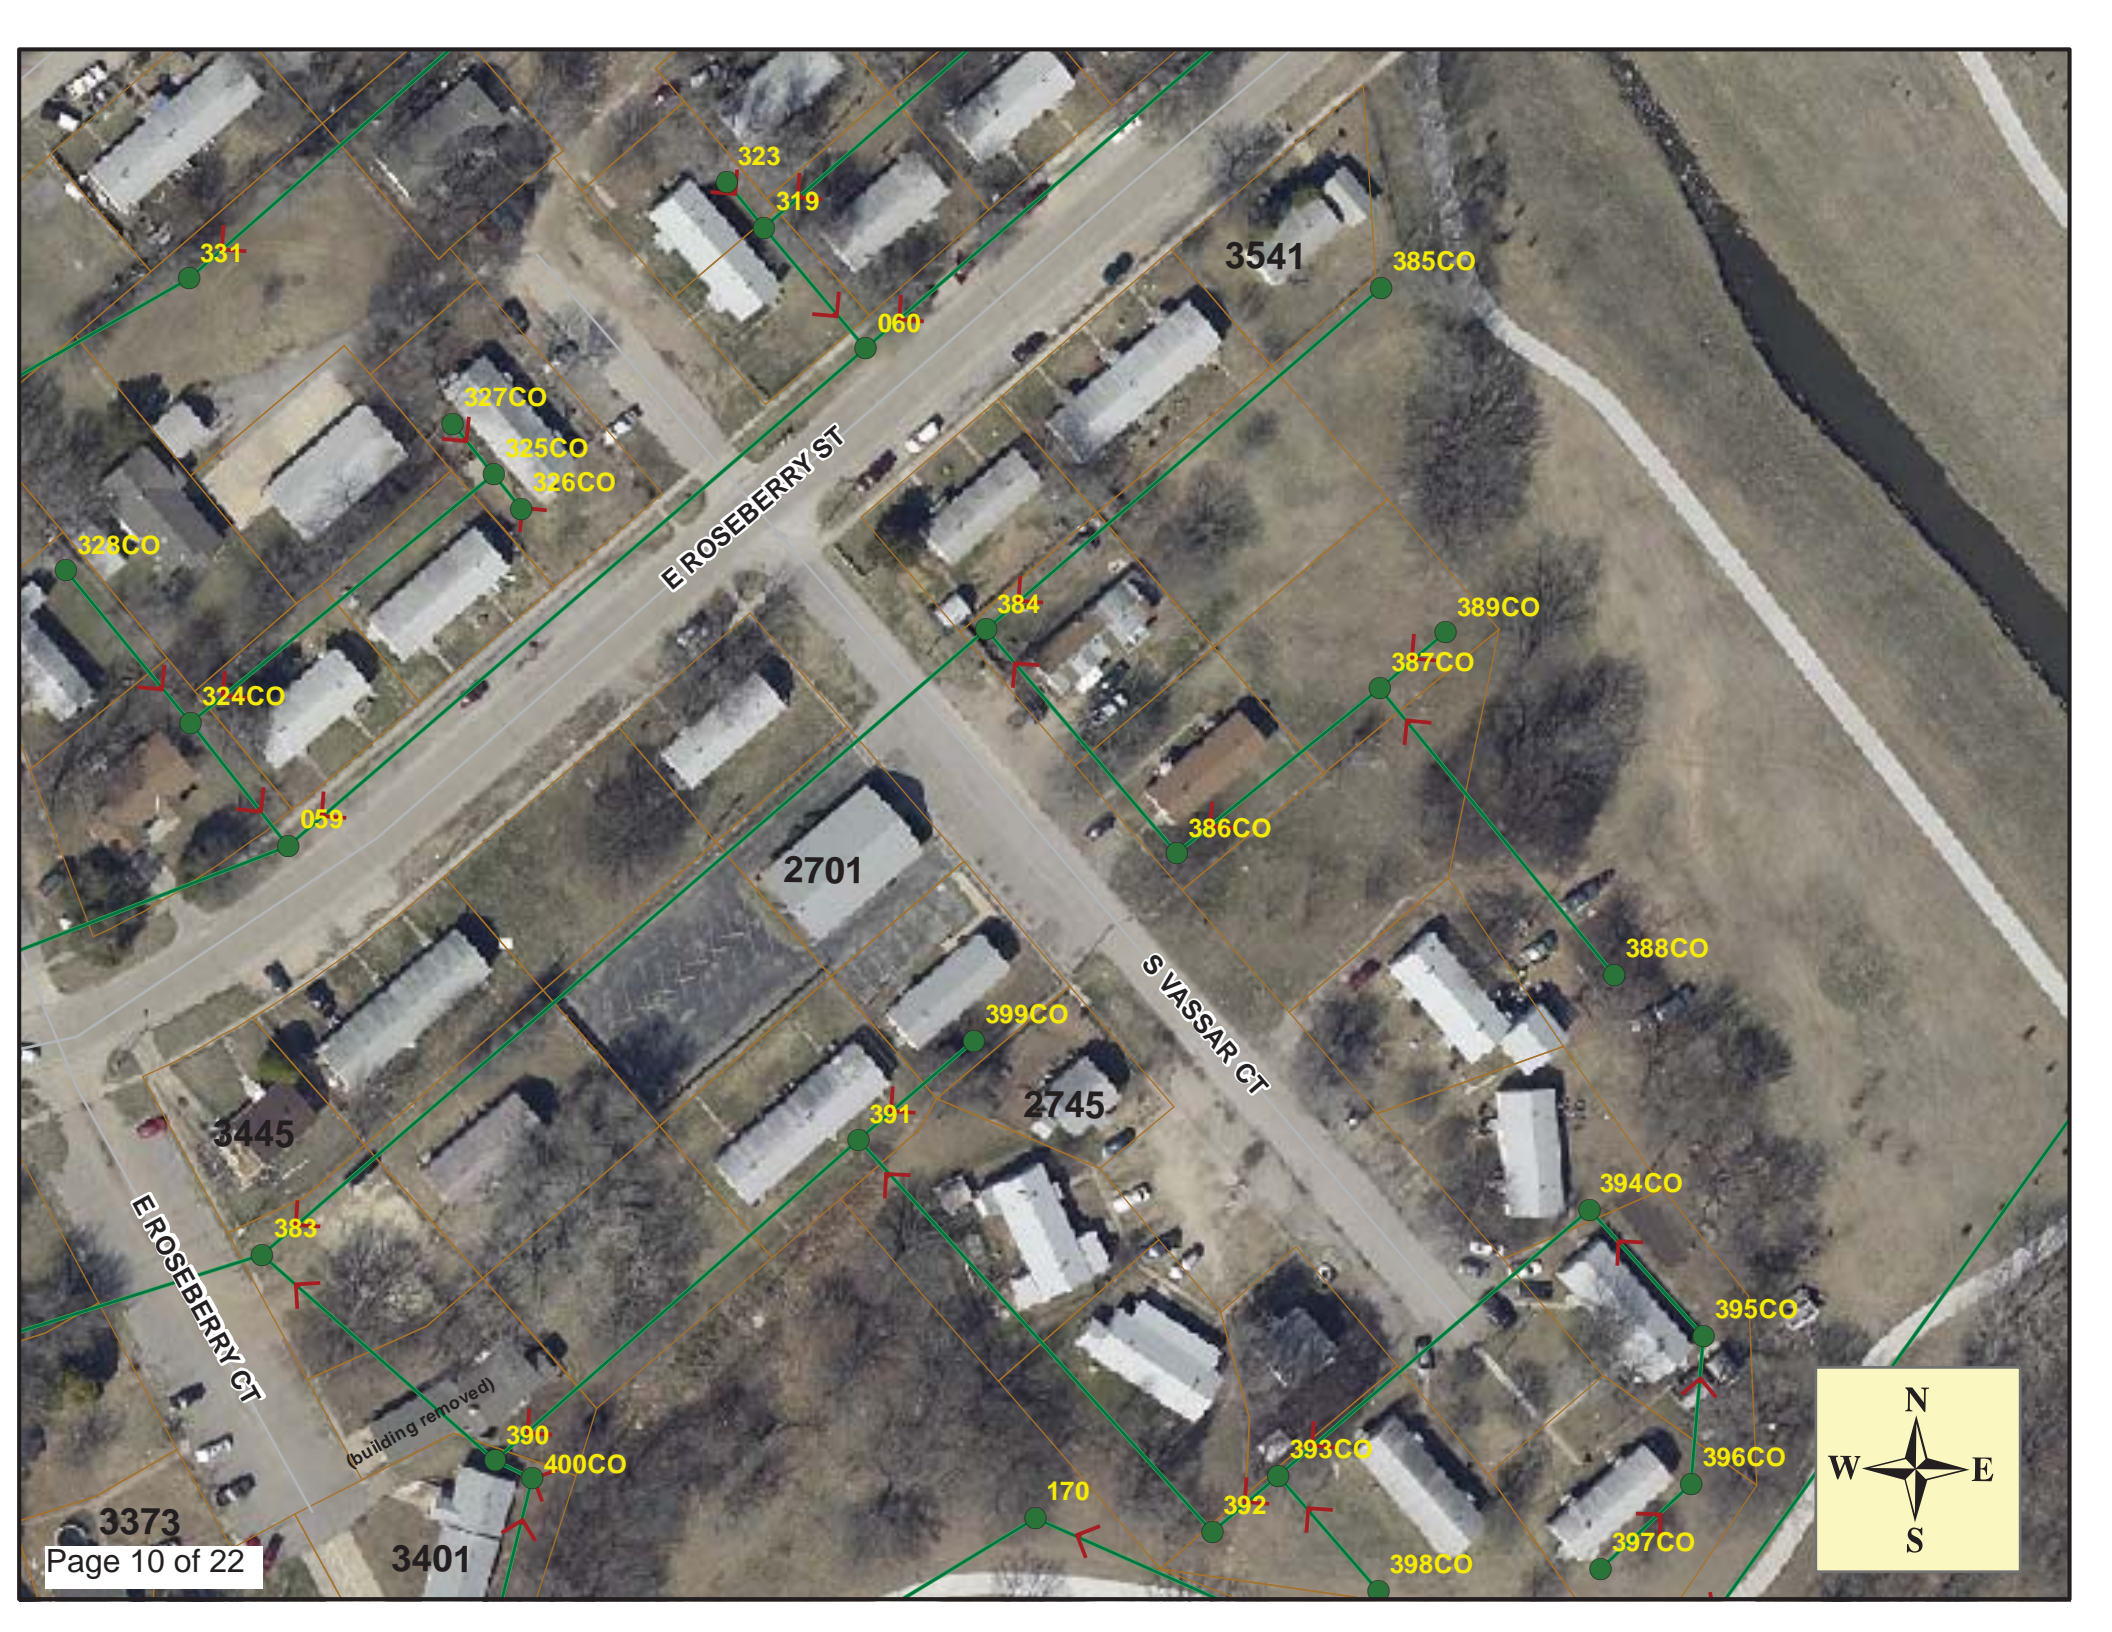
Video Inspection Master Report

US Structure: **5744-385CO**
DS Structure: **5744-384**

Obs. #	VTR	Counter	Distance	Location	Description	Rating	Ratings		
							Obsrvd (gpm)	Est. (gpm)	Struct Clean Remain (gpm)
1			0.0		5744-384 DS Manhole	1		TV AGAINST THE FLOW	
2			17.6	2700 S VASSAR CT	Wye Service	1			
3			17.7	3501 E ROSEBERRY	Wye Service	1			
4			48.5	2700 S VASSAR CT	Break-In Conn	1			
5			48.6	3509 E ROSEBERRY	Wye Service	1			
6			80.9		Roots	1			
7			83.5		Roots	1			
8			95.1	ball of roots	Sealed Off Wye	5			
9			95.1	3517 E ROSEBERRY	ball of roots Wye Service	3			
10			100.1		Roots	1			
11			121.6		Sealed Off Wye	5			
12			122.3	3525 E ROSEBERRY CT	Wye Service	5			
				ball of roots, hangs into the main					
13			154.2	ball of roots	Sealed Off Wye	5			
14			154.2	3533 E ROSEBERRY	roots Wye Service	3			
15			199.0	ball of roots	Sealed Off Wye	5			
16			216.5		Roots	1			
17			230.8	roots (heavy in invert)	Roots	4			
18			231.8	3541 E ROSEBERRY	ball of roots Wye Service	5			
19			232.1	INCOMPLETE TELEVISIONING	<u>Camera Blocked</u>	0

Camera cannot get through the roots. Can't see past this point. The line is supposed to be 240 ft long, but that cannot be verified.

US Structure: **5744-384** 2700 S VASSAR ST Date Insp: 8/3/2012 Basin: C01A
 DS Structure: **5744-383** 3405 E ROSEBERRY CT Dir Televised: Upstream To Downstream

#	Counter	Distance	Location	Description	Rating	Ratings		
						Obsrvd (gpm)	Est. (gpm)	Remain (gpm)
1		0.0		5744-384 US Manhole	1			
2		7.5		Crack-Radial	1			
3		17.4		Crack-Radial	2			
4		44.8		Crack-Radial	2			
5		97.8		Crack-Radial	2			
6		105.3		Crack-Radial	2			
7		105.6		Wye Service	1			
8		105.6		Wye Service	1			
9		138.2		Wye Service	1			
10		138.2		Wye Service	1			
11		147.1		PVC Break-In Conn	1			
12		156.0		Crack-Horizontal	2			
13		170.9		Crack-Radial	2			
14		184.7		Sealed Off Wye	3			
15		184.8		Sealed Off Wye	5			
16		190.3		Roots	1			
17		211.9		Sealed Off Wye	2			
18		211.9		Wye Service	1			
19		215.4		Crack-Radial	1			
20		241.5		Sealed Off Wye	1			
21		242.3		Sealed Off Wye	1			
22		247.3		Broken Pipe	4			
23		265.0		Crack-Radial	3			
24		272.7		Crack-Radial	3			
25		288.3		Wye Service	5			
26		288.7		Wye Service	5			
27		296.9		Crack-Radial	2			
28		311.8		Crack-Radial	4			
29		318.3		Wye Service (in sag)	1

30		318.3		Wye Service (in sag)	1			
31		325.5		Crack-Radial	3			
32		330.6		Crack-Radial	3			
33		335.5		Crack-Radial	3			
34		343.2		Crack-Radial	2			
35		346.9		Wye Service	4			
36		346.9		Wye Service	1			
37		350.1		Roots	1			
38		352.5		Roots	1			
39		394.0		Wye Service	5			
40		394.0		Wye Service	1			
41		417.5		Crack-Radial	2			
42		437.0		sludge buildup in the line

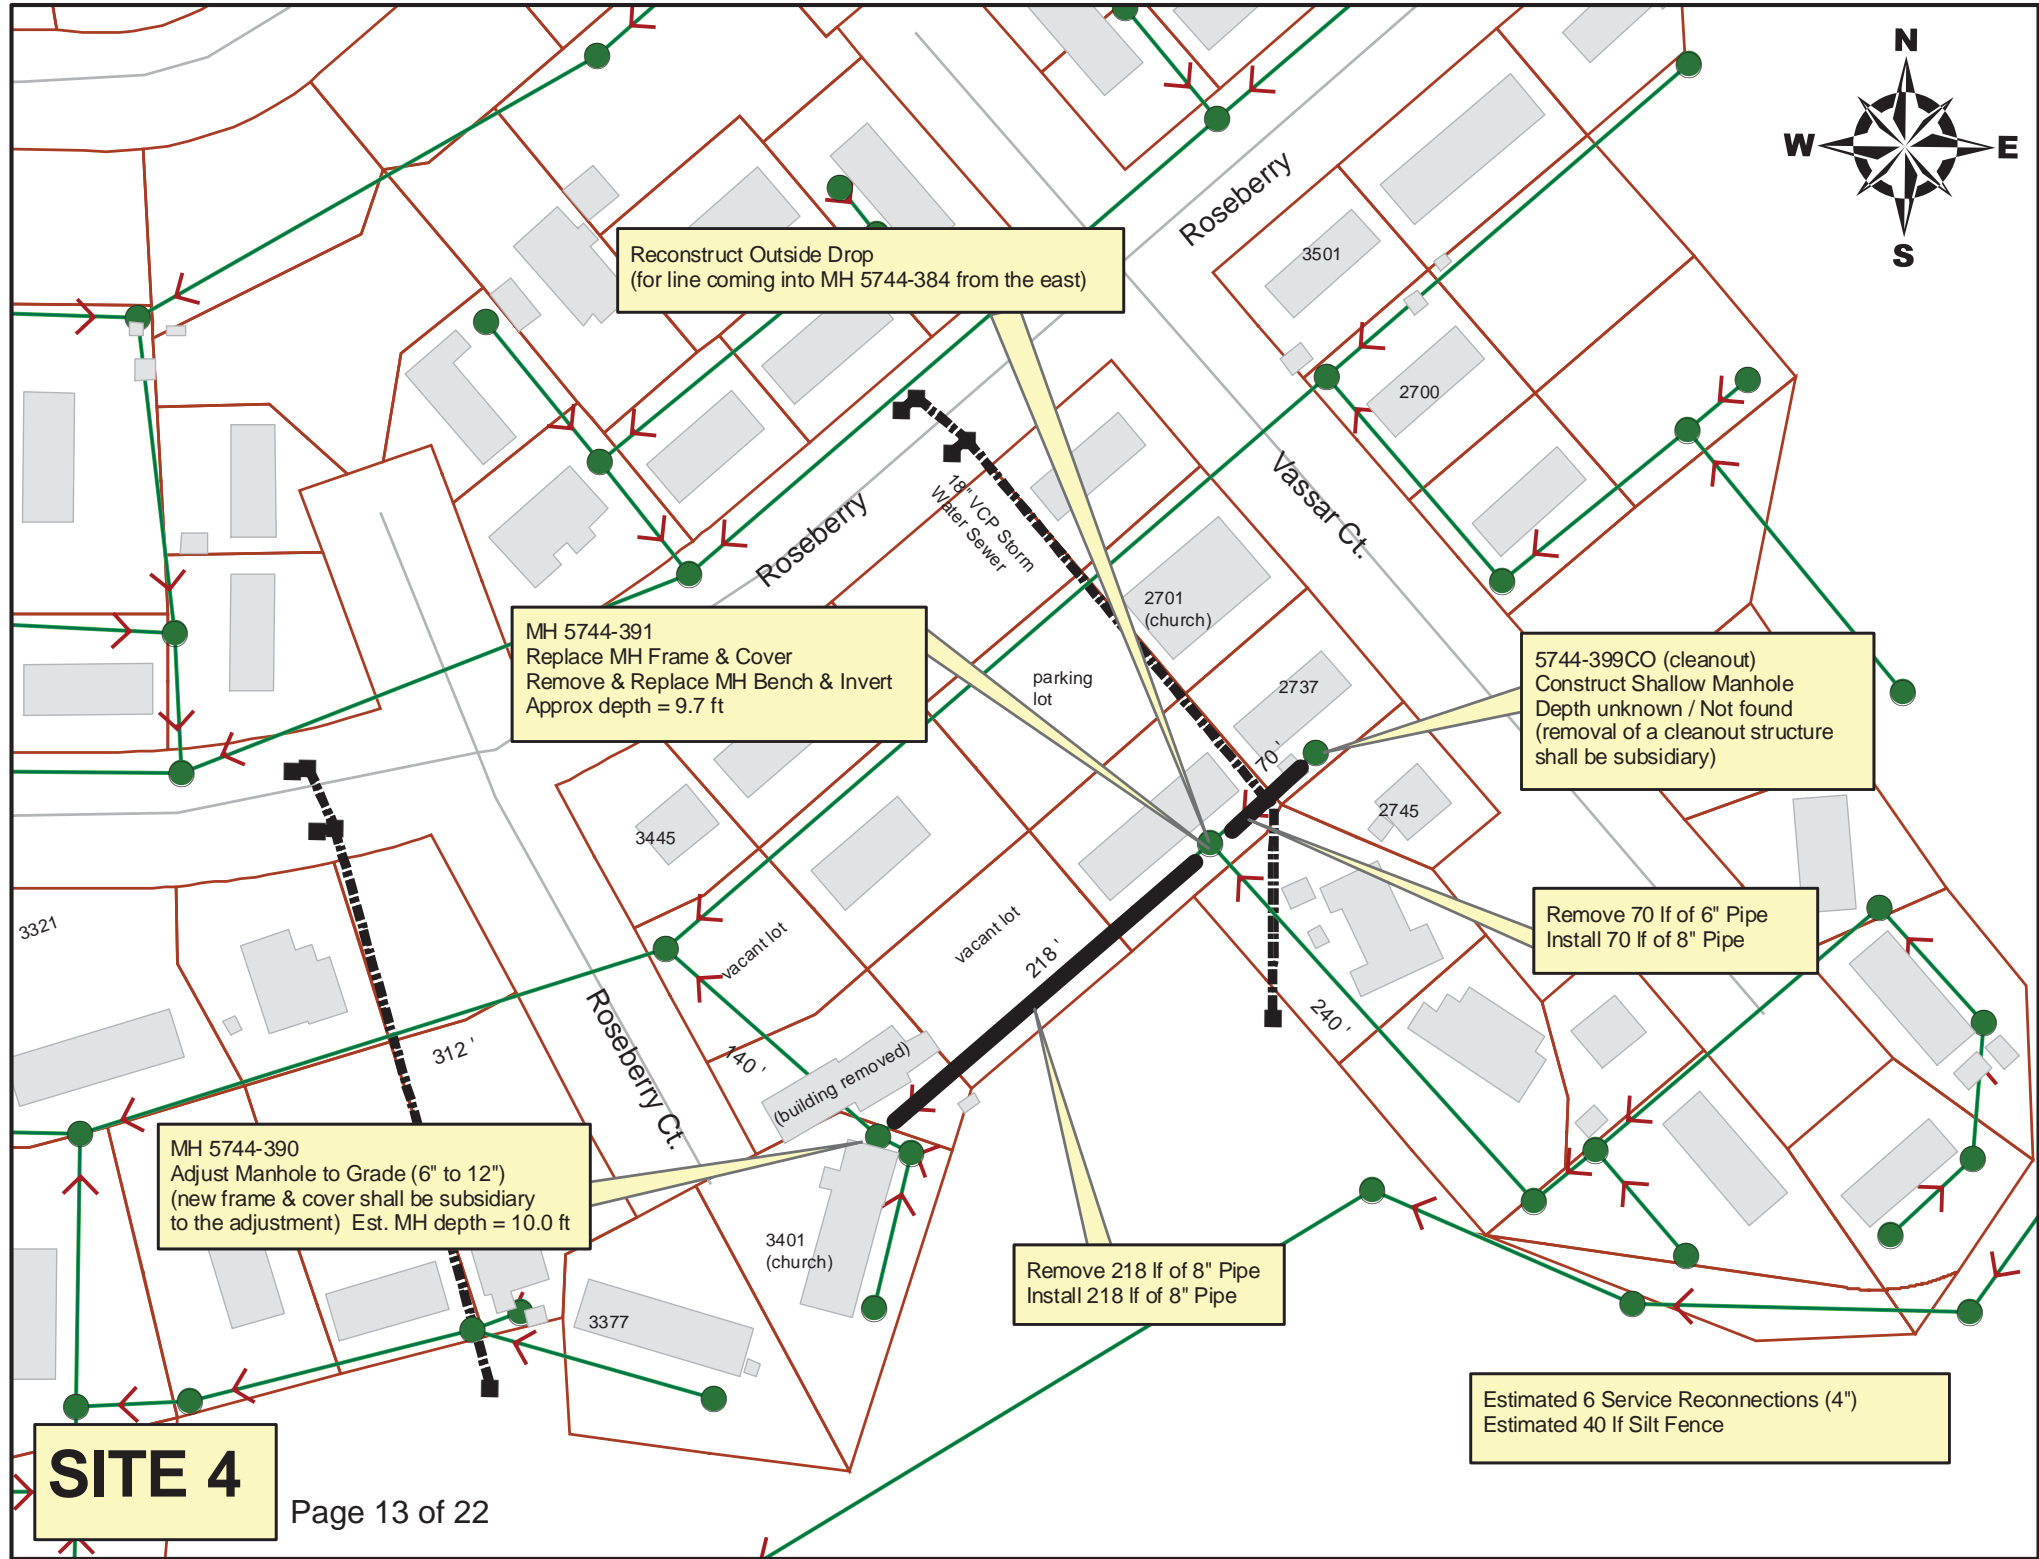
SITE 4

Reconstruct Outside Drop
(for line coming into MH 5744-384 from the east)

MH 5744-391
Replace MH Frame & Cover
Remove & Replace MH Bench & Invert
Approx depth = 9.7 ft

5744-399CO (cleanout)
Construct Shallow Manhole
Depth unknown / Not found
(removal of a cleanout structure shall be subsidiary)

Remove 70 lf of 6" Pipe
Install 70 lf of 8" Pipe

MH 5744-390
Adjust Manhole to Grade (6" to 12")
(new frame & cover shall be subsidiary to the adjustment) Est. MH depth = 10.0 ft

Remove 218 lf of 8" Pipe
Install 218 lf of 8" Pipe

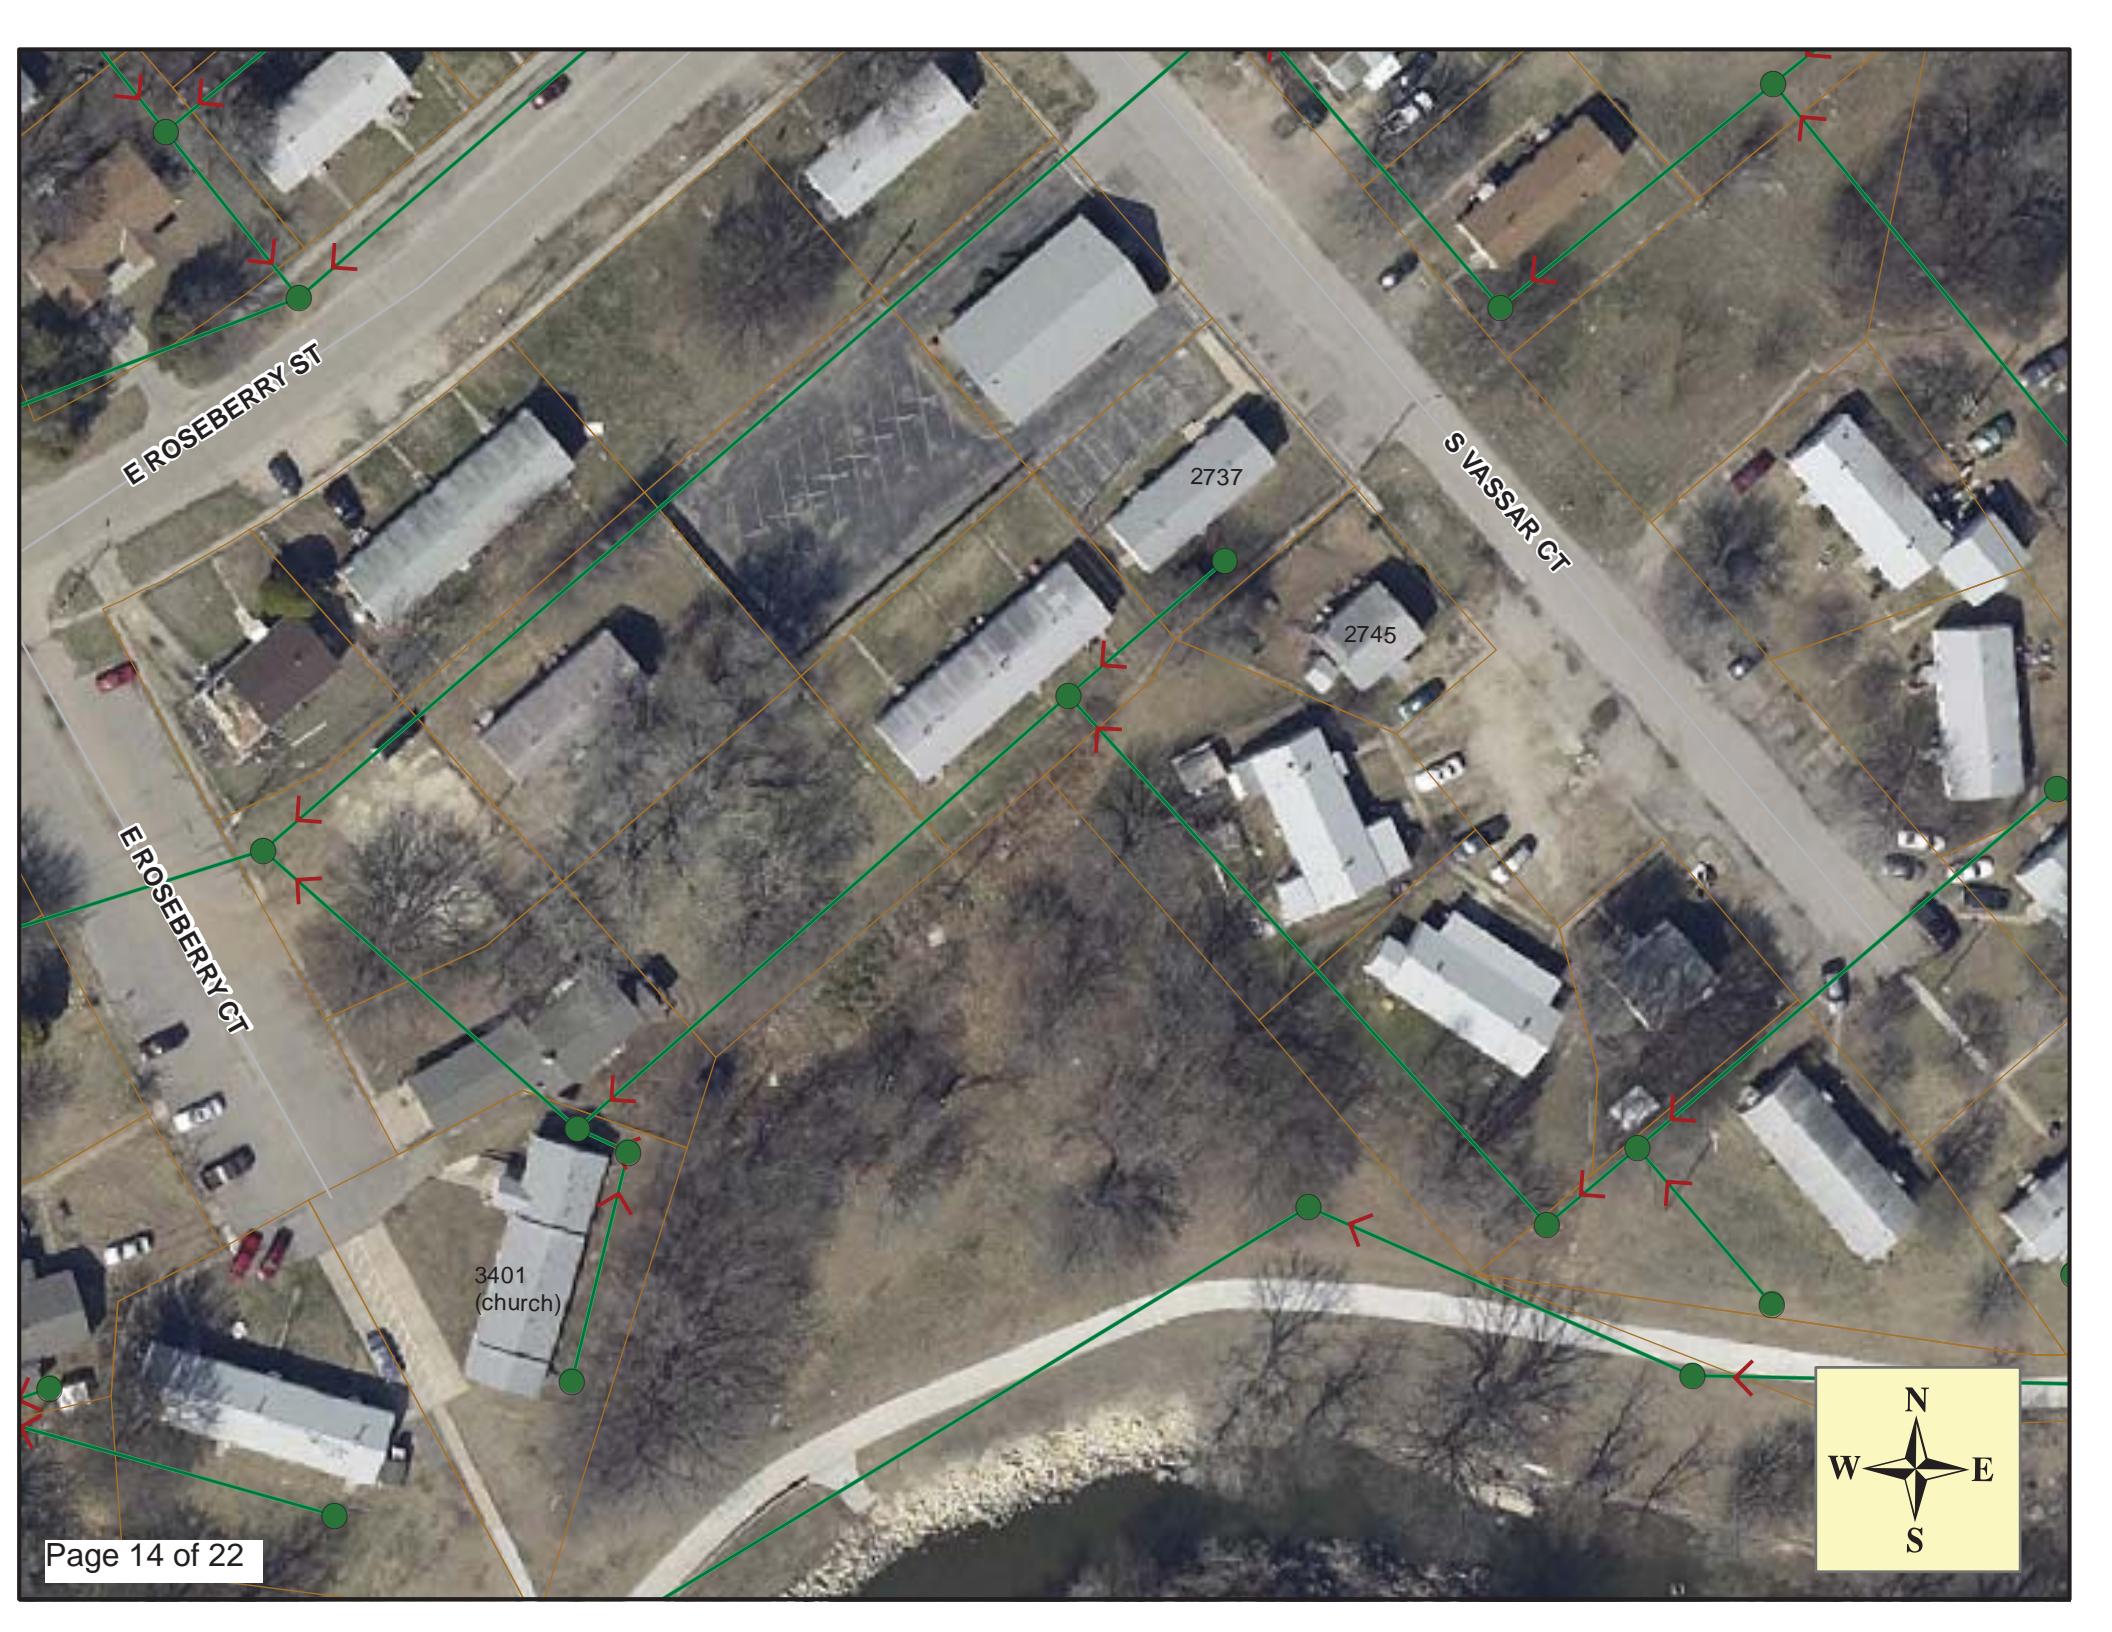
Video Inspection Master Report

US Structure: 5744-399CO
DS Structure: 5744-391

Obs. #	VTR	Counter	Distance	Location	Description	Rating	Ratings			
							Obsrvd (gpm)	Est. (gpm)	Struct Clean	Remain (gpm)
1			0.0	5744-391	DS Manhole	1				
Outside Drop Hole Pipe appears to dip downward, and then back up again, just past the outside drop hole. Broken pipe in the bottom of the dip										
2			6.6		Camera Blocked	5				
Pipe must be replaced. No way to verify length of this segment.

US Structure: 5744-391 2725 S VASSAR CT Date Insp: 8/3/2012 Basin: C01A
 DS Structure: 5744-390 2968 S CLIFTON ST Dir Televised: Upstream To Downstream

Obs. #	VTR Counter	Distance	Location	Description	Rating	Ratings		
						Obsrvd (gpm)	Est. (gpm)	Struct Clean Remain (gpm)
1		0.0	5744-391	US Manhole	1			
2		13.4	2729 E VASSAR	Wye Service	1			
3		20.0		Crack-Radial	2			
4		22.8		Crack-Radial	1			
5		35.2		Crack-Radial	1			
6		42.6	2725 E VASSAR	full of roots / Wye Service	5			
7		58.3		Crack-Radial	2			
8		67.3		Crack-Radial	1			
9		70.2		Roots	1			
10		76.3		Roots	1			
11		79.5		Crack-Radial	2			
12		88.9		Crack-Radial	2			
13		90.5		Wye Service	2			
14		93.5		Crack-Radial	2			
15		96.5		Roots	1			
16		99.6		Roots	2			
17		105.8		Roots	1			
18		109.0		Roots	1			
19		112.2		Crack-Radial	2			
20		118.2		Roots	1			
21		120.3		Sealed Off Wye	2			
22		124.4		Crack-Radial	5			
23		127.9		Crack-Radial	3			
24		134.0		Crack-Horizontal	2			
25		137.1		Crack-Radial	2			
26		143.1		Crack-Radial	3			
27		148.0		heavy roots / Wye Service	5			
28		149.3		Roots	1			
29		152.6		Crack-Radial	1

30		155.6		Roots	1			
31		158.9		Crack-Radial	2			
32		165.2		Roots	1			
33		168.0		Roots	1			
34		171.1		Roots	1			
35		180.5		Crack-Radial	1			
36		186.4		Crack-Radial	1			
37		189.6		Roots	1			
38		193.6		full of roots / Wye Service	5			
39		195.8		Roots	1			
40		196.5		Crack-Horizontal	2			
41		203.8		Crack-Radial	2			
42		212.9		Crack-Radial	3			
43		217.7	(inside church fence)	5744-390 DS Manhole	1			Lots of roots and cracks
