2013 Sanitary Sewer Reconstruction Phase 5

OCA 620640 / 468-84895

Video Inspection Master Report

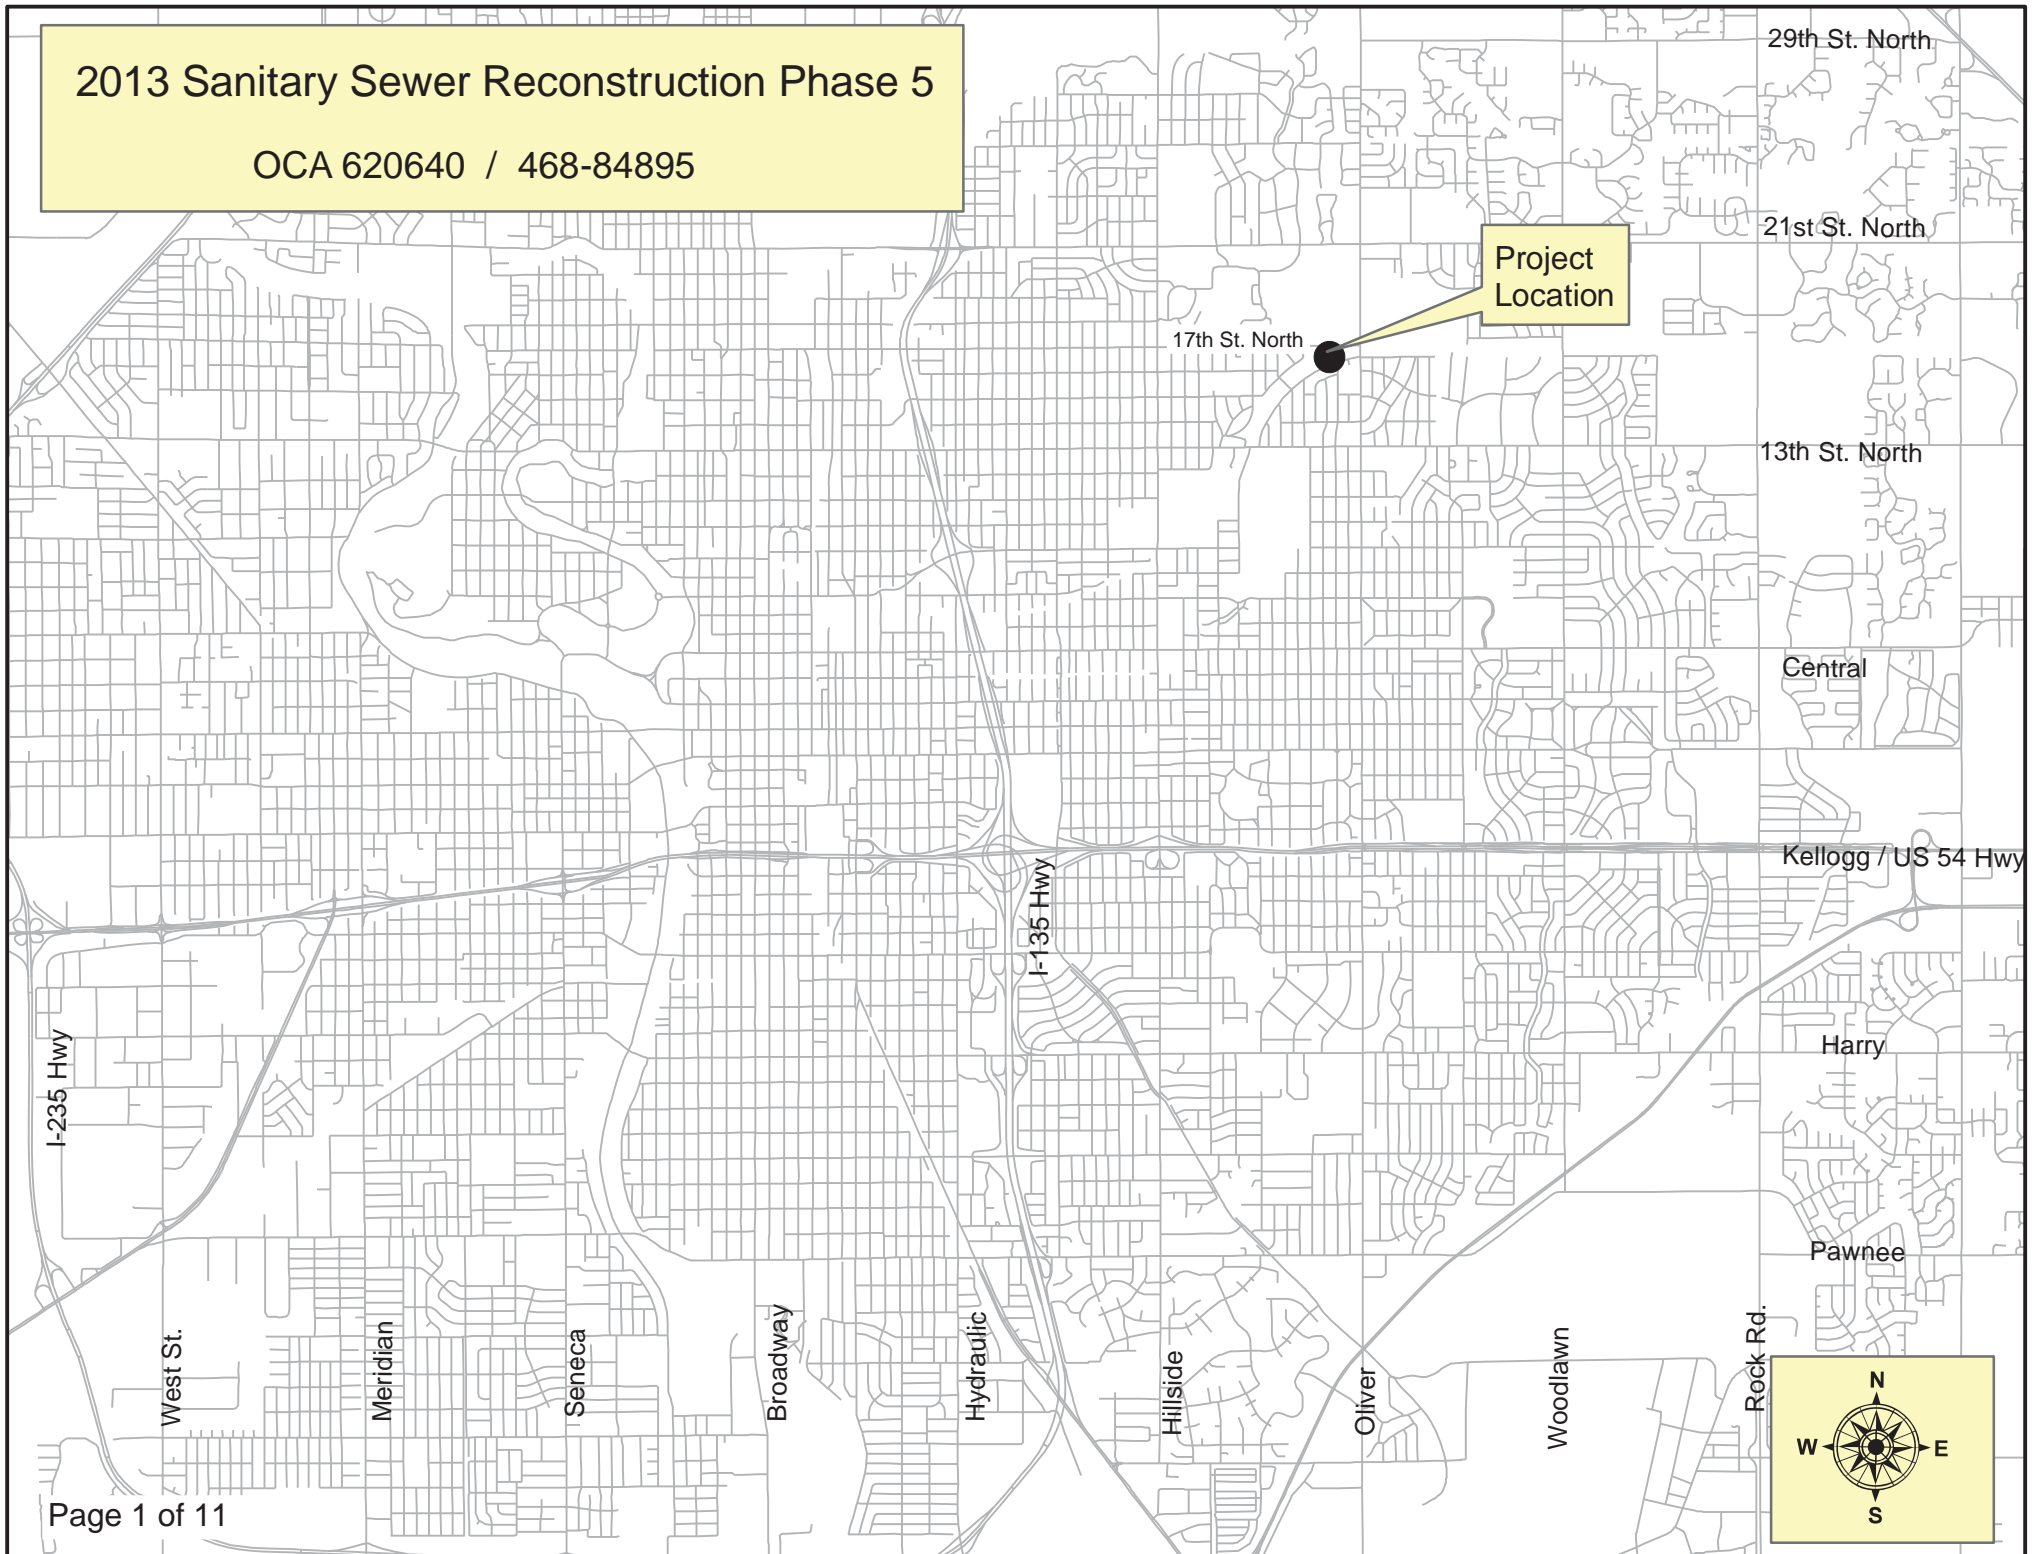
MH 5749-275
4702 E Vesta (south of fence)
Replace Manhole Frame & Cover
Approx depth = 8.8 ft

MH 5749-274
4620 E Vesta (north of fence)
Replace Manhole Frame & Cover
Approx depth = 7.2 ft

MH 5749-273
4526 E Vesta (north of fence)
Adjust MH to Grade (6" to 12")
(adjustment will include replacing
the manhole frame & cover)
Approx depth = 9.3 ft

MH 5749-272
4426 E Vesta (north of fence)
Adjust MH to Grade (6" to 12")
(adjustment will include replacing
the manhole frame & cover)
Remove & Replace MH Bench & Invert
Depth not measured

MH 5749-271
4322 E Vesta (north of fence)
Replace MH Frame & Cover
Approx depth = 13.7 ft

MH 5749-276
4726 E Vesta
Replace Manhole Frame & Cover
(MH located approx 6' east & 1'
north of shed) Depth not measured.

A double-pipe storm water system with
a small concrete wall crosses the
sanitary sewer. Contractor shall support
or replace the storm structures as
necessary to complete this project.

The sewer lies within a 12 ft wide easement inside
of the residential lots. Public Works staff surveyed
the property lines and where the pipe is being
replaced, the fences appear to be at or near the
south side of that easement.

Remove 322 lf of 8" Pipe
Install 322 lf of 8" Pipe

Remove 320 lf of 8" Pipe
Install 320 lf of 8" Pipe

Remove 301 lf of 8" Pipe
Install 301 lf of 8" Pipe
