Point Repair: An 8" sanitary sewer main crosses a creek and the creek bank has washed out on the west end of the crossing. Sewer Maintenance has made a temporary repair to stabilize the sewer main. Contractor shall make a permanent repair, as outlined in "General Notes" for this site. (also see aerial photo and site photos)

SITE 7

2007 SANITARY SEWER RECONSTRUCTION PHASE 10 (SITE 7)

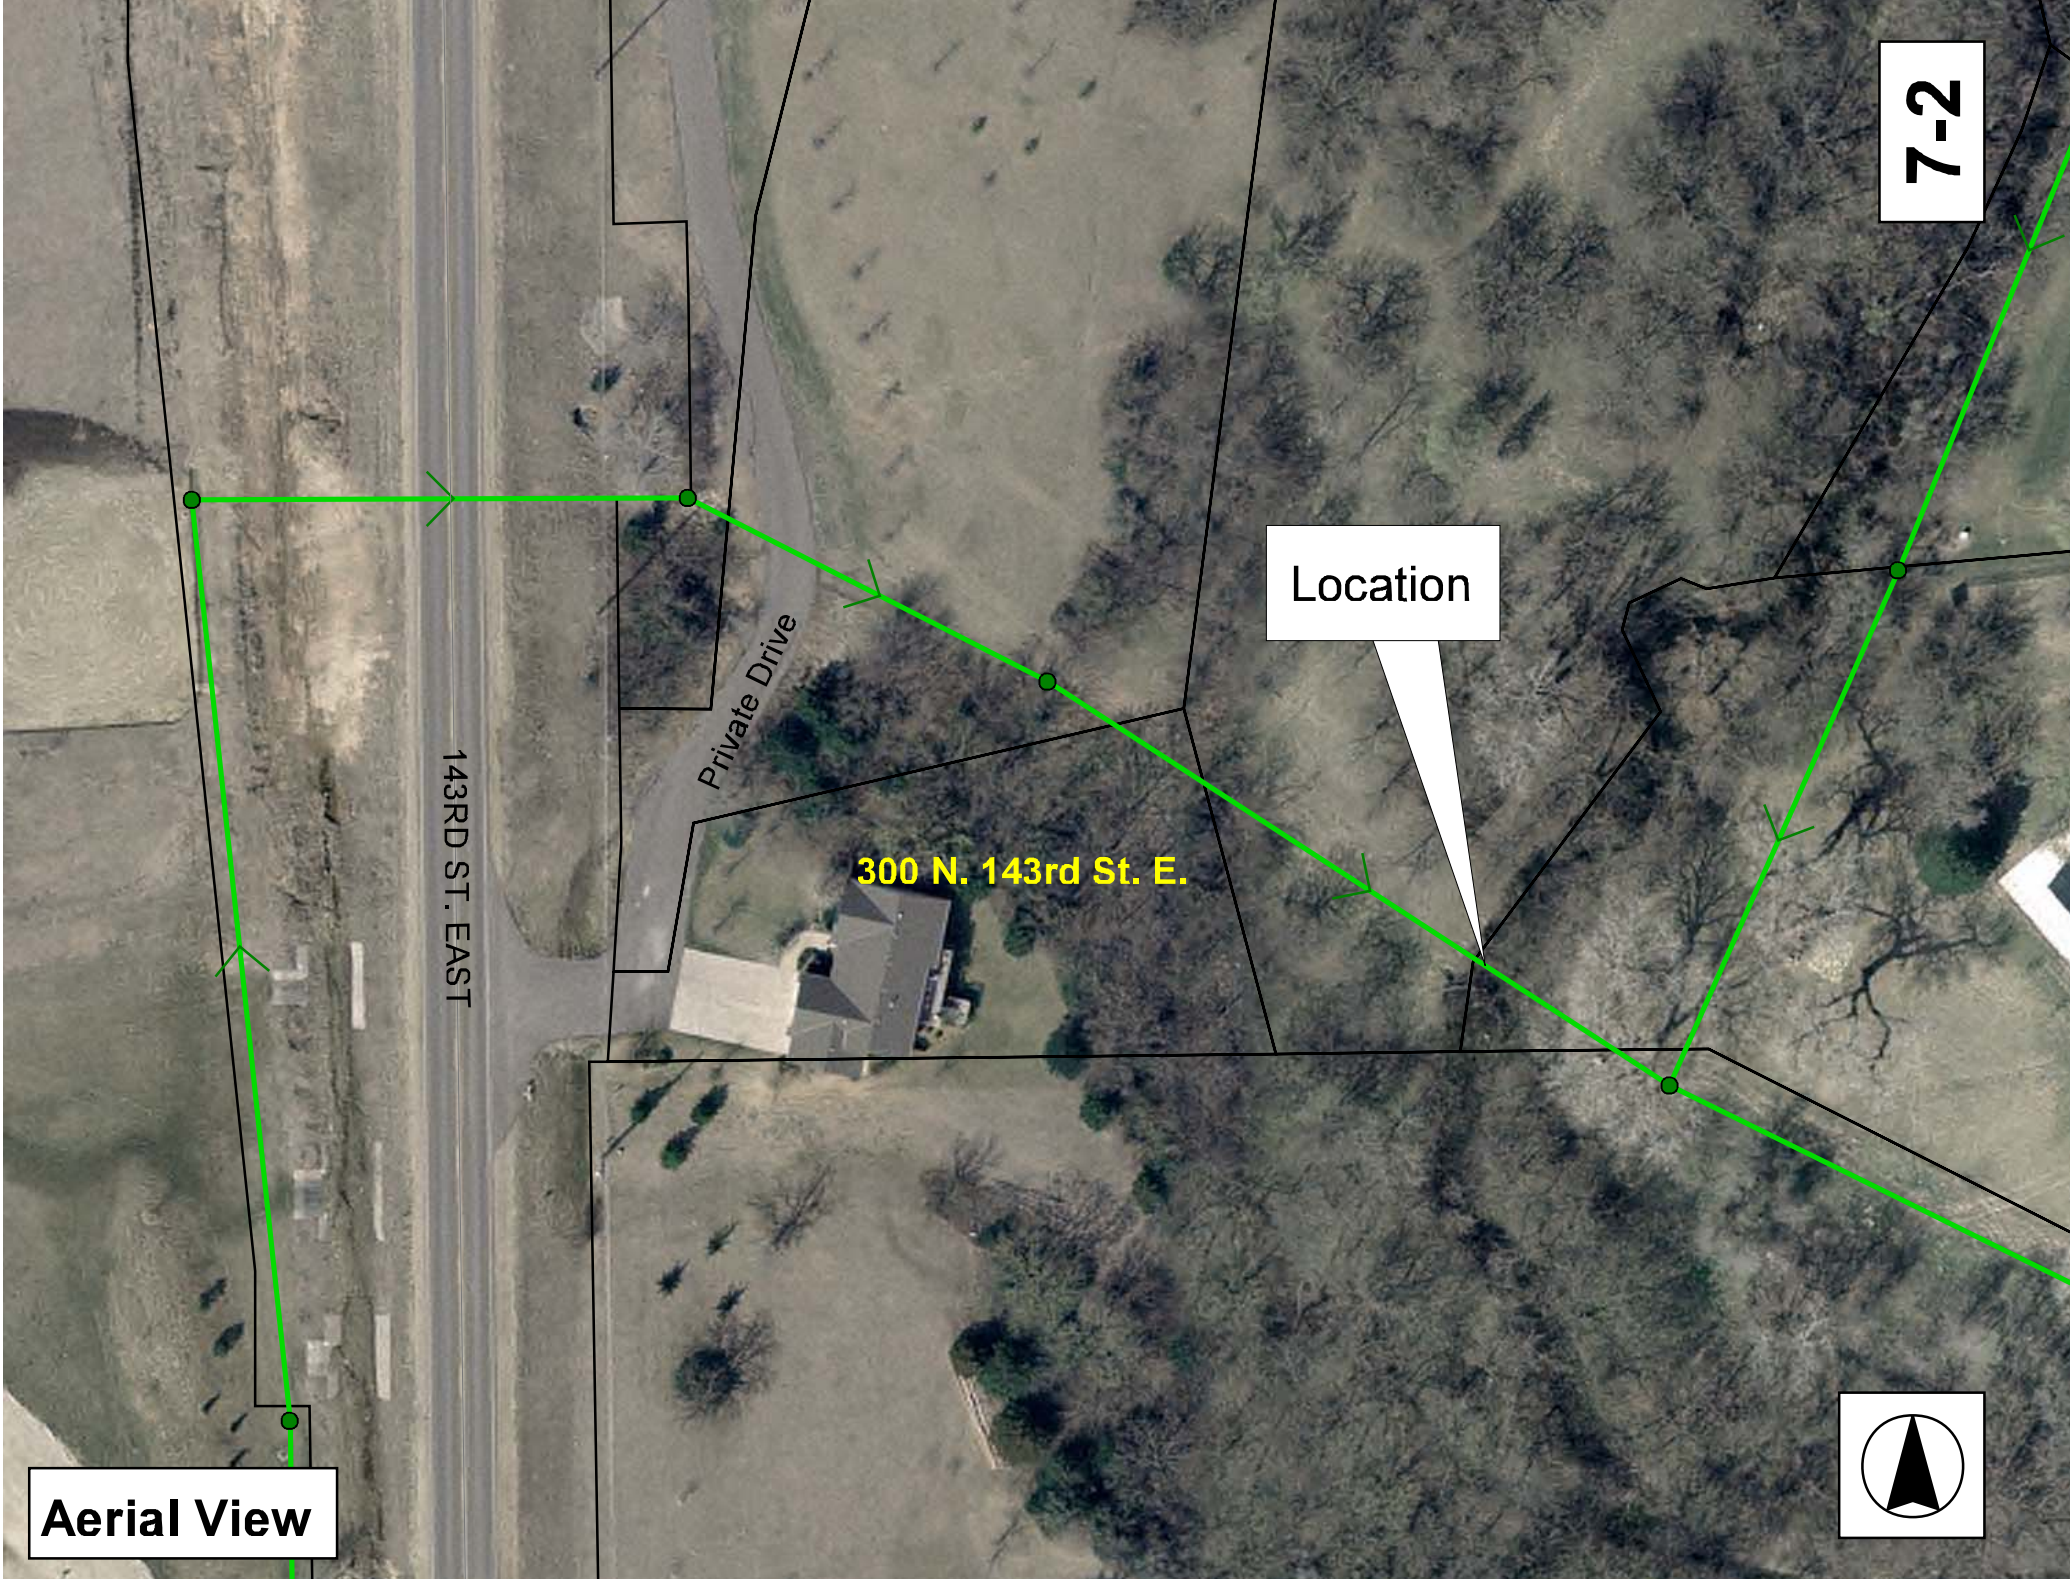
Aerial View

The pipe is 8" PVC. The creek bank has washed out (to the west), approximately 10 feet beyond the existing concrete encasement and cut-off wall. Sewer Maintenance placed bags of concrete mix under the exposed PVC pipe, then added rock to fill the cavity where the creek bank had washed away.

- 1) Remove the existing rock and cement bags from the temporary repair.
- 2) Install approx 15 lf of concrete encasement with a cut-off wall (see detail sheet). Dowel into the existing structure and extend the encasement/cut-off wall into the west bank of the creek.
- 3) The creek bank around the repair should be filled with 5x9 Rip Rap (same rock as used in the temporary repair). Additional Rip Rap can be obtained from Martin Mareitta Aggregates at 7160 Diamond Rd. Augusta (Judy 775-5482). Murrieta's is located 6 miles east of the intersection of Andover Rd. and 70th St North in Andover.
- 4) Contact both property owners prior to beginning this Site. They are aware that another repair will be made, but access to the area does cross private property.

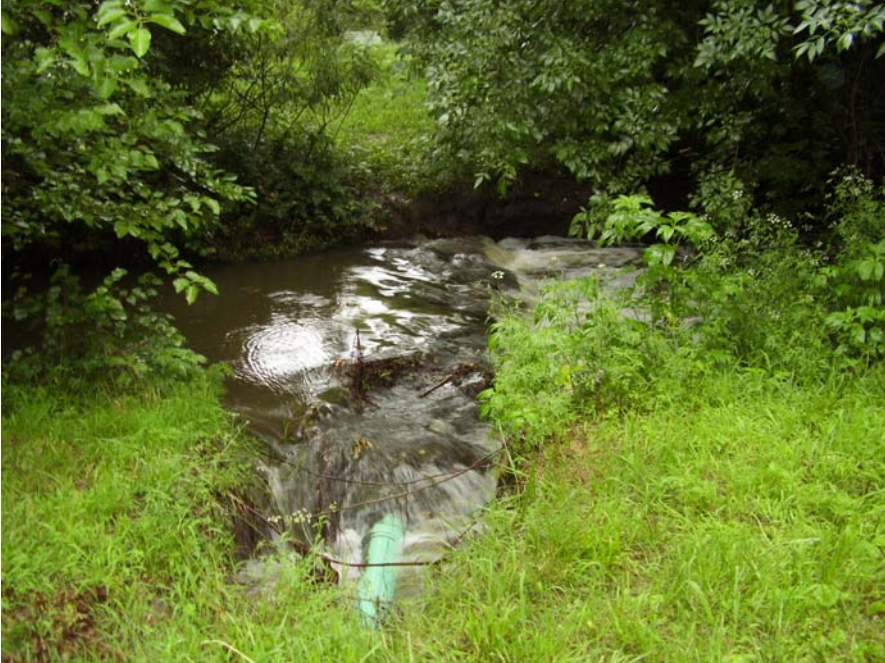
Standing on the west bank, looking east. Approx. 10 lf of pipe was exposed to the west of the existing encasement and cut-off wall. (June, 2007)

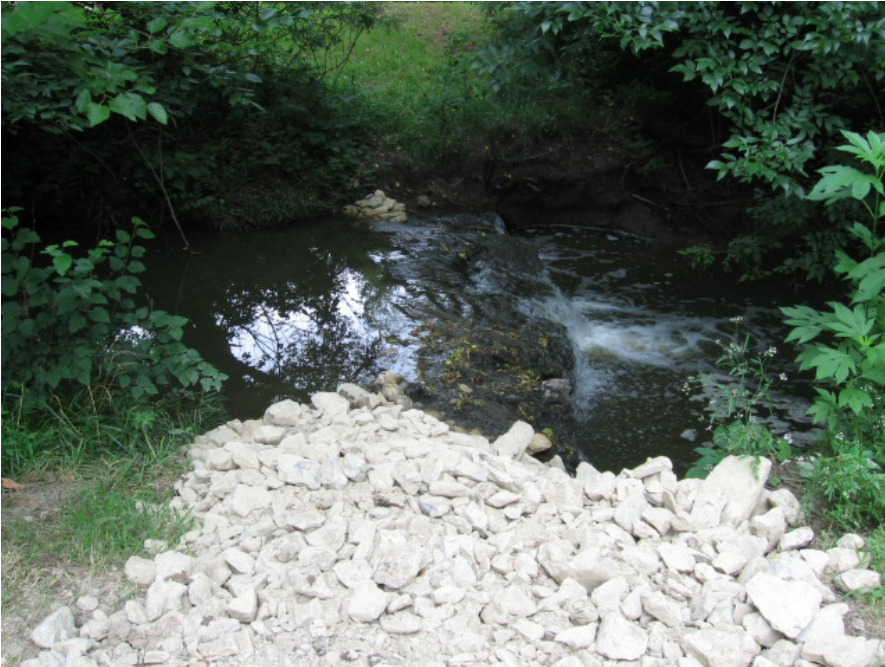
Standing on the west bank, looking east, after Sewer Maintenance made a temporary repair to stabilize the pipe.
