## Video Inspection Master Report

US Structure: 5247-393                      2914 W MAPLE ST                      Date Insp: 4/26/2013                      Basin: C07C  
 DS Structure: 5247-392                      242 S ST PAUL AVE                      Dir Televised: Upstream To Downstream

Project No. : B-200                      Dia/Ht: 8                      Material: VCP                      Length: 184.5

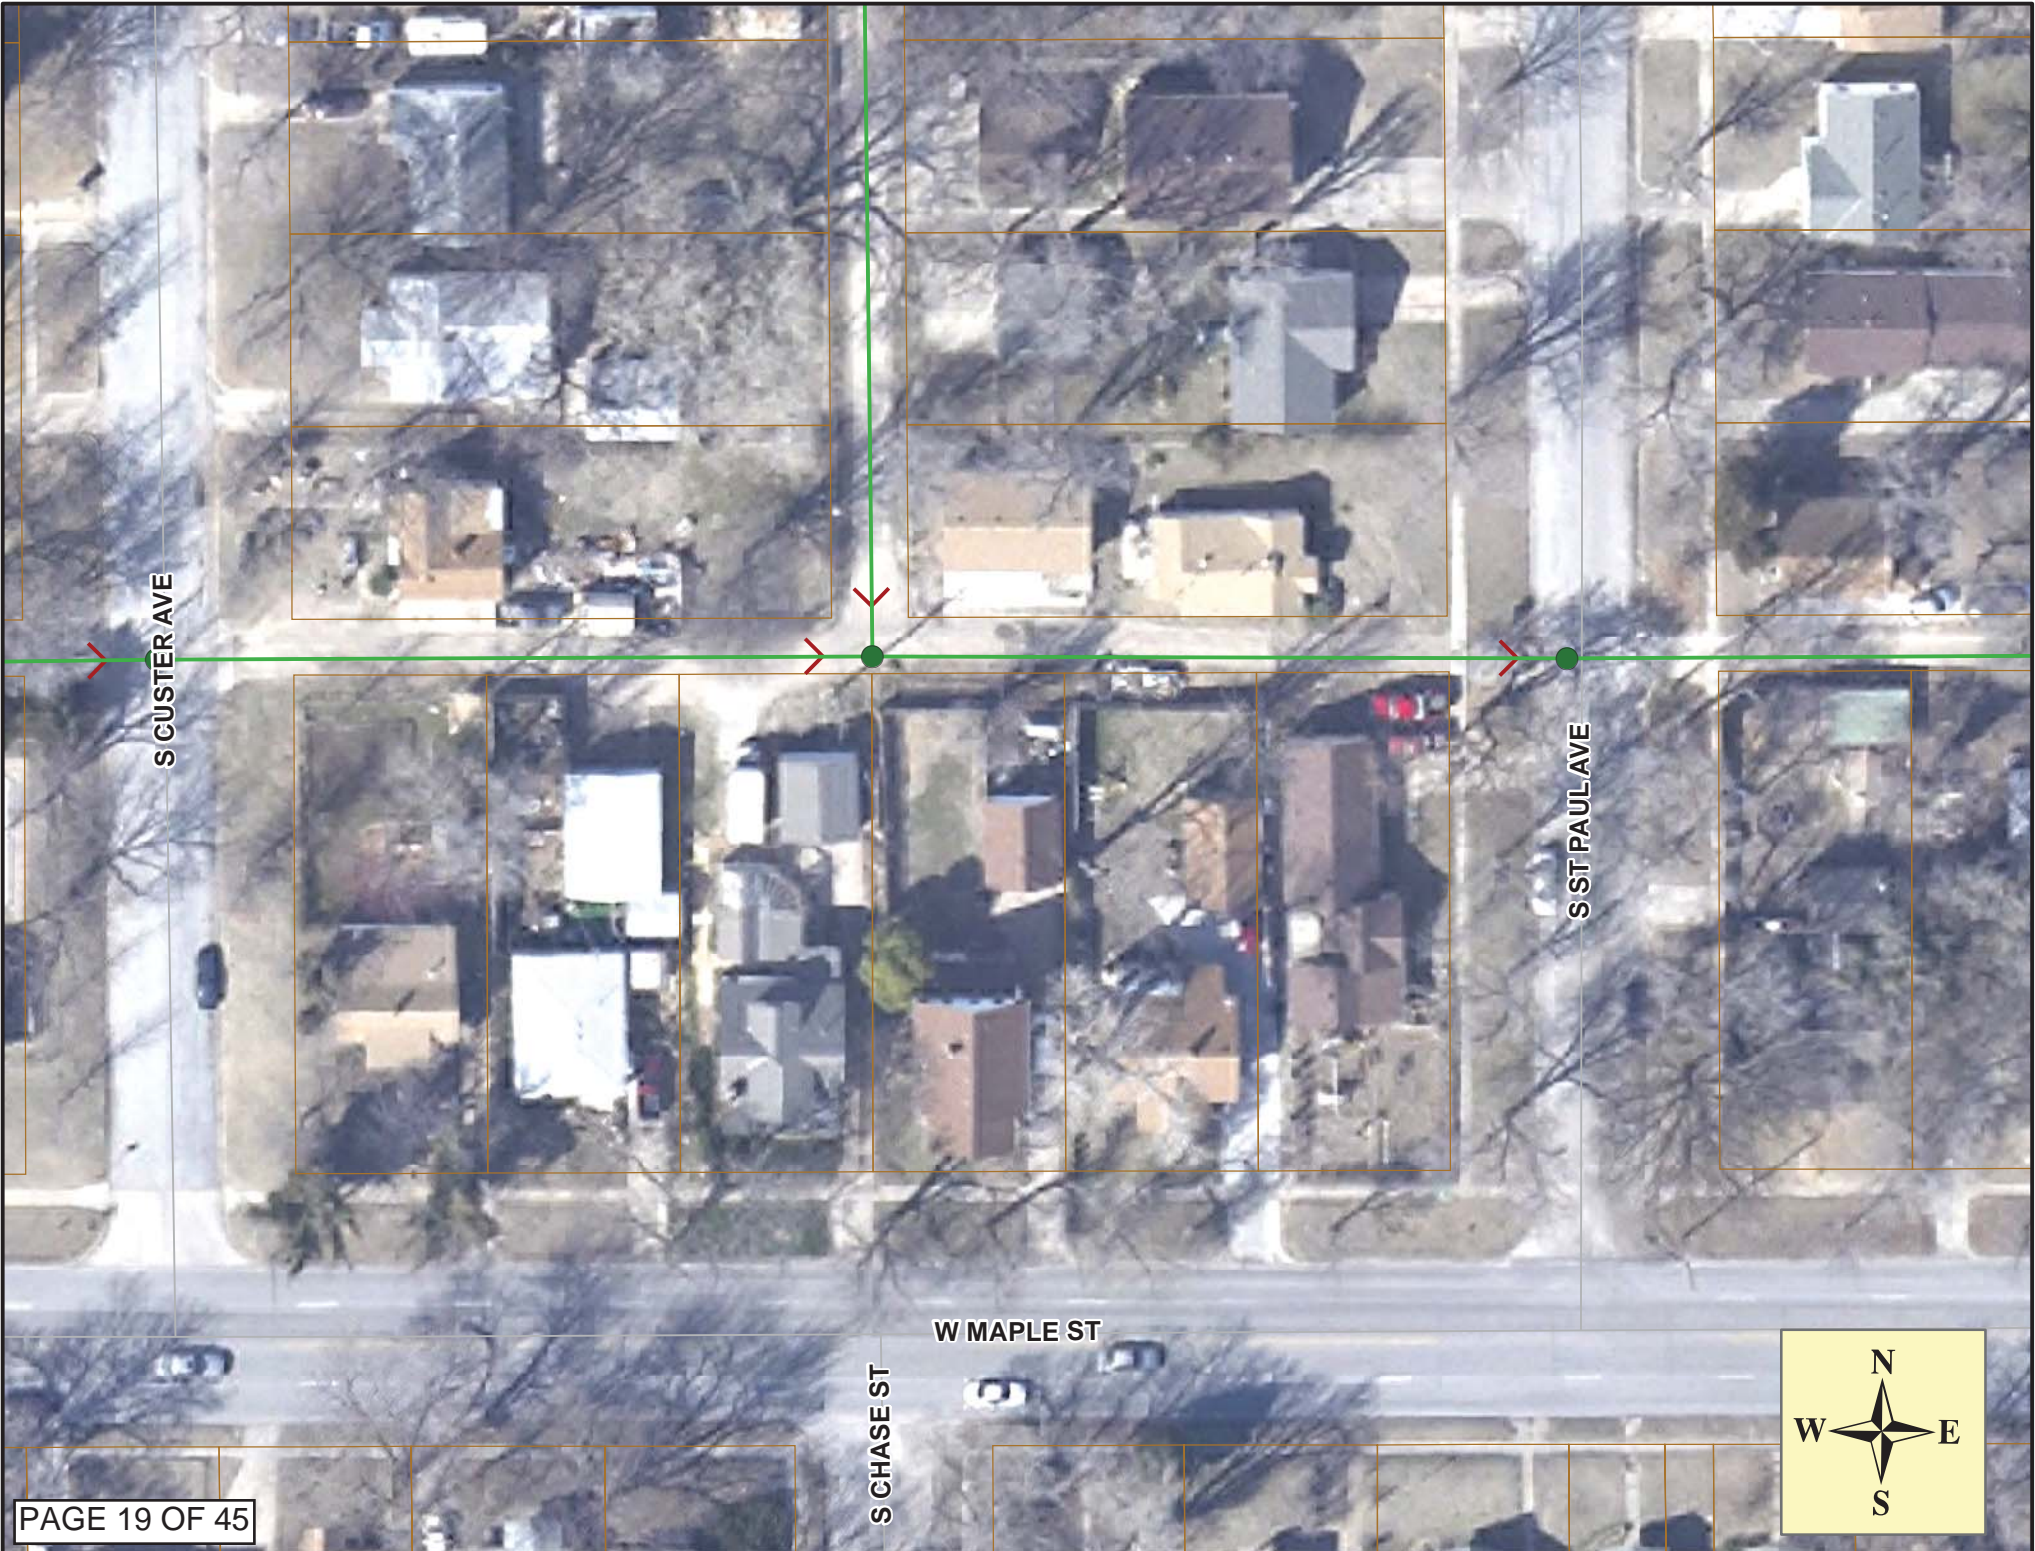
MH 5247-393  
Replace MH Frame & Cover  
Approx depth = 6.1 ft

2.5" water line located approx. 2 ft west  
of the west curb line

Remove & replace 14 lf of A/C Pavement (in street)  
Remove & replace 7 lf Concrete Approach (incl gutter)  
Remove & replace 12 lf of A/C Pavement (in alley)  
Remove & replace 4 lf Concrete Sidewalk  
Install 36 lf of Fill Sand (flushed & vibrated)

MH 5247-392  
Approx depth = 4.9 ft

Remove 186 lf of 8" Pipe  
Install 186 lf of 8" Pipe  
Estimated 4 Service Reconnections (4")
