SITE 11

11-1

Television Inspection Master Report

US Manhole: 5348-043 1901 W 13TH ST Date Insp: 4/10/2007 Basin: C03E
DS Manhole: 5348-040 Dir Televised: Upstream To Downstream

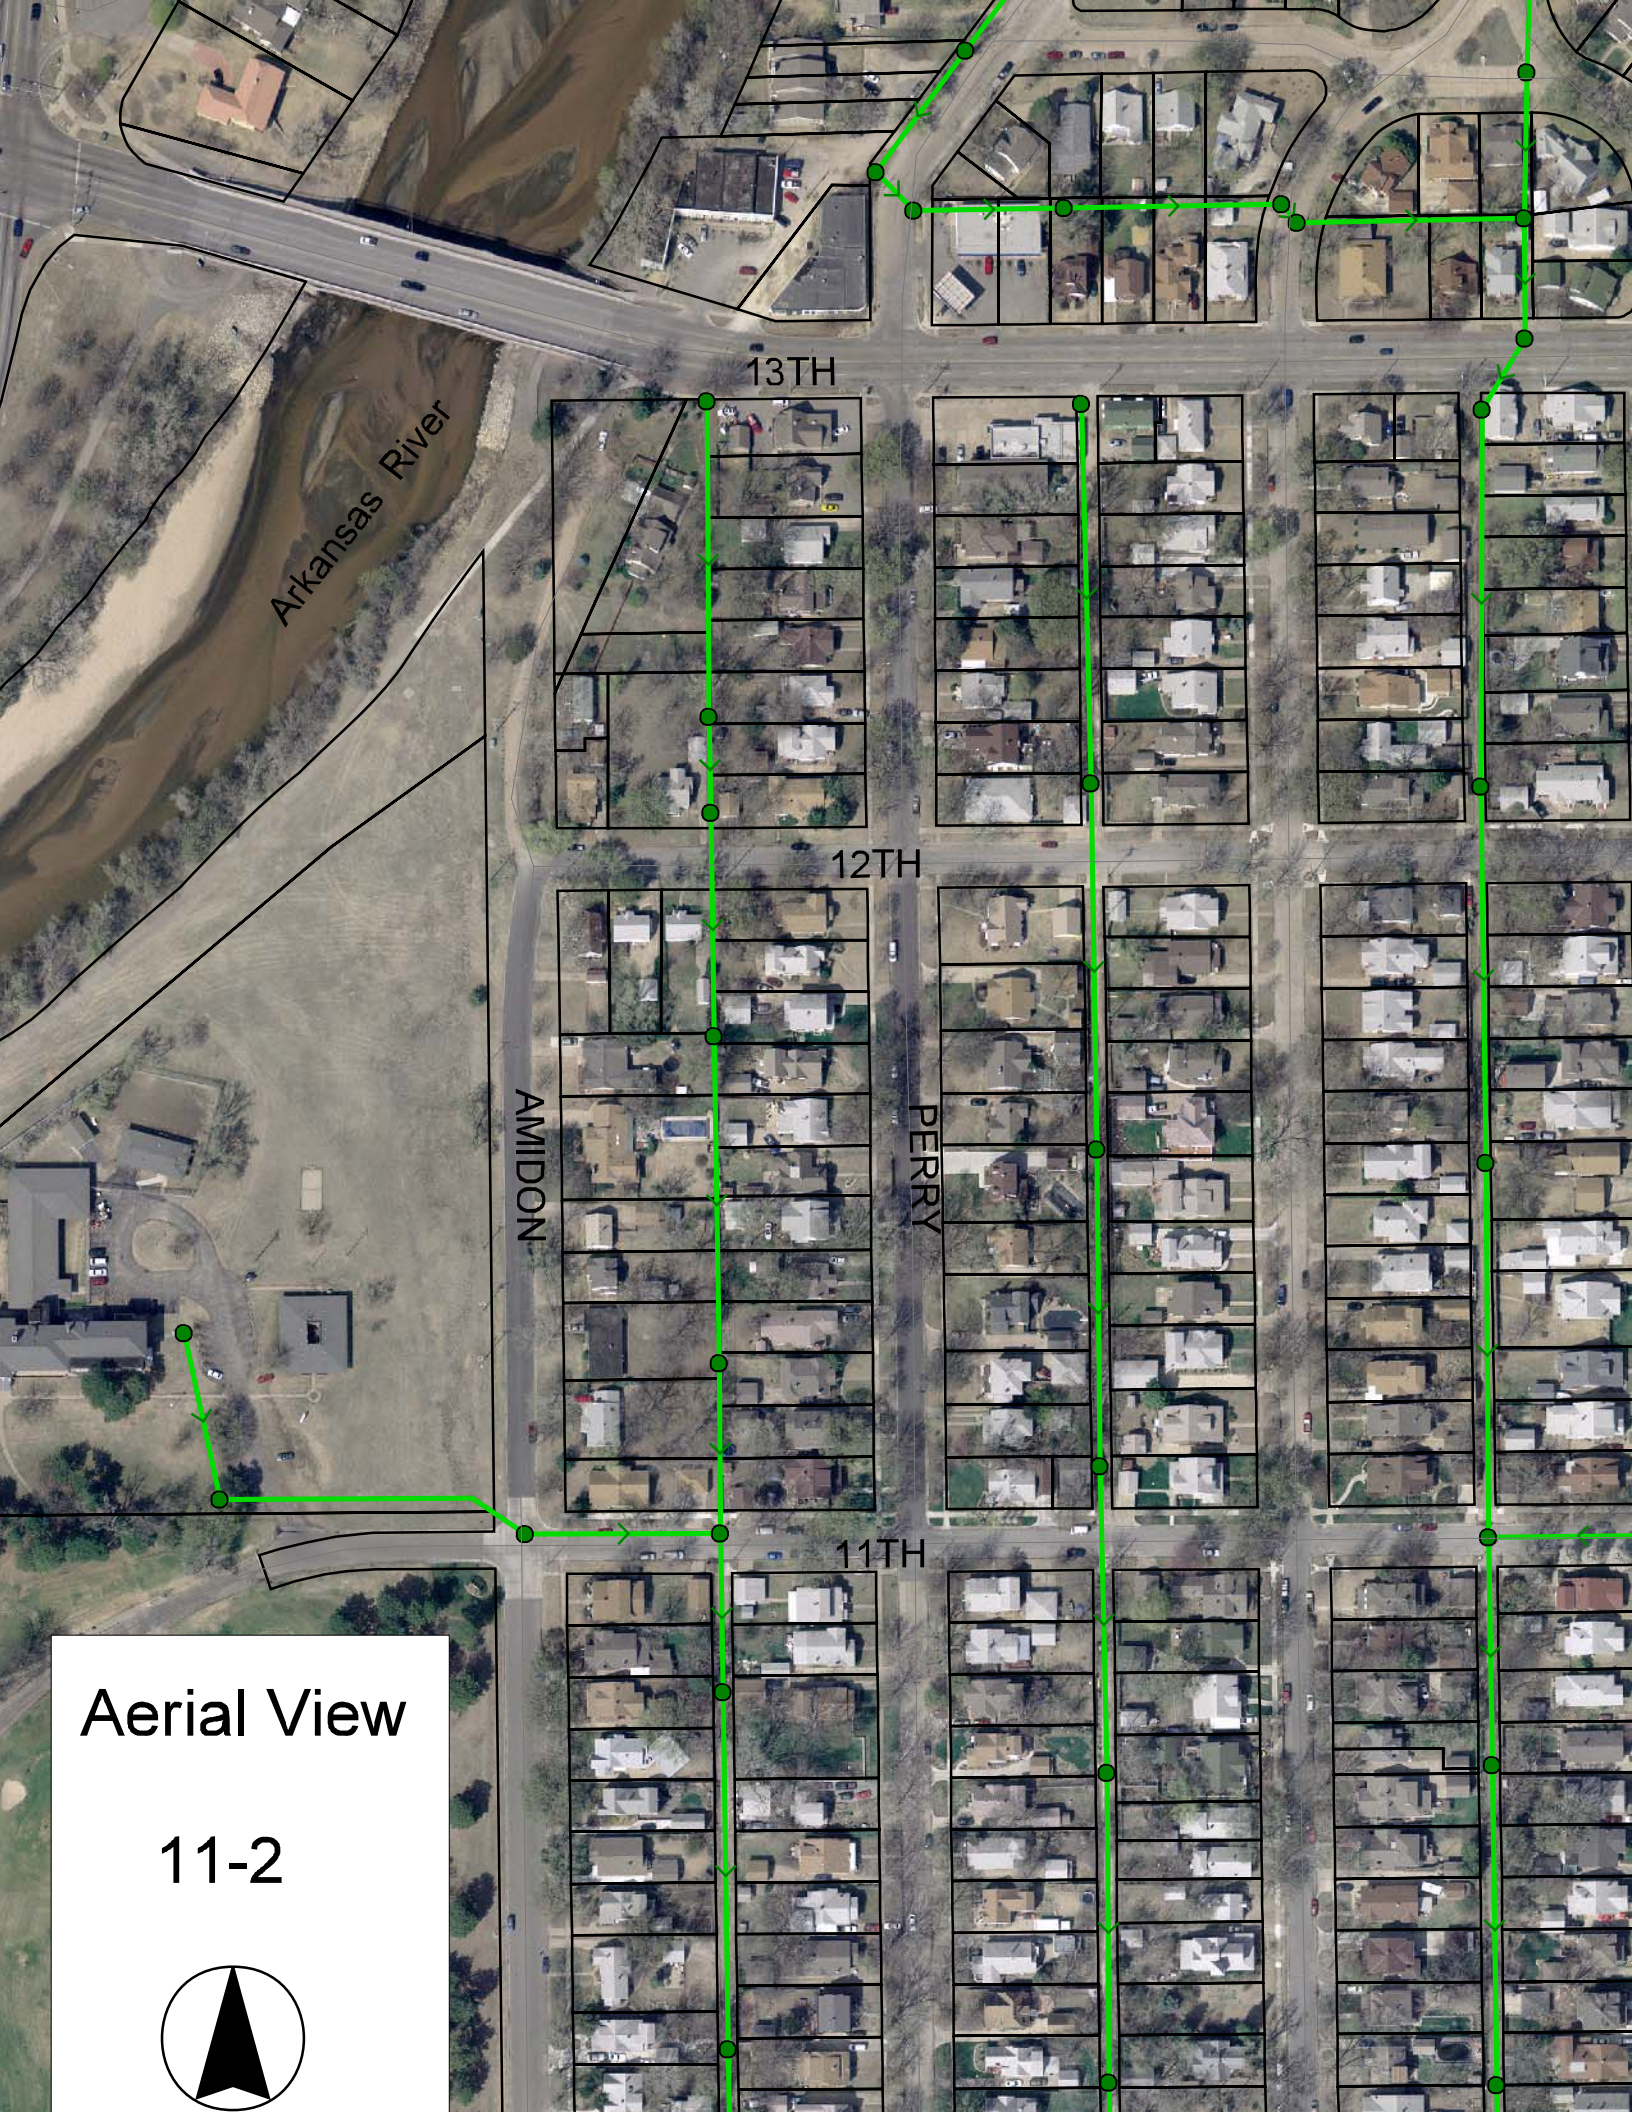
MH # 5348-043
 Abandon Manhole, per City Spec
 Approx depth = 6.2 ft

MH # 5348-040
 Abandon Manhole
 (line through this manhole and abandon
 over the CIPP liner, per City Spec)

MH # 5348-039
 Depth not measured

MH # 5348-037
 Approx depth = 5.7 ft

MH # 5348-034
 Approx depth = 5.5 ft

MH # 5348-032
 Approx depth = 4.3 ft

MH # 5348-030
 Approx depth = 6.2 ft

MH # 5348-043 (re-use MH number)
 Construct Manhole over sanitary sewer,
 at 20 lf south of existing MH 5348-043.
 (see tv log - this is location of an east tap)

Install 377 lf of 8" Cured-in-Place Liner
 from new MH 5348-043 to MH 5348-039

Abandon Observation Hole (over CIPP):
 @ 107 lf S. of MH 5348-039
 @ 106 lf N of MH 5348-034
 @ 46 lf N of MH 5348-032
 (See TV Logs / Abandon per City Spec)

Install 846 lf of 8" Cured-in-Place Liner
 from MH 5348-039 to MH 5348-030
