← SITE 3

## Television Inspection Master Report

US Structure: 5748-028      3400 E MURDOCK ST      Date Insp: 4/2/2010      Basin: EC02A  
 DS Structure: 5748-027      3400 E MURDOCK ST      Dir Televised: Upstream To Downstream

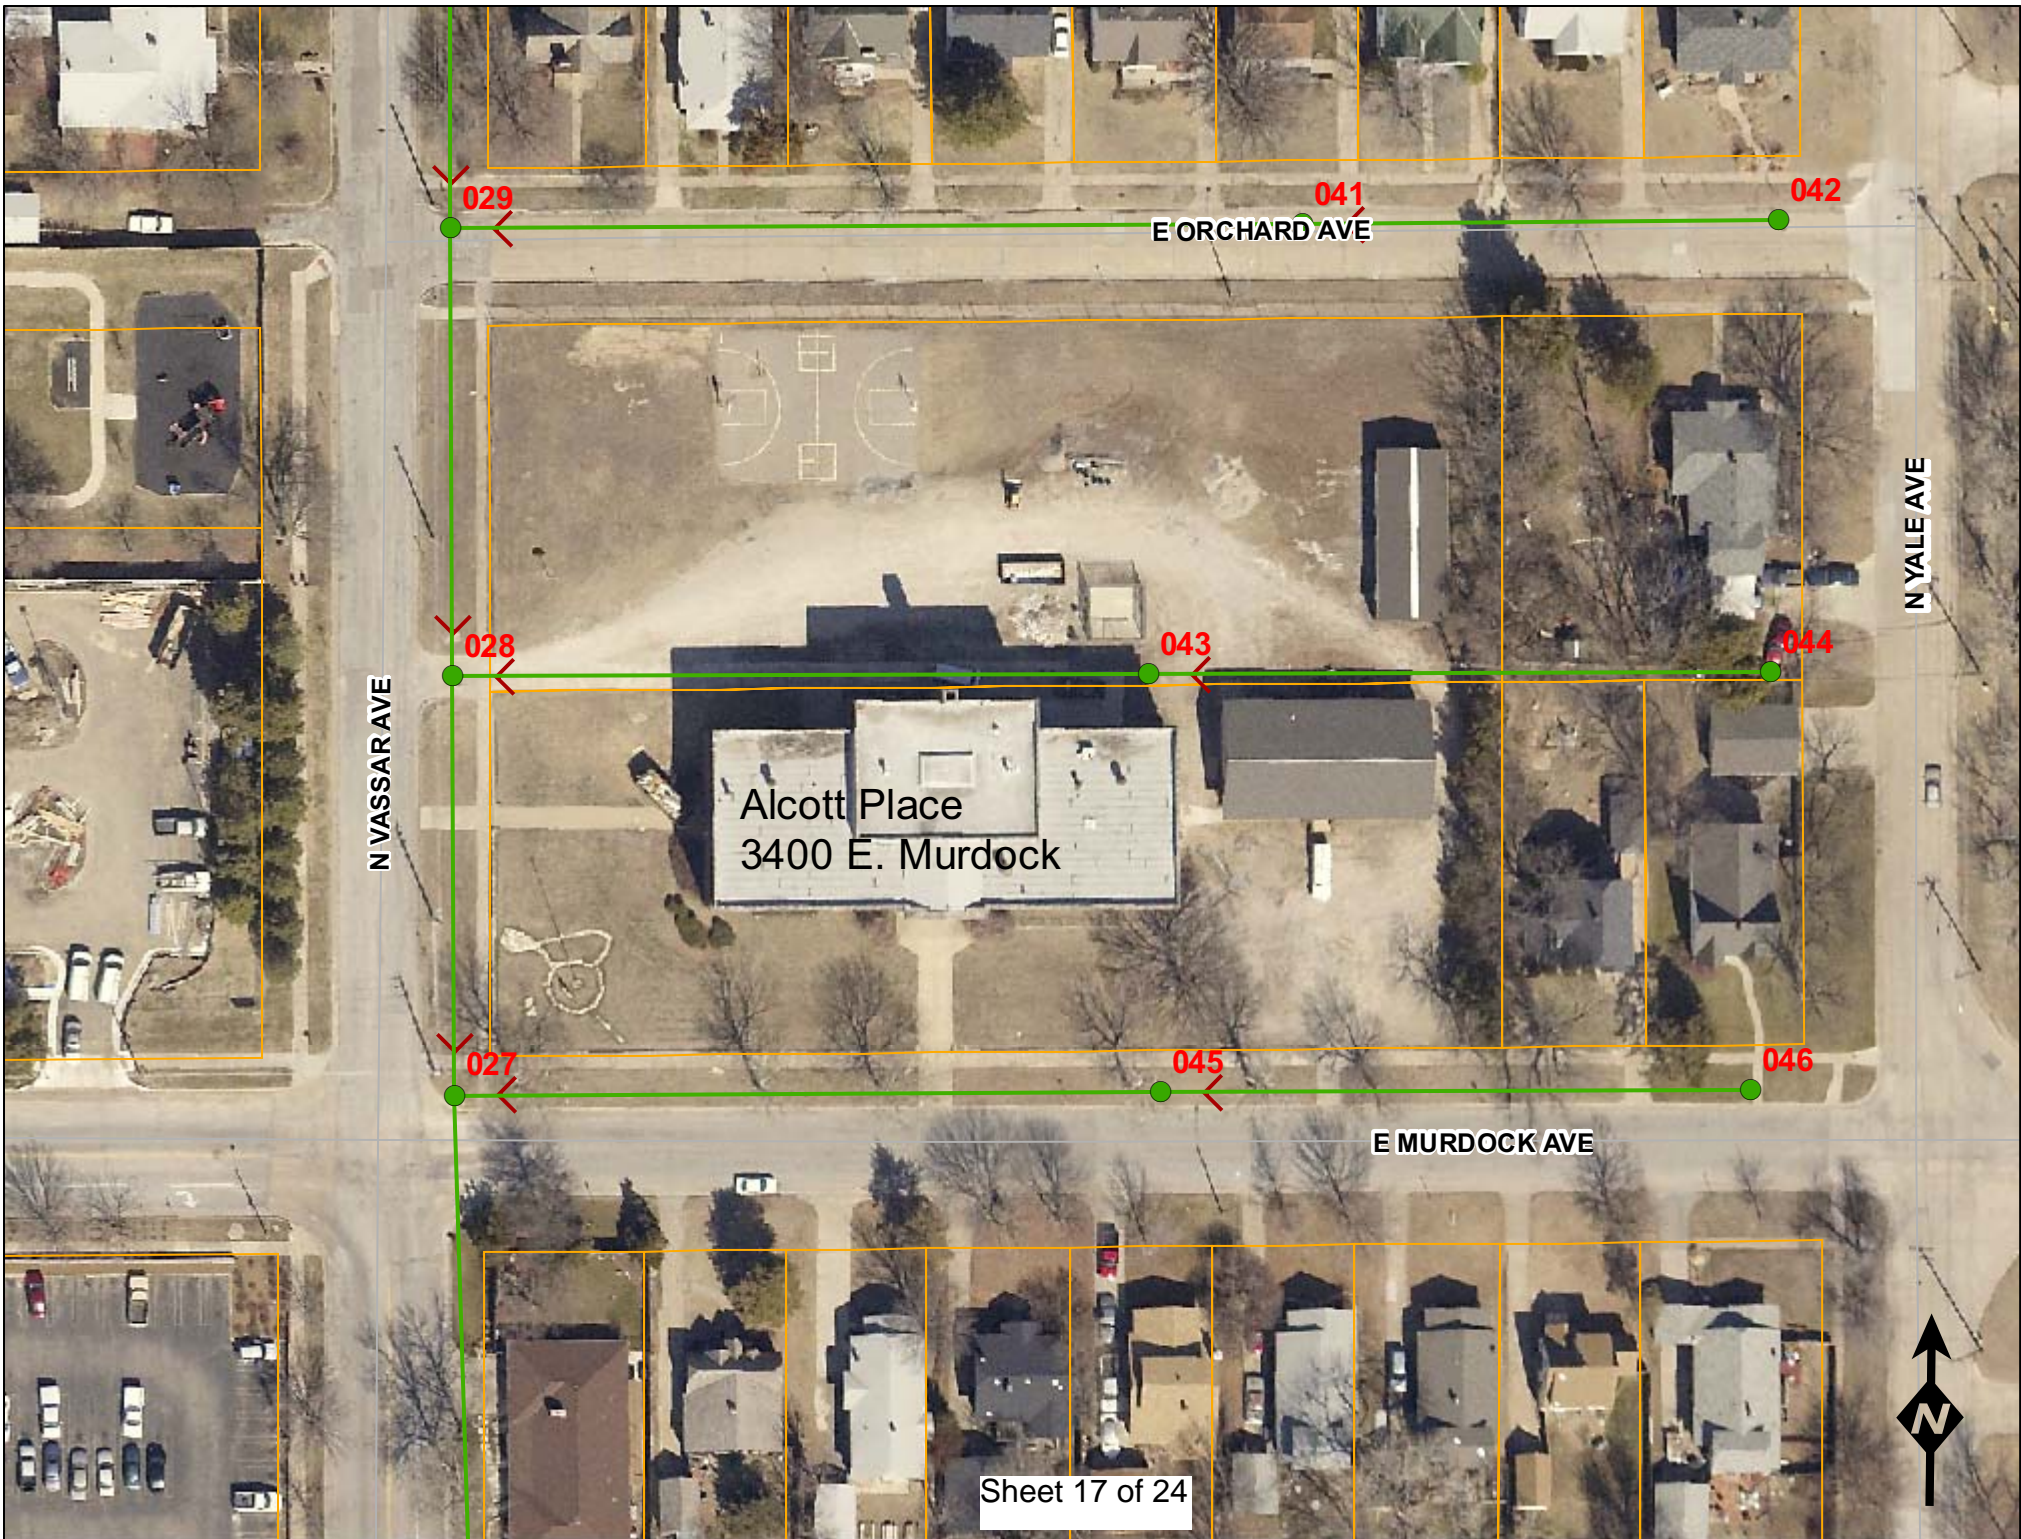
MH 5748-028  
Approx depth = 6.5 ft

MH 5748-027  
Approx depth = 5.2 ft

MH 5748-045  
Replace Manhole Frame & Cover  
Approx depth = 4.4 ft

Broken pipe north of MH 5748-027 makes it impossible to line the pipe without a point repair. Need to go 25' north of MH 5748-027 to get to good pipe. The downstream 25 lf is all horizontal cracks in every 3' segment.

Point Repair: Remove and replace 25 lf of 8" pipe, from MH 5748-027 to 25 lf north (see tv log) (5' sidewalk replacement shall be incidental)

REPLACE DOWNSTREAM 25 LF OF PIPE TO ALLOW FOR CIPP IN THE FUTURE.
