# 2011 SANITARY SEWER RECONSTRUCTION PHASE 1

**OCA # 620571 / 468-84726**  
( North of Kellogg, East of Oliver )

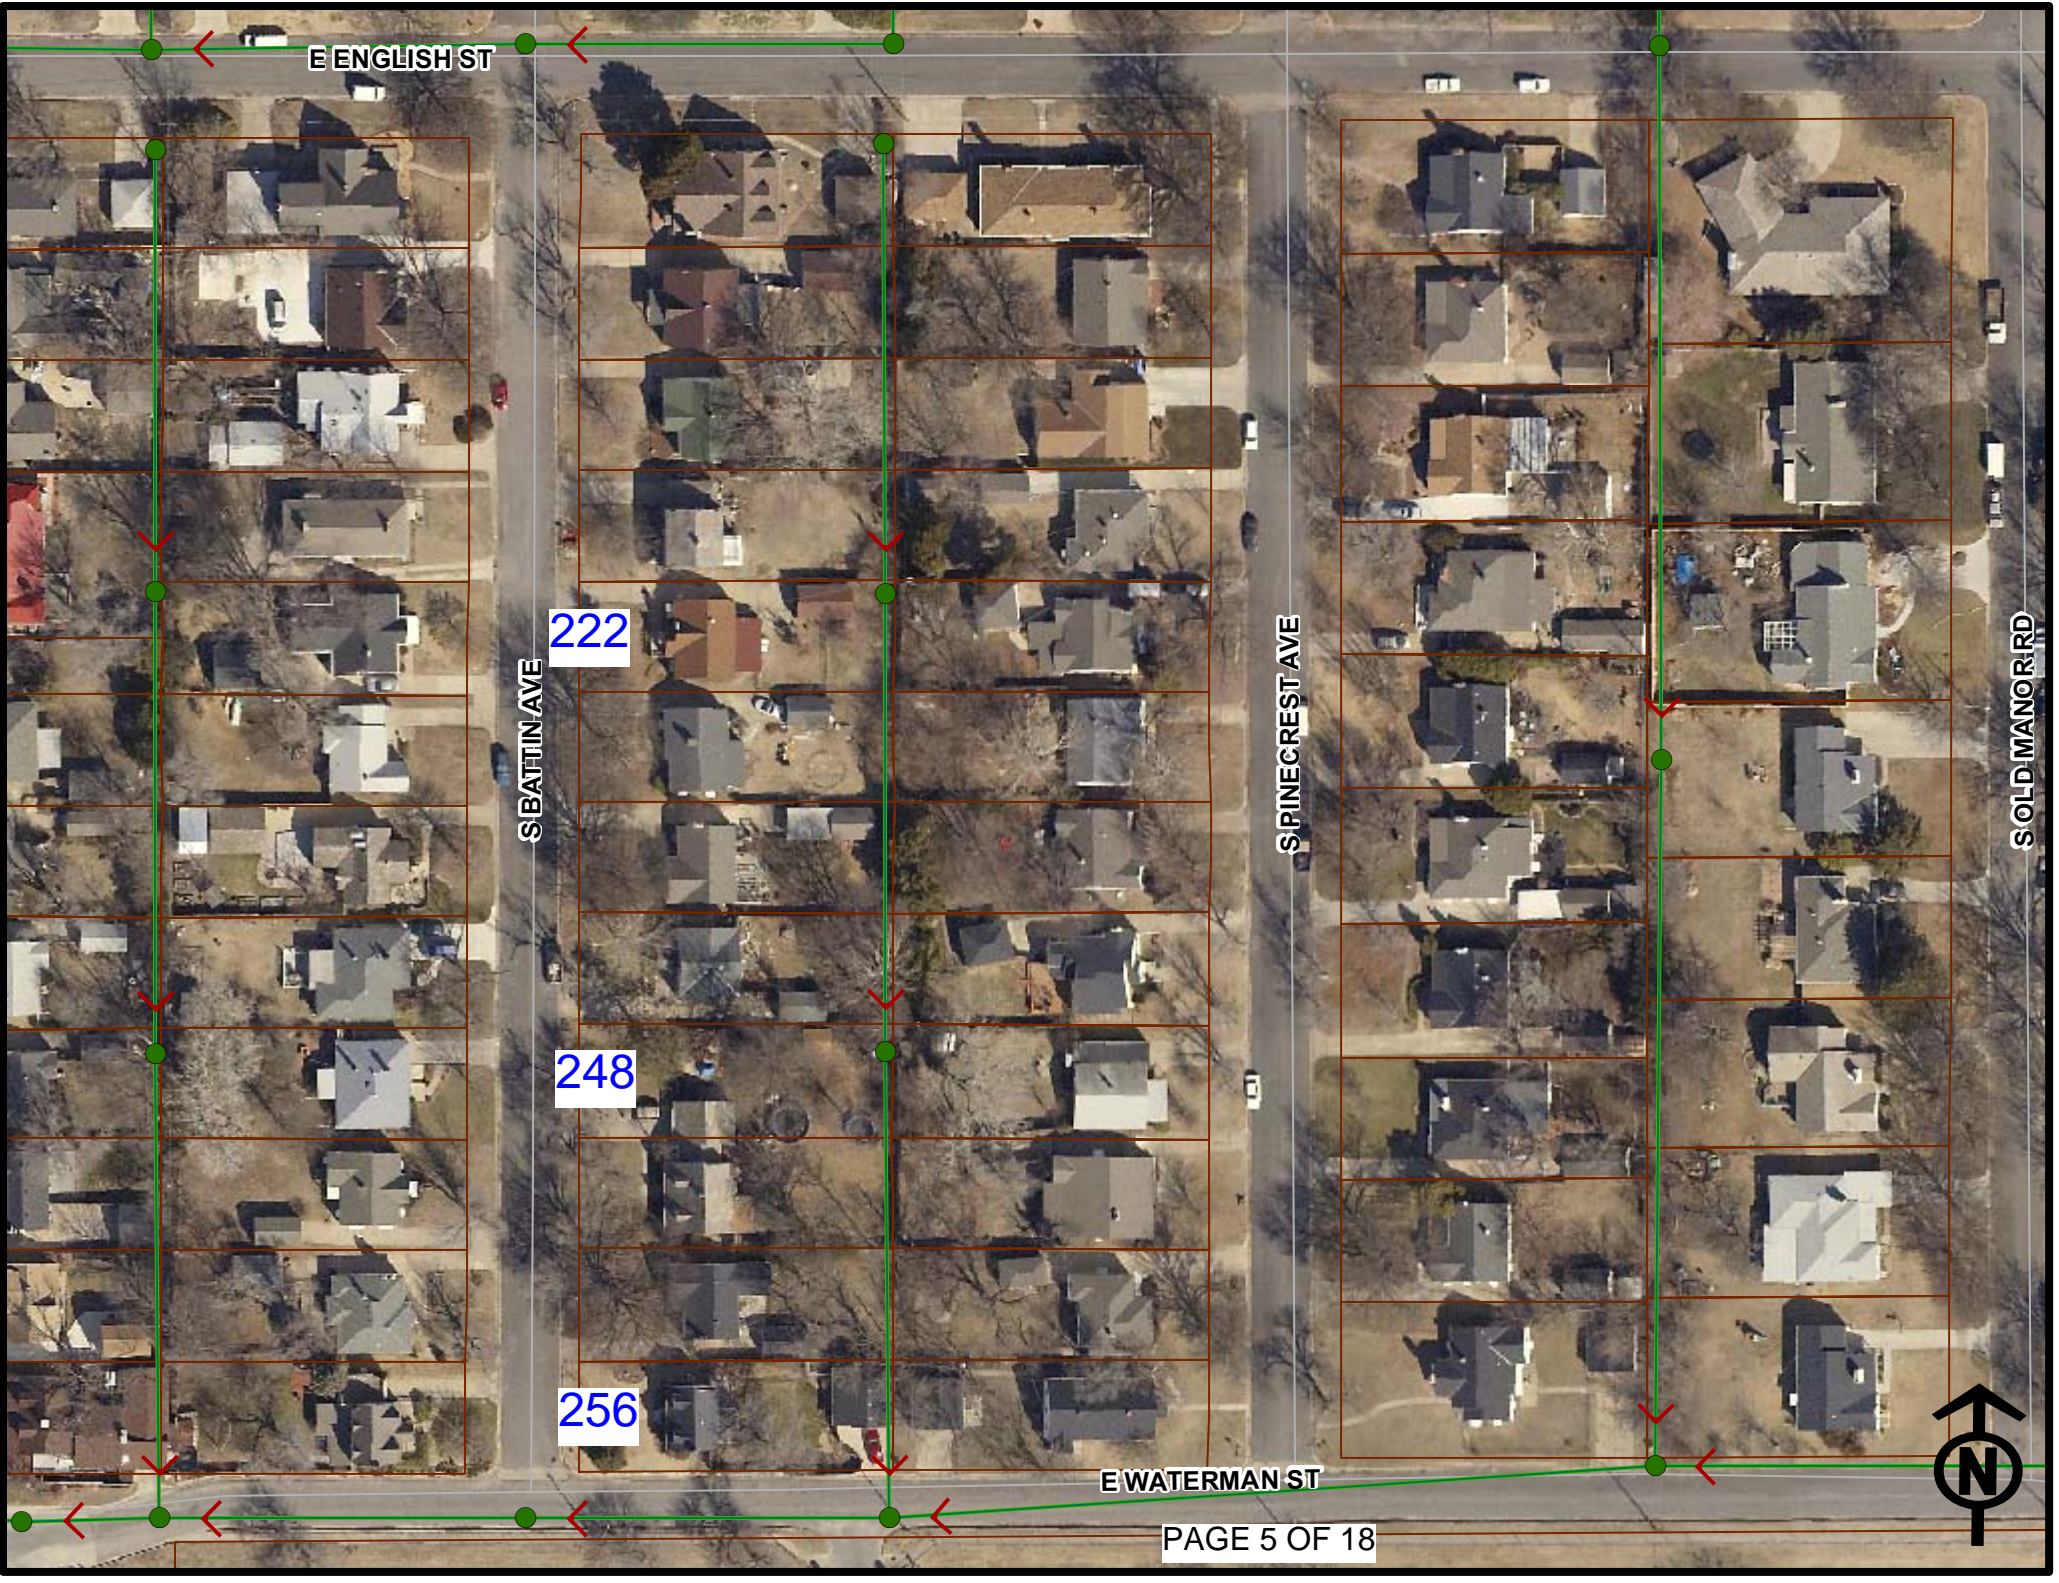
SITE 1

MH # 5847-419  
Abandon Manhole  
Approx depth = 11.6 ft.

MH # 5847-418  
Remove Manhole  
Approx depth = 11.9 ft.

MH # 5847-417  
Replace Manhole Frame & Cover  
Approx depth = 9.9 ft.

MH # 5847-380  
Remove & Replace Bench & Invert  
Approx depth = 9.0 ft.

Obs. #	VTR Counter	Distance	Location	Description	Rating	Obsrvd (gpm)	Ratings		Remain (gpm)	
							Est. (gpm)	Struct Clean		
1		0.0		5847-418 US Manhole	<b><u>THIS IS THE MID-BLOCK SEGMENT</u></b>					
2		5.0	W	Break-In Conn	5	0.010	400	0	0.010	
222 S BATTIN										
3		11.2		Sealed Off Wye	1	0.000	0	0	0.000	
4		15.9		Sealed Off Wye	1	0.000	0	0	0.000	
5		29.0		Broken Pipe	2	0.008	44	0	0.008	
6		30.2		Broken Pipe	3	0.010	60	0	0.010	
7		31.8	E	Break-In Conn	4	0.008	60	0	0.008	
223 S PINECREST										
8		36.6		Sealed Off Wye	1	0.000	0	0	0.000	
9		39.0		Sealed Off Wye	1	0.000	0	0	0.000	
10		42.8		Crack-Horizontal	1	0.001	1	0	0.001	
11		48.2		Crack-Horizontal	2	0.002	2	0	0.002	
12		50.5		Crack-Horizontal	3	0.004	5	0	0.004	
13		53.9		Broken Pipe	2	0.008	44	0	0.008	
14		56.6		Crack-Radial	5	0.010	18	0	0.010	
15		60.0	W	Wye Service	2	0.000	0	0	0.000	
228 S BATTIN / ROOTS										
16		62.0		Roots	2	0.004	2	4	0.004

17		63.7	E	Wye Service	2	0.000	0	0	0.000	
227 S PINECREST										
18		64.7		Broken Pipe	3	0.010	60	0	0.010	
19		74.6		Crack-Horizontal	2	0.002	2	0	0.002	
20		87.0		Sealed Off Wye	1	0.000	0	0	0.000	
21		89.2		Sealed Off Wye	1	0.000	0	0	0.000	
22		115.0		Sealed Off Wye	1	0.000	0	0	0.000	
23		115.5		Crack-Radial	2	0.002	2	0	0.002	
24		115.5		Sealed Off Wye	2	0.000	0	0	0.000	
25		118.4	E	Break-In Conn	2	0.002	0	0	0.002	
227 S PINECREST										
26		118.4		Broken Pipe	3	0.010	60	0	0.010	
27		122.3		Crack-Horizontal	3	0.004	5	0	0.004	
28		123.9		Crack-Horizontal	2	0.002	2	0	0.002	
29		125.8		Crack-Horizontal	3	0.004	5	0	0.004	
30		130.8		Crack-Horizontal	3	0.004	5	0	0.004

31	133.0		Broken Pipe	3	0.010	60	0	0.010
32	135.1		Crack-Radial	4	0.008	10	0	0.008
33	140.6	W	Wye Service	1	0.000	0	0	0.000
234 S BATTIN								
34	142.9		Sealed Off Wye	1	0.000	0	0	0.000
35	162.8		Broken Pipe	4	0.030	78	0	0.030
36	164.3	W	Wye Service	4	0.000	60	0	0.000
236 S BATTIN / FULL OF ROOTS								
37	166.6	E	Break-In Conn	5	0.010	400	0	0.010
231 S PINECREST / PVC								
38	168.0		Broken Pipe	5	0.060	100	0	0.060
39	168.0		Stopped Inspection	5	0.000	0	0	0.000

Obs. #	VTR Counter	Distance	Location	Description	Rating	Obsrvd (gpm)	Ratings		Remain (gpm)
							Est. (gpm)	Struct Clean	
1		0.0	5847-417 DS Manhole	/ TV AGAINST THE FLOW					
2		6.9		Sealed Off Wye	1	0.000	0	0	0.000
3		9.6		Sealed Off Wye	1	0.000	0	0	0.000
4		11.3		Broken Pipe	3	0.010	60	0	0.010
5		12.9		Crack-Horizontal	4	0.008	10	0	0.008
6		15.9		Broken Pipe	3	0.010	60	0	0.010
7		19.1		Broken Pipe	3	0.010	60	0	0.010
8		22.1		Broken Pipe	2	0.008	44	0	0.008
9		25.5		Crack-Horizontal	3	0.004	5	0	0.004
10		28.4		Broken Pipe	5	0.060	100	0	0.060
11		29.9		Stopped Inspection	5	0.000	0	0	0.000

Televising not available. Cleaner pulled a lot of mud from the main. Cannot get the camera into the sewer main.

MH # 5847-\_\_\_\_  
Construct Manhole  
(over existing sanitary sewer,  
approx 35 lf south of MH 5847-419)  
1-4" stub W/NW - tie in existing service  
1-4" stub E/NE - tie in existing service  
(seal off pipe north of manhole)

Remove and replace 372 lf of 8" pipe  
from new manhole to MH 5847-417

Remove and replace 130 lf of 8" pipe  
from MH 5847-417 to new manhole

MH # 5847-\_\_\_\_  
Construct Manhole  
(over existing sanitary sewer,  
approx 75 lf north of MH 5847-380)

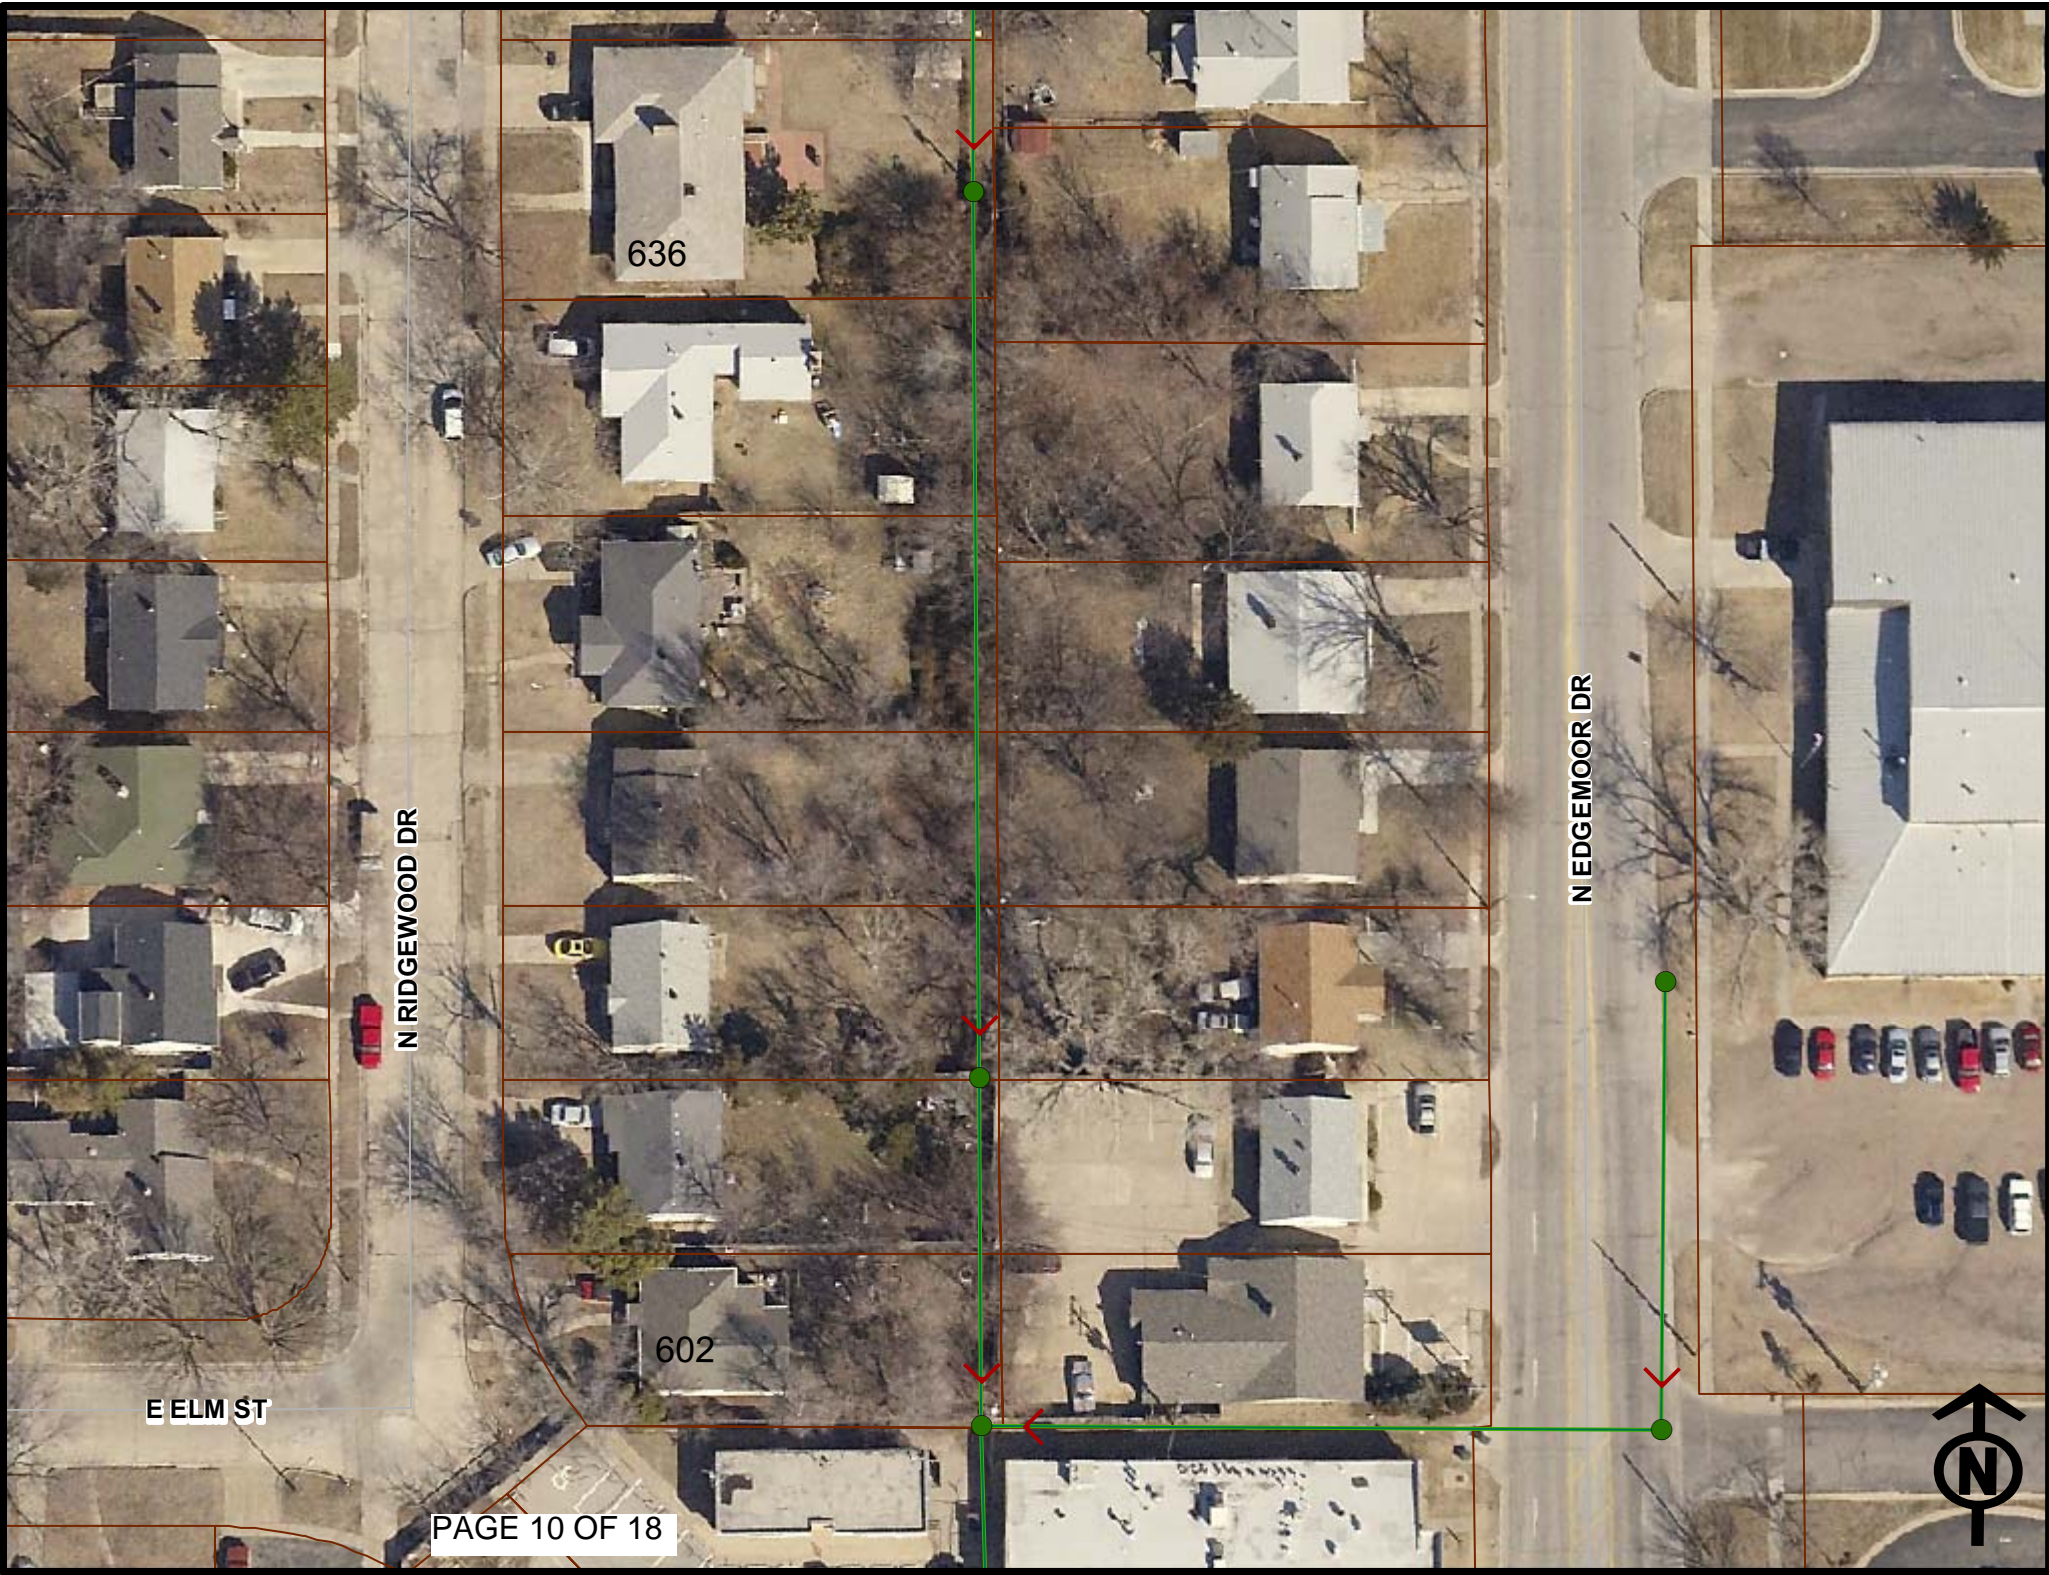
Obs. #	VTR Counter	Distance	Location	Description	Rating	Obsrvd (gpm)	Ratings			Remain (gpm)
							Est. (gpm)	Struct	Clean	
1		0.0		5848-041 US Manhole						
2		7.3	W	Wye Service	2		0.000	0	0	0.000
636 N RIDGEWOOD										
3		10.7		Sealed Off Wye	1		0.000	0	0	0.000
4		14.8		Broken Pipe	2		0.008	44	0	0.008
5		18.1	E	Break-In Conn	4		0.008	60	0	0.008
635 N EDGEMOOR										
6		20.9		Broken Pipe	2		0.008	44	0	0.008
7		23.6		Broken Pipe	4		0.030	78	0	0.030
8		27.1		Broken Pipe	4		0.030	78	0	0.030
9		29.8		Roots	2		0.004	2	4	0.004
10		31.4		Broken Pipe	4		0.030	78	0	0.030
11		34.3		Sealed Off Wye	5		0.000	0	0	0.000
12		37.5		Sealed Off Wye	4		0.000	0	0	0.000
13		39.1		Broken Pipe	4		0.030	78	0	0.030
14		42.6		Broken Pipe	4		0.030	78	0	0.030
15		43.6		<b>Stopped Inspection</b>						(loose debris, bricks, possible broken pipe)

Obs. #	VTR Counter	Distance	Location	Description	Rating	Obsrvd (gpm)	Ratings			Remain (gpm)
							Est. (gpm)	Struct	Clean	
1		0.0		5848-040 DS Manhole						(located south of the wood fence, by utility pole)
602 N RIDGEWOOD / TV AGAINST THE FLOW										
2		10.8		Crack-Horizontal	1		0.001	1	0	0.001
3		13.8		Crack-Horizontal	2		0.002	2	0	0.002

4	16.7	E	Wye Service	4	0.000	60	0	0.000
603 N EDGEMOOR / full of roots								
5	16.8		Broken Pipe / Invert is shifted & sticking up	5	0.060	100	0	0.060
6	19.1	W	Extended Tap	5	0.002	400	0	0.002
602 N RIDGEWOOD / PVC extended tap / roots								
7	20.3		Broken Pipe	4	0.030	78	0	0.030
8	22.8		Broken Pipe	3	0.010	60	0	0.010
9	25.9		Broken Pipe	3	0.010	60	0	0.010
10	28.8		Crack-Horizontal	1	0.001	1	0	0.001
11	40.4		Sealed Off Wye	2	0.000	0	0	0.000
12	40.4		Crack-Horizontal	3	0.004	5	0	0.004
13	43.5		Sealed Off Wye	2	0.000	0	0	0.000
14	43.5		Broken Pipe / shifting pipe	4	0.030	78	0	0.030
15	46.3		Roots	2	0.004	2	4	0.004
16	46.9		Broken Pipe / shifting pipe	4	0.030	78	0	0.030
17	49.6		Broken Pipe	3	0.010	60	0	0.010
18	64.3	E	Wye Service	3	0.000	2	0	0.000
607 N EDGEMOOR / roots inside								
19	67.0	W	Break-In Conn	2	0.002	0	0	0.002
608 N RIDGEWOOD / PVC								
20	91.1		Sealed Off Wye	5	0.000	0	0	0.000
21	93.9		Sealed Off Wye	4	0.000	0	0	0.000

22	<b>99.8</b>		<b>Unmapped Manhole 5848-440</b>					
23	114.8	E	Wye Service	3	0.000	2	0	0.000
613 N EDGEMOOR / roots inside								
24	118.0	W	Break-In Conn	2	0.002	0	0	0.002
612 N RIDGEWOOD								
25	138.4		Sealed Off Wye	5	0.000	0	0	0.000
26	141.3		Sealed Off Wye	5	0.000	0	0	0.000
27	165.2	E	Wye Service	5	0.000	400	0	0.000
617 N EDGEMOOR / roots inside								
28	168.1	W	Wye Service	1	0.000	0	0	0.000
618 N RIDGEWOOD								
29	174.5		Broken Pipe	4	0.030	78	0	0.030
30	177.5		Shifting Pipe / Broken Pipe	4	0.030	78	0	0.030
31	180.6		Broken Pipe	4	0.030	78	0	0.030
32	183.7		Broken Pipe	4	0.030	78	0	0.030
33	186.6		Broken Pipe	4	0.030	78	0	0.030
34	189.2		Sealed Off Wye	5	0.000	0	0	0.000
35	189.8		Crack-Horizontal	5	0.010	18	0	0.010

36	192.2		Sealed Off Wye	5	0.000	0	0	0.000
37	192.7		Broken Pipe	5	0.060	100	0	0.060
38	195.8		Broken Pipe	4	0.030	78	0	0.030
39	198.5		Broken Pipe	5	0.060	100	0	0.060
40	202.8		Broken Pipe	4	0.030	78	0	0.030
180' to 206' is non-stop shifted pipe, out of round, badly cracked)								
41	207.4		Crack-Horizontal	2	0.002	2	0	0.002
42	213.5	E	Break-In Conn	1	0.001	0	0	0.001
621 N EDGEWOOD / PVC								
43	216.0	W	Sealed Off Wye	3	0.000	0	0	0.000
622 N RIDGEWOOD / roots inside								
44	237.0		Sealed Off Wye	2	0.000	0	0	0.000
45	239.8		Sealed Off Wye	4	0.000	0	0	0.000
46	240.8		Crack-Horizontal	1	0.001	1	0	0.001
47	243.0		Broken Pipe	4	0.030	78	0	0.030
48	246.4		Crack-Horizontal	3	0.004	5	0	0.004
49	249.3		Broken Pipe	4	0.030	78	0	0.030
50	252.2		Broken Pipe	4	0.030	78	0	0.030
51	255.2		Broken Pipe	4	0.030	78	0	0.030
52	258.2		Broken Pipe	4	0.030	78	0	0.030
53	264.1	E	Break-In Conn	4	0.008	60	0	0.008
629 N EDGEWOOD / roots inside
