2012 Sanitary Sewer Reconstruction

Phase 6

OCA 620600 / 468-84842

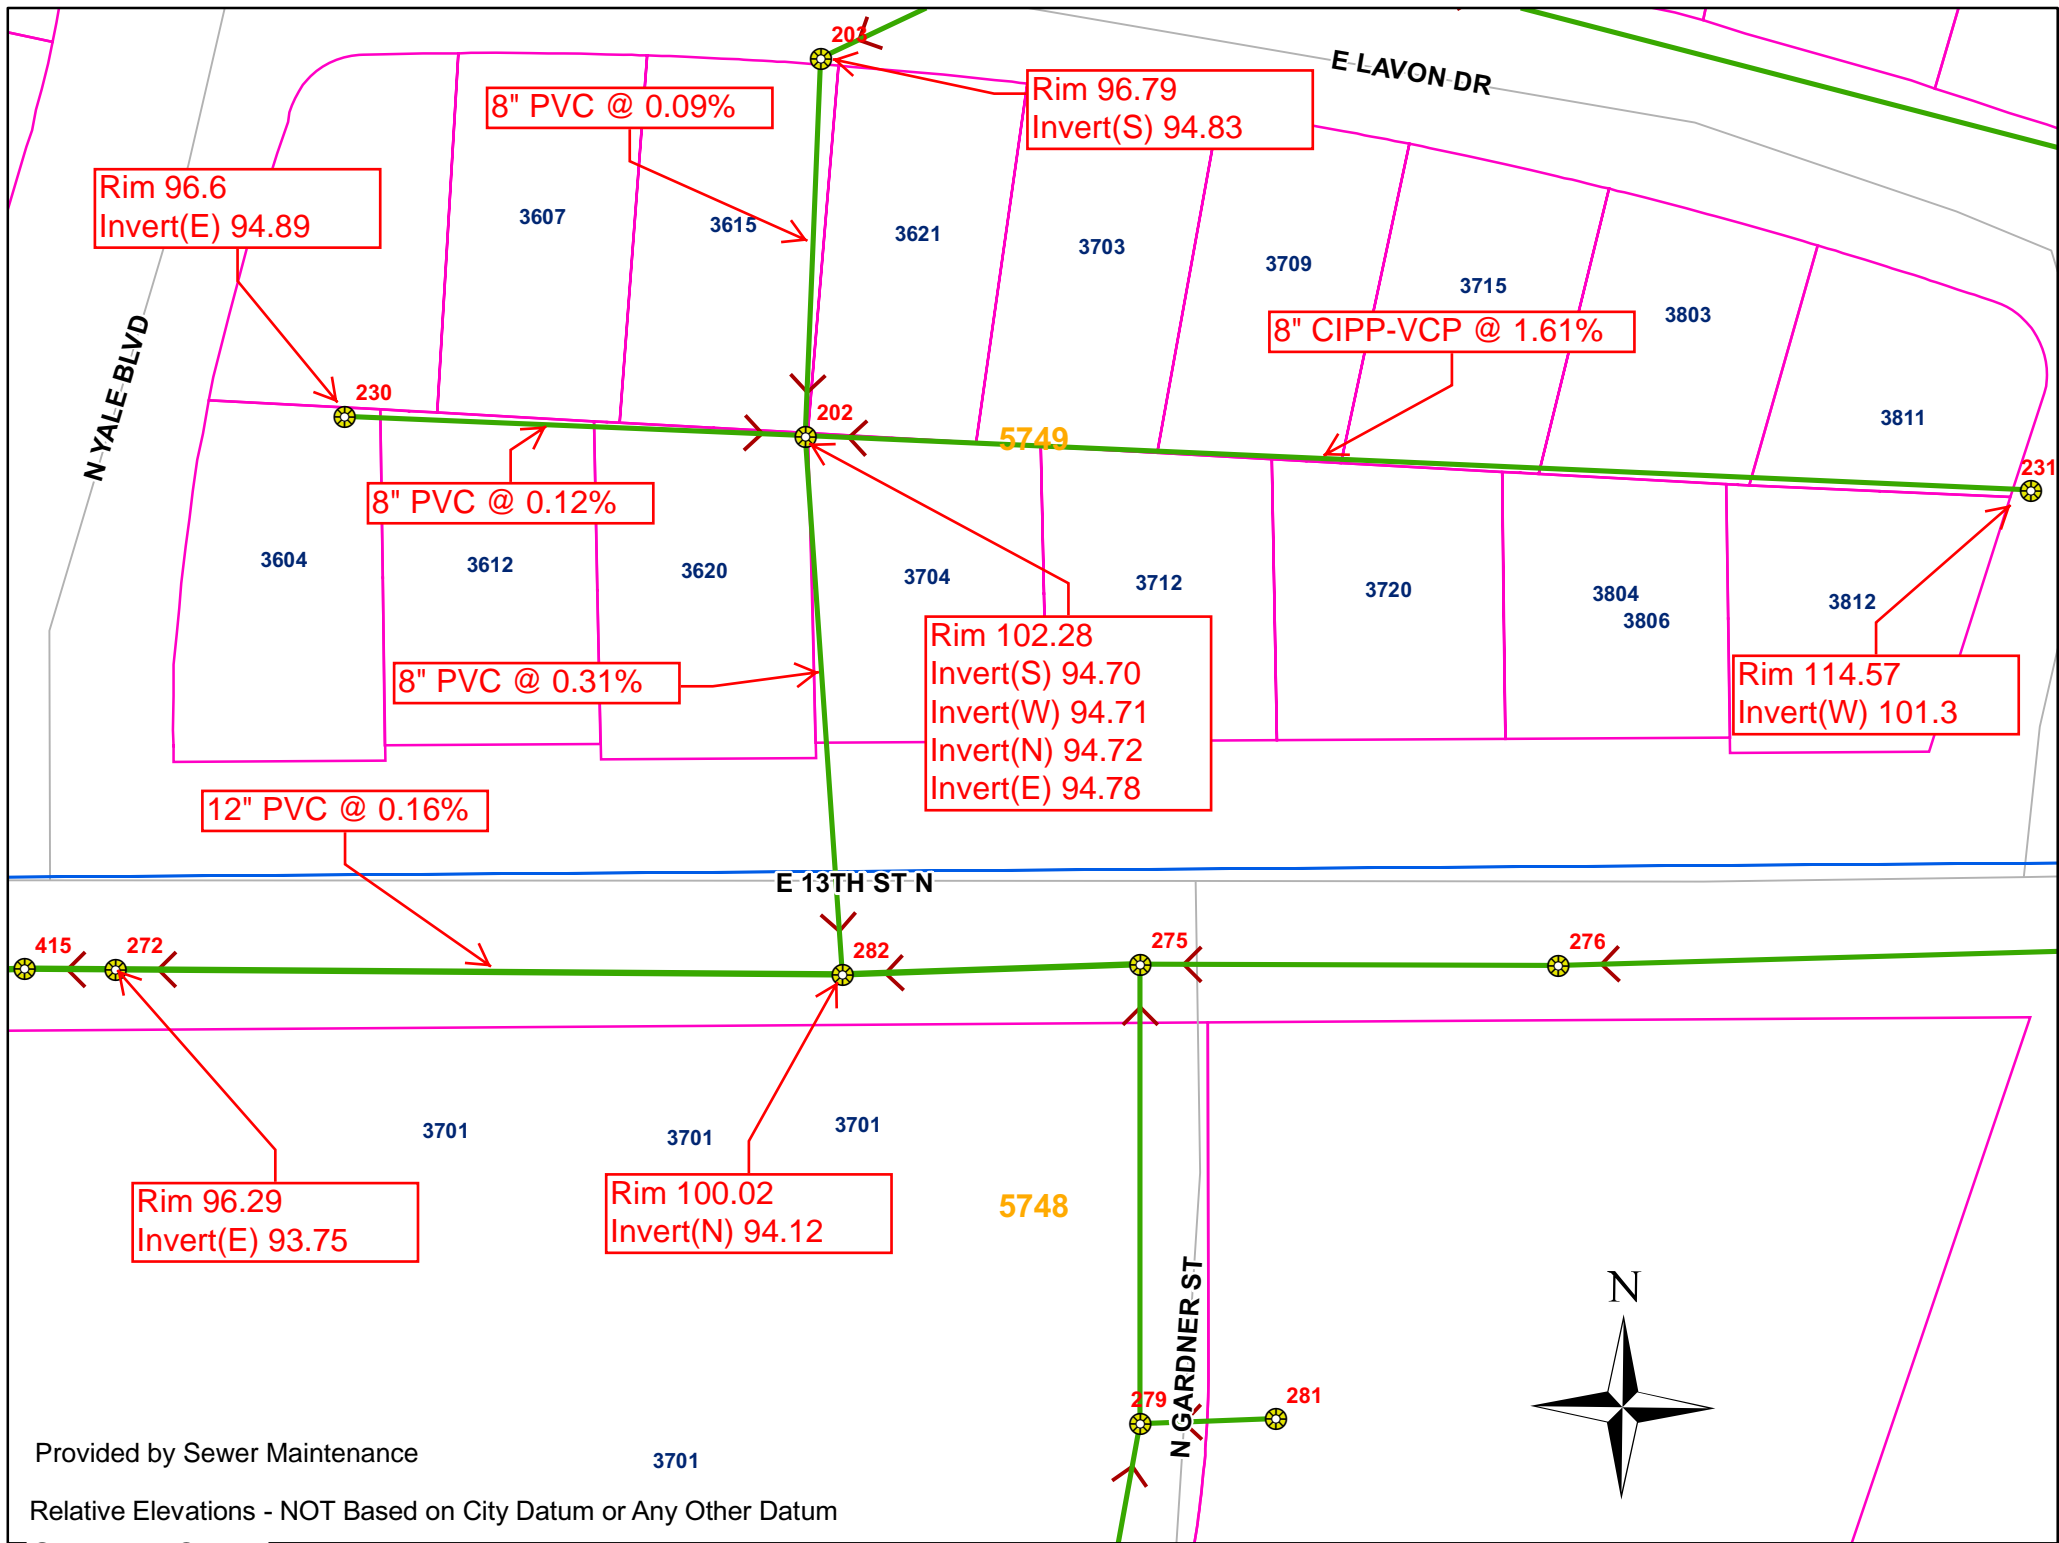
SITE 1

The homes west of MH 5749-202 experience backups, so the goal is to redirect flow and shape manhole inverts in a manner to correct that problem. MH 5749-140 is oversized to allow approx 18 inches between the two incoming pipes.
There is a 10' easement between 3620 and 3704 E. 13th Street, with 5 feet to either side of the property line. There is a 15' easement between 3704 E 13th and 3621 Lavon, with 7.5 feet to either side fo the property line.

MH 5749-202
Remove and Replace Manhole Bench & Invert
(reshape invert to better facilitate moving the flow
from the west through the manhole) (seal off the
pipe on east wall) Approx MH depth = 7.6 ft.

MH 5749-204
Construct Standard Manhole (4' dia) over existing sanitary
sewer (locate it as close as possible to MH 5749-202)
(remove line to the west between the manholes)

MH 5749-140
Construct Standard Manhole (5' dia) over existing sanitary
sewer (locate it 10' to 12' south of MH 5749-202)
(manhole does not need a special lining inside)

Install approx 12 lf of 8" pipe between
MH 5749-204 and MH 5749-140.
