Install 658 lf of 8" Cured-in-Place Liner

Video Inspection Master Report

US Structure: 4848-374 859 N MAUS LN Date Insp: 5/8/2009 Basin: W06A
 DS Structure: 4848-373 831 N MAUS LN Dir Televised: Downstream To Upstream

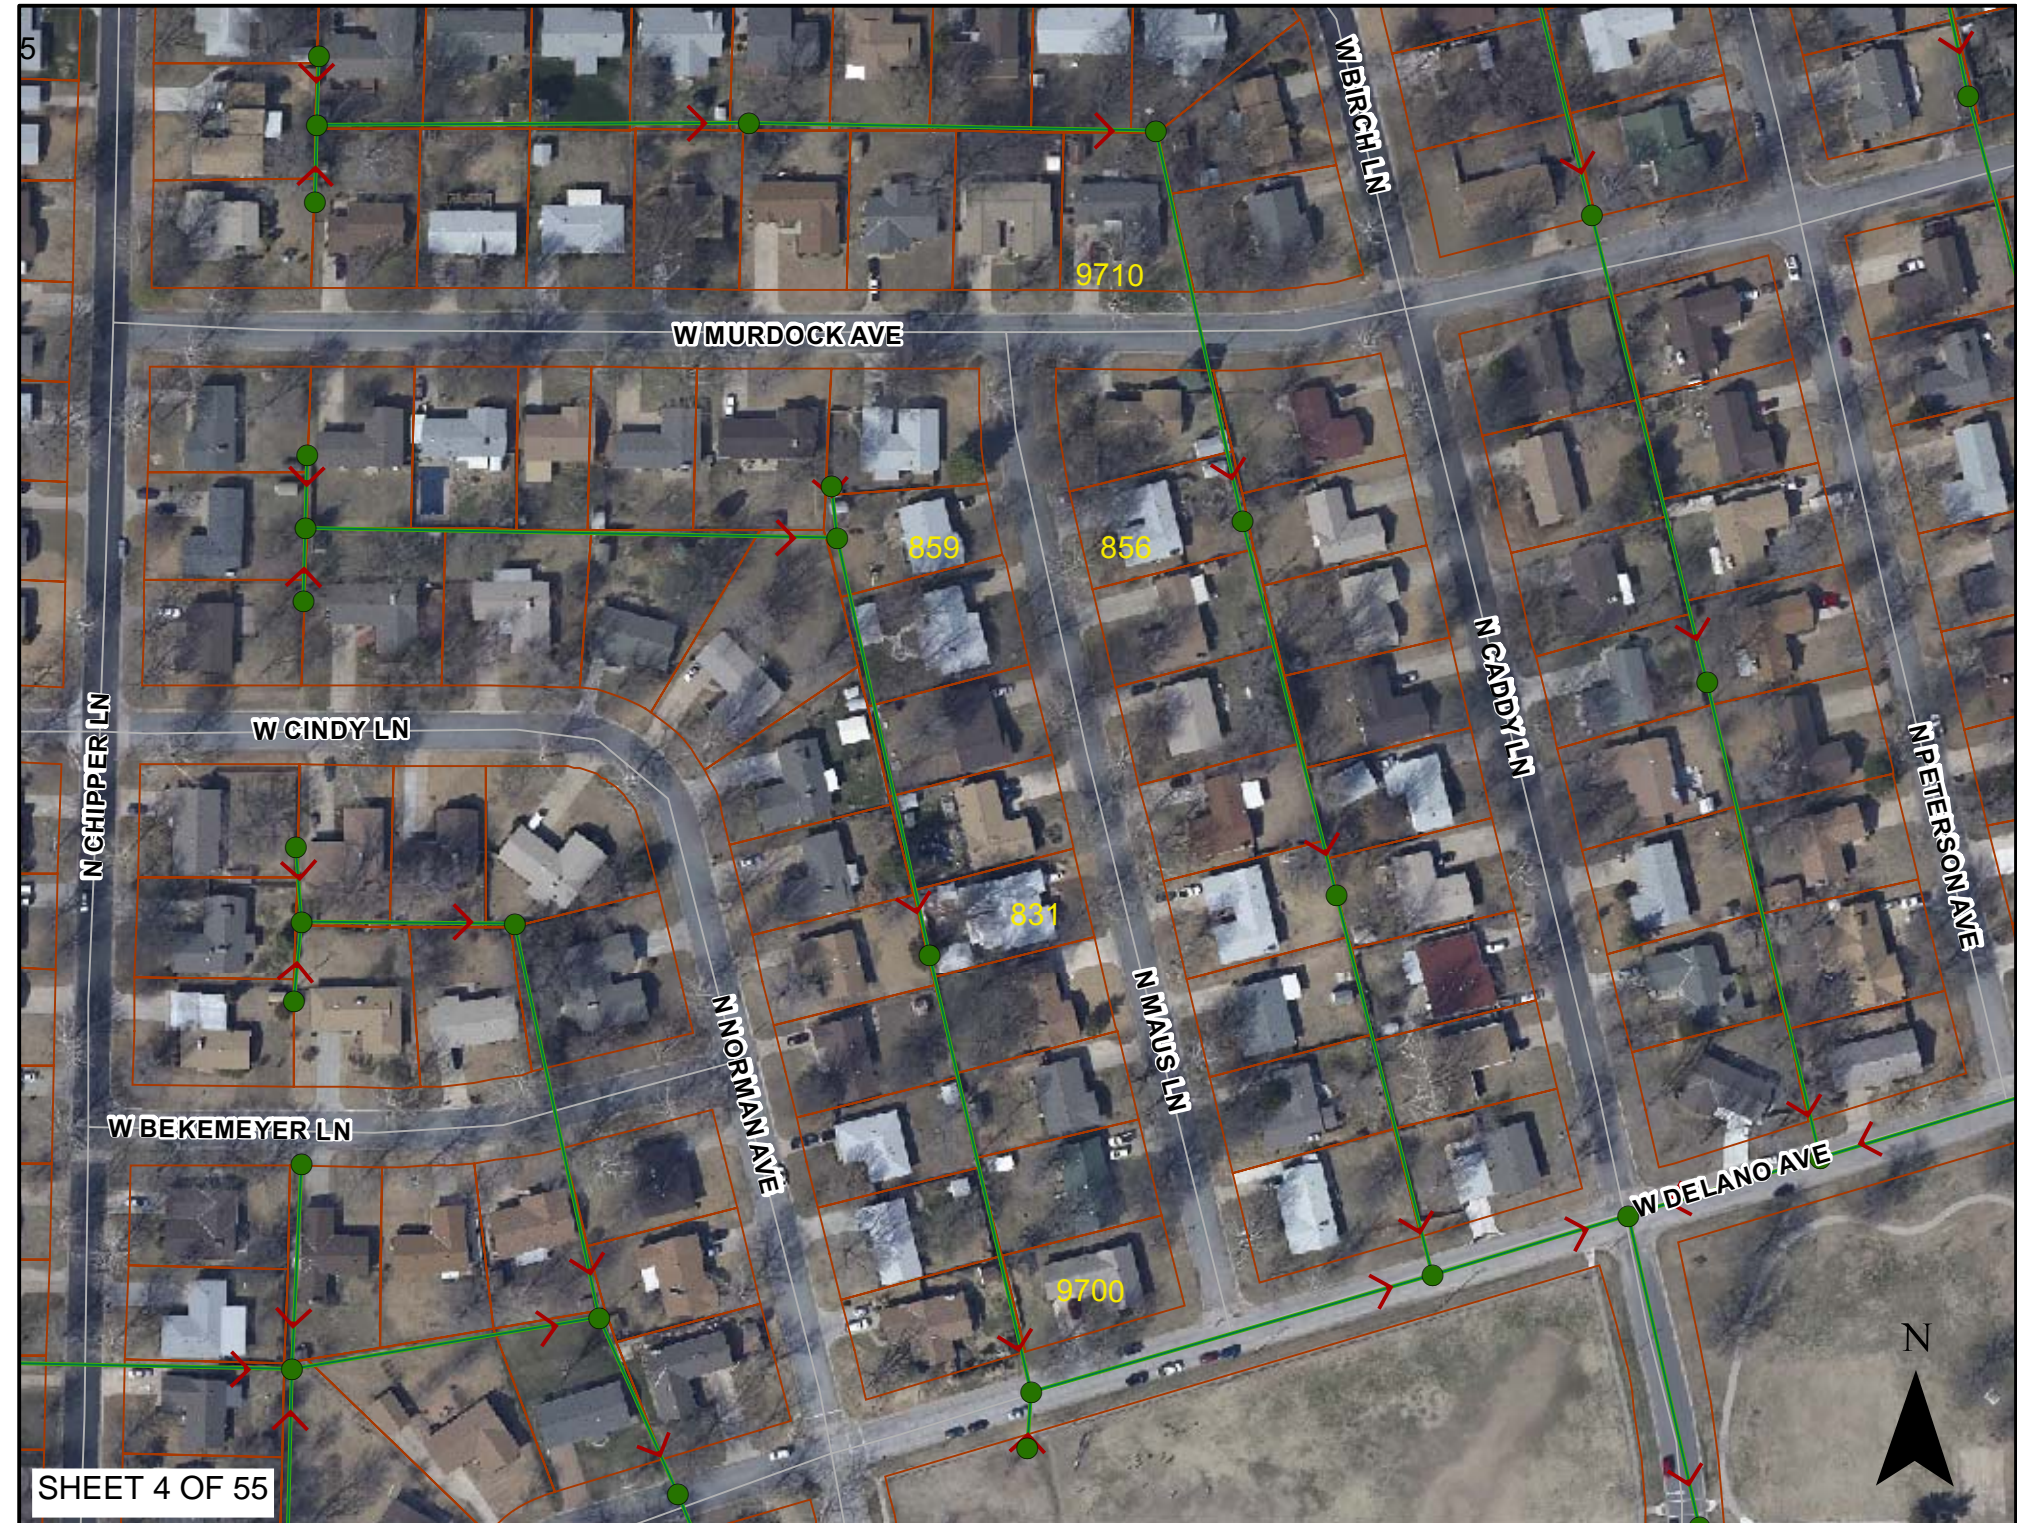
SHEET 3 OF 55

MH # 4848-374
859 N. Maus
Approx depth = 8.4 ft

MH # 4848-373
831 N. Maus
Approx depth = 8.6 ft

MH # 4848-372
Approx depth = 8.1 ft
