SITE 1

PAGE 3 OF 22

Video Inspection Master Report

US Structure: 5747-572 3700 E DOUGLAS AVE Date Insp: 5/16/2012 Basin: EC02A
 DS Structure: 5747-570 3444 E DOUGLAS AVE Dir. Televised: Upstream To Downstream

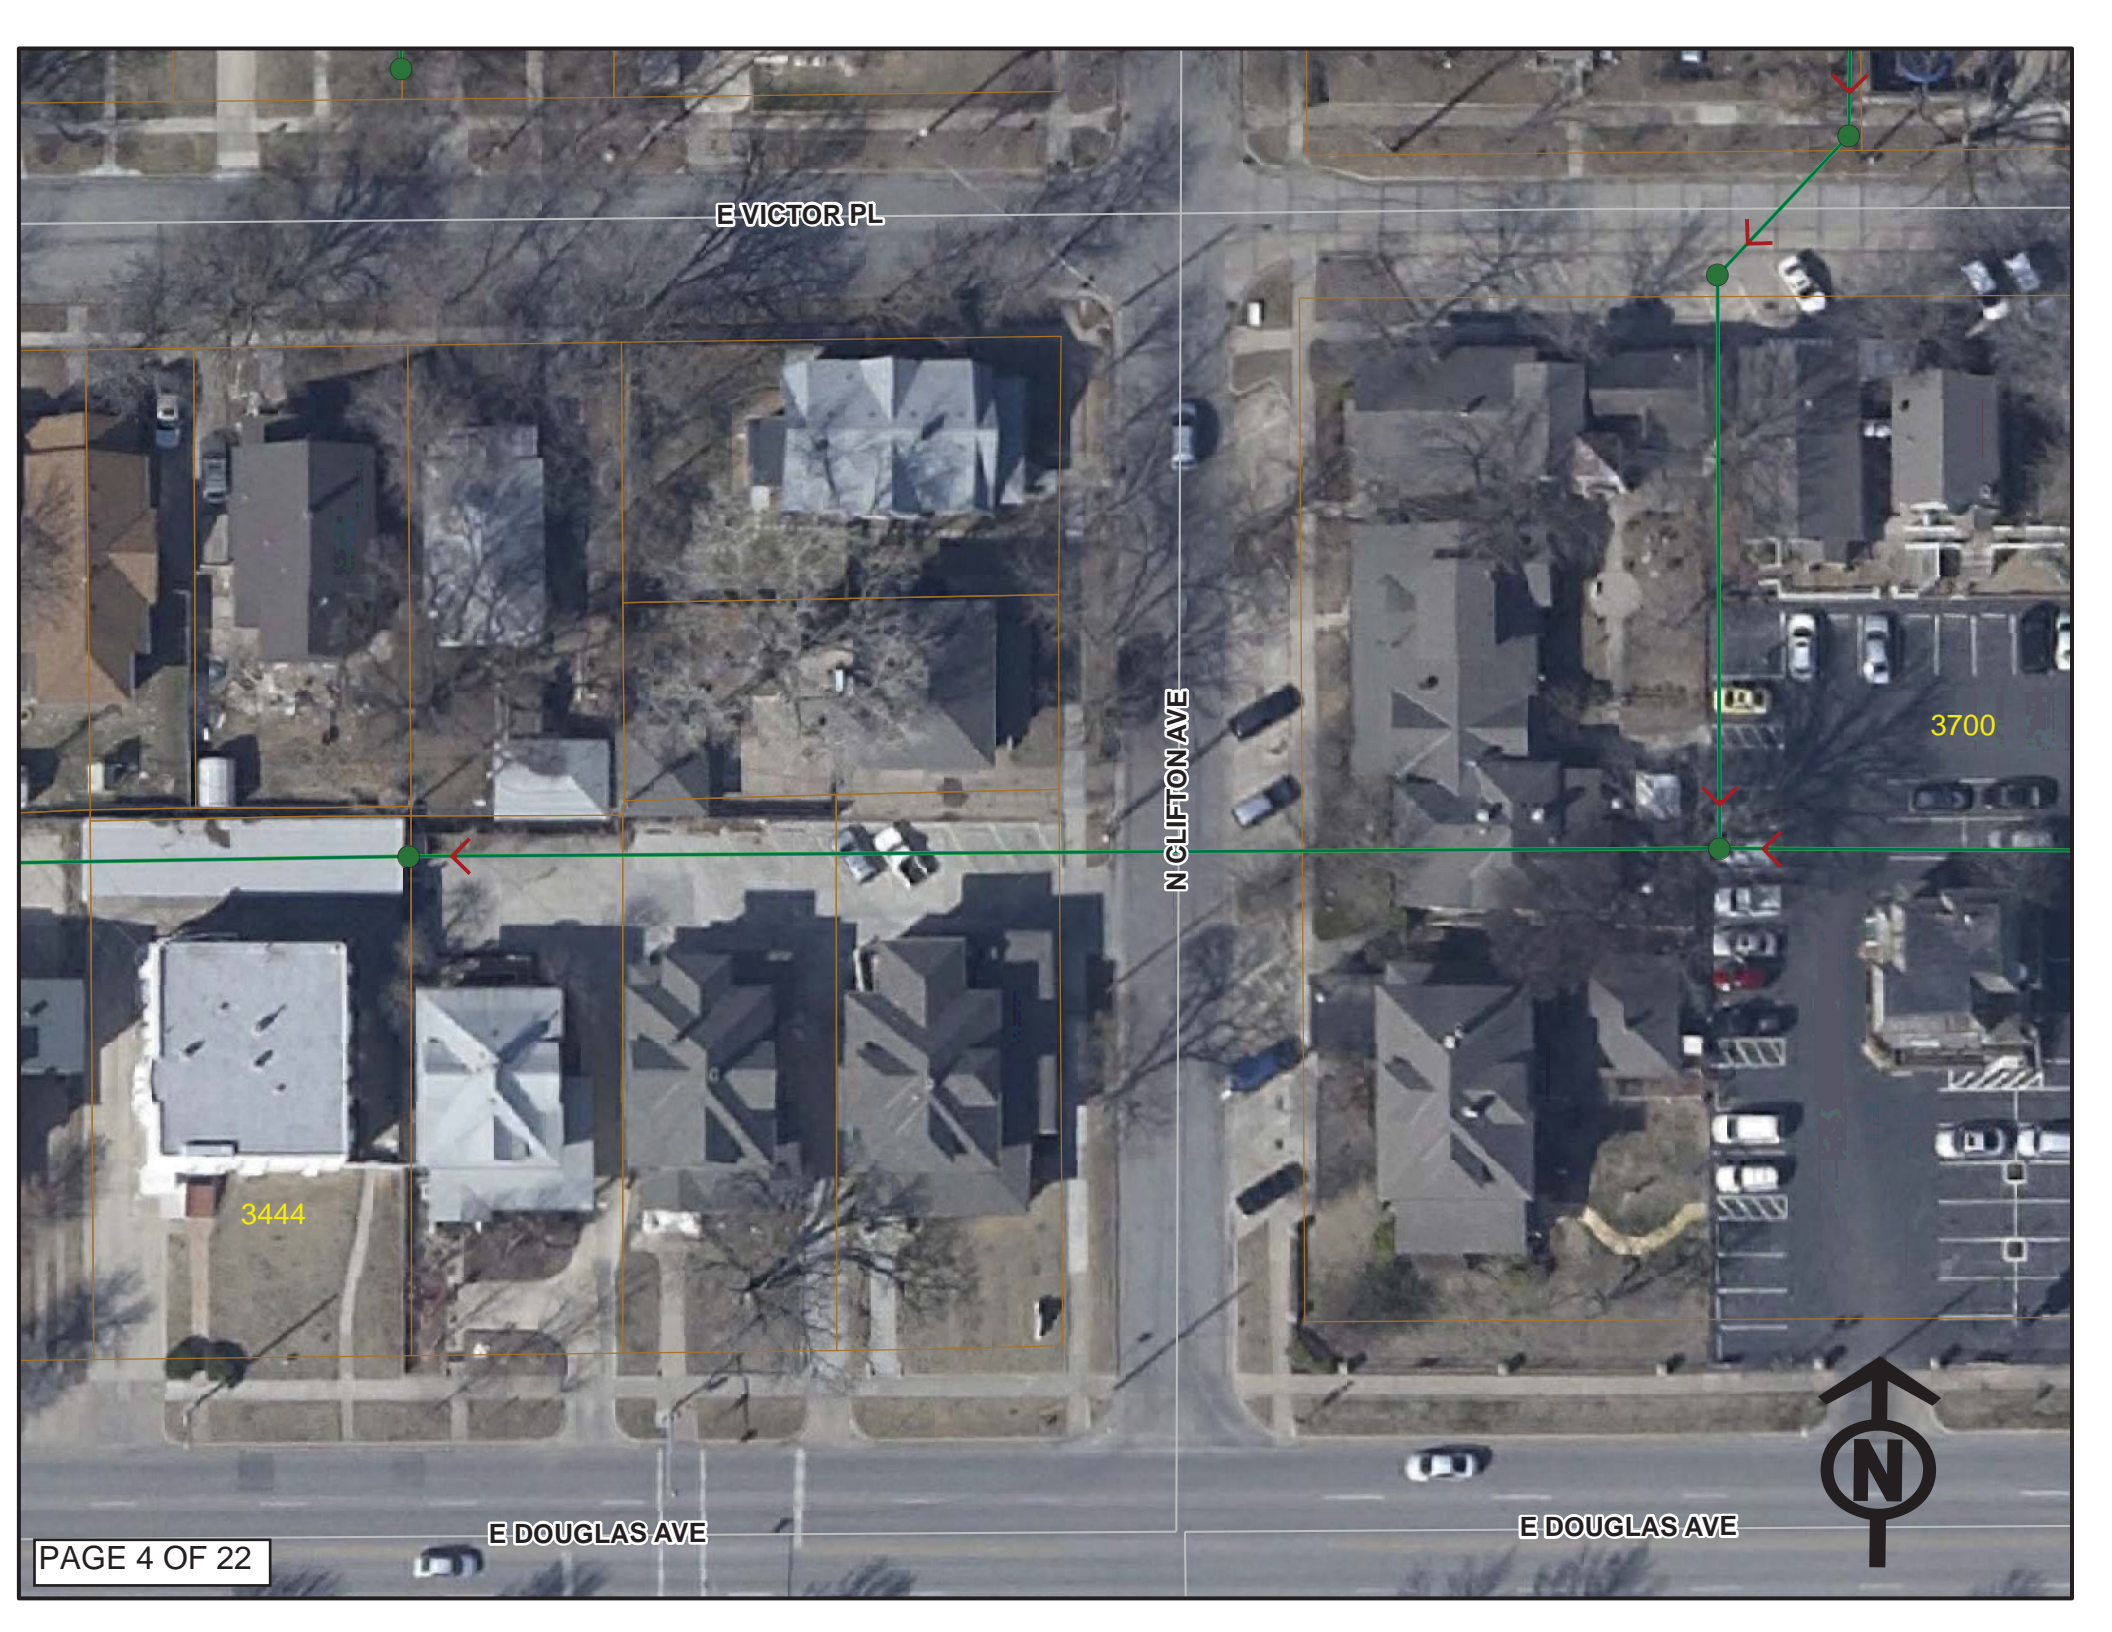
The clay service is on the south side of the main and has broken off, causing a cavity. The main is 8" clay with a cured-in-place liner. A point repair on the 8" main should not be necessary.

MH 5747-570
3444 E. Douglas
(located under the wall of
covered parking stalls)
Approx MH depth = 11.8 ft

MH 5747-572
3700 E. Douglas
(located in asphalt parking lot)
Approx MH depth = 16.2 ft

Service Connection Replaced:
Replace the 4" connection for 3700 E. Douglas,
located at 89 ft. west of MH 5747-572.

Contractors should review the site. The excavation area is not as deep as the upstream manhole. Any damage to the concrete shall be replaced and shall be subsidiary to the repair.

Estimated 22 sy of Erosion Control Mat
Estimated 40 lf of Silt Fence
