Install 754 lf of 8" Cured-in-Place Liner from MH 5747-692 to MH 5747-686

SITE 4

Sheet 14 of 42

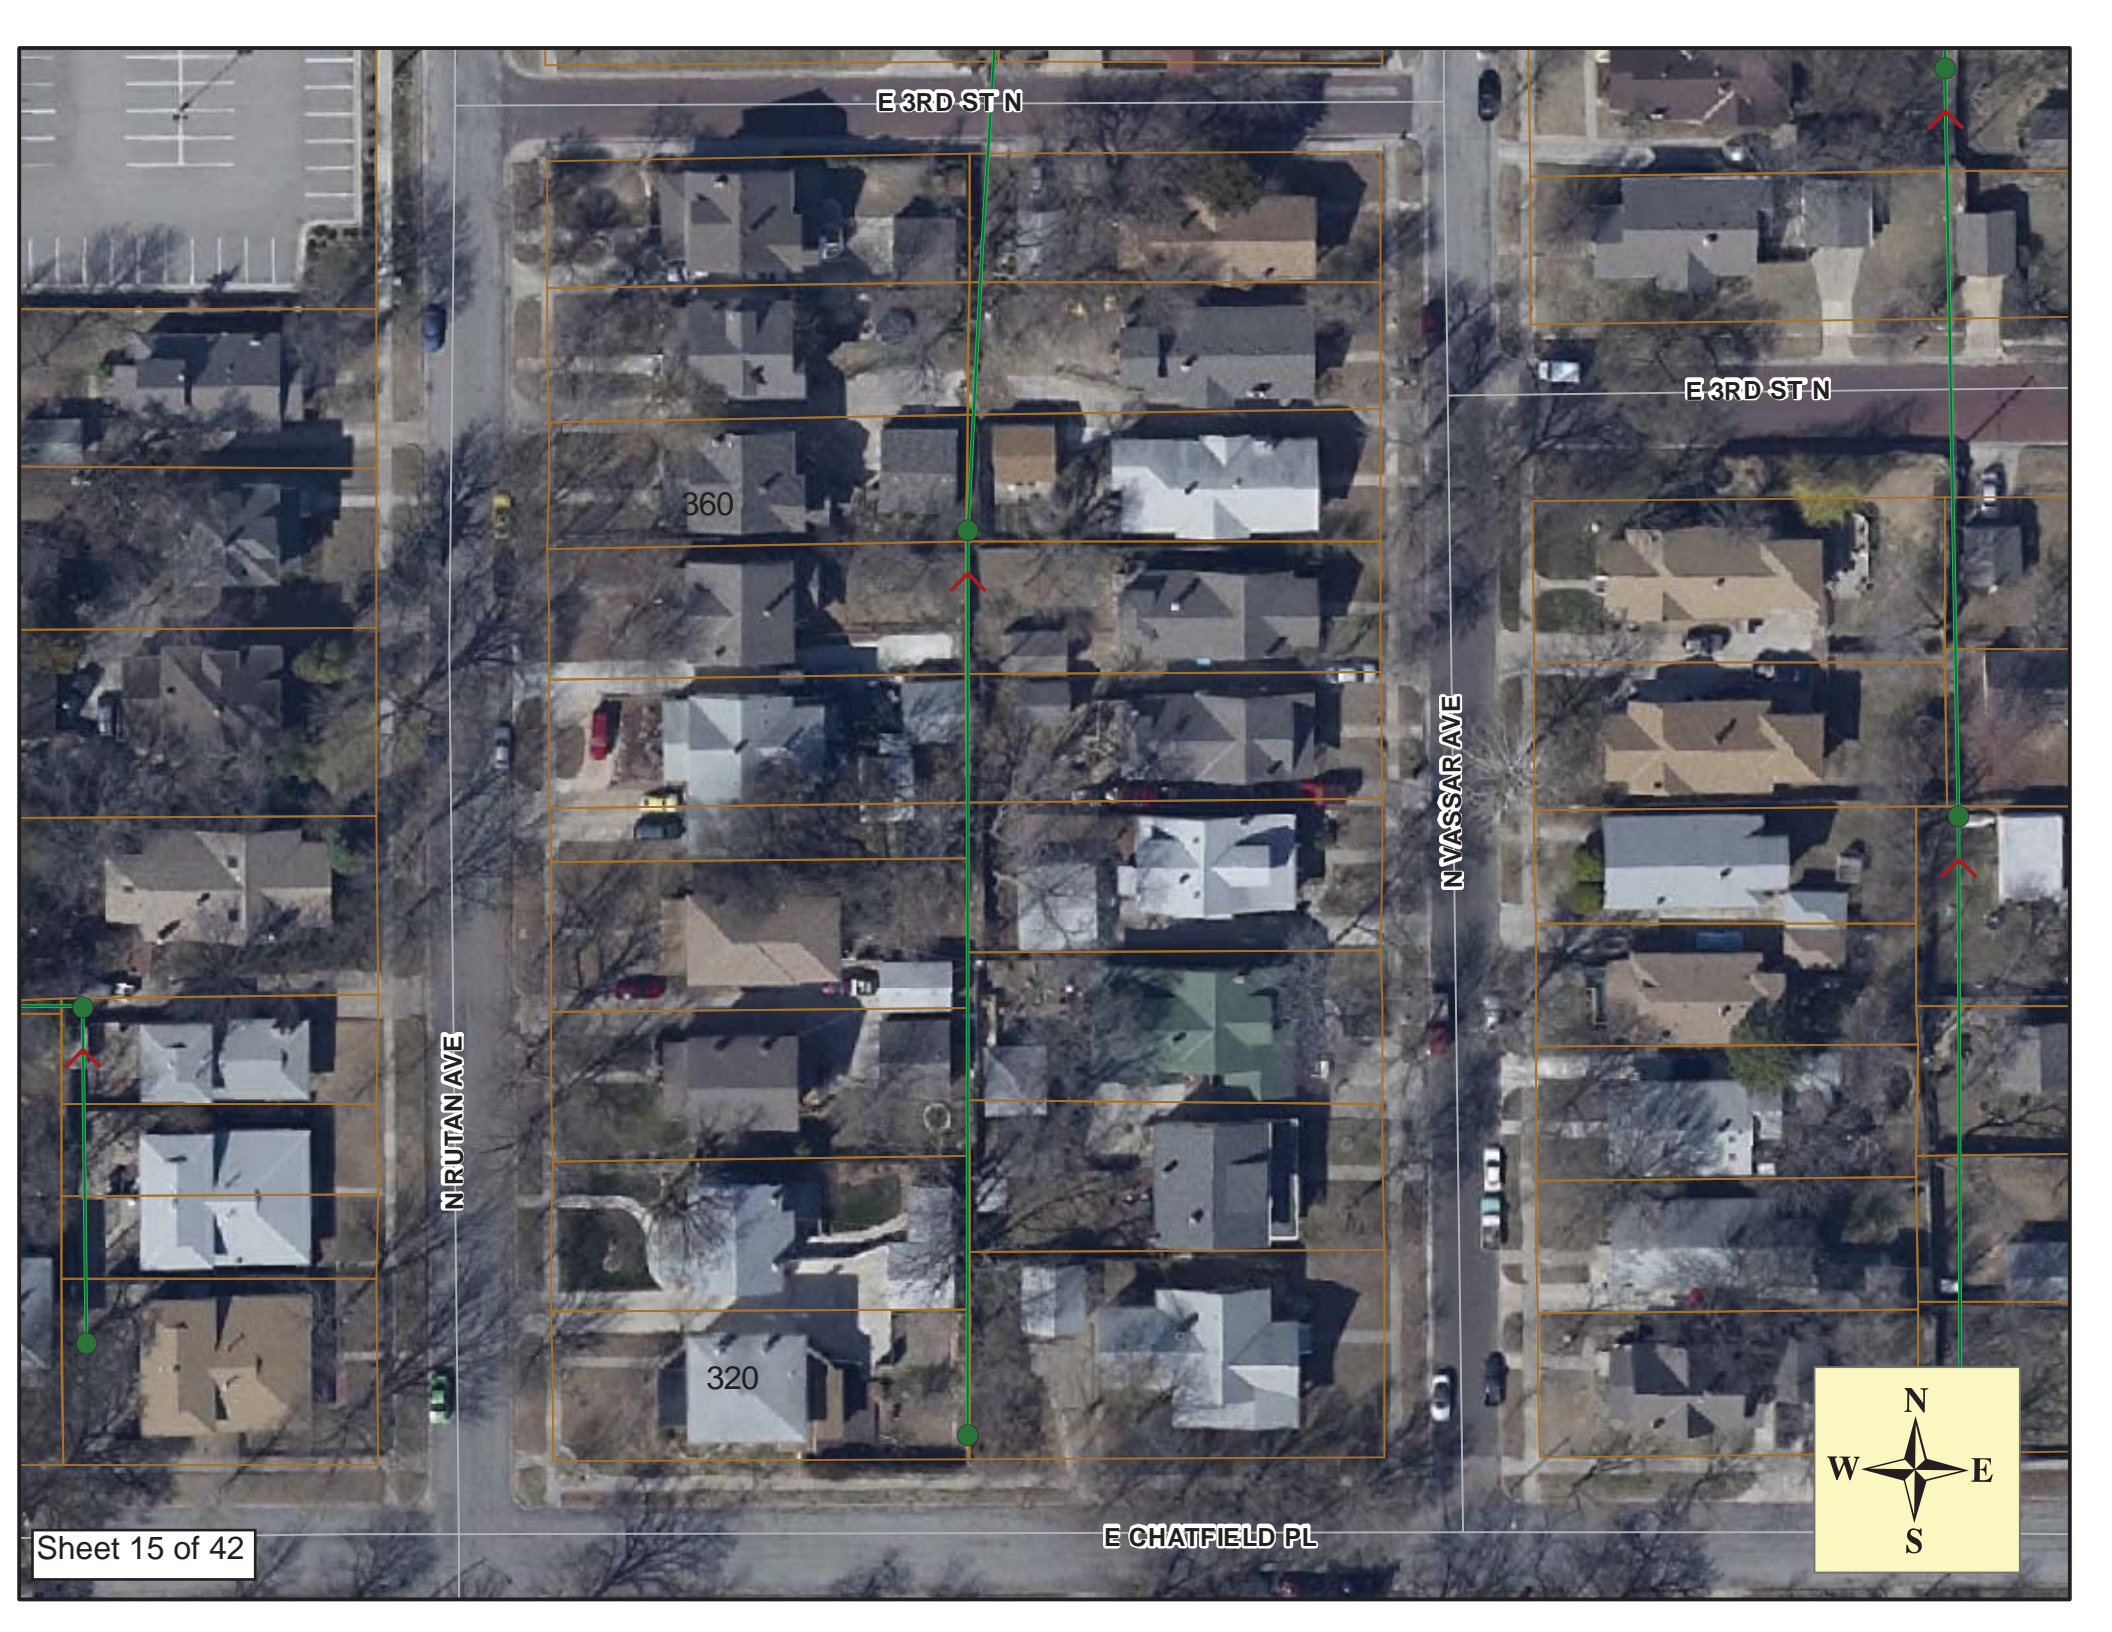
MH 5747-686
On side of hill
Approx depth = 10.0 ft

MH 5747-688
401 N. Vassar
Depth not measured

MH 5747-690
360 N. Rutan
Depth not measured

MH 5747-692
320 N. Rutan
Approx depth = 8.1 ft
