**SITE 4**

# Television Inspection Master Report

US Structure: 5744-244CO      3943 E. Roseberry      Date Insp: 9/30/2008      Basin: C01A  
 DS Structure: 5744-117      3955 E. Roseberry      Dir Televised: Down->Up

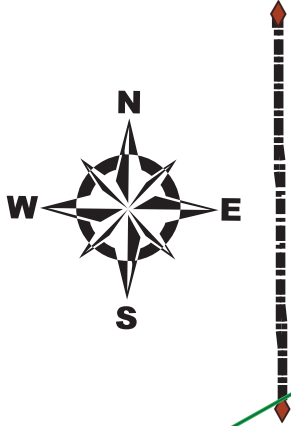
MH 5744-117  
 Replace Manhole Frame & Cover  
 Estimated Pipe Depth (West) = 6 ft  
 Approx MH Depth = 18.8 ft  
 Modify Existing Outside Drop (West)  
 SEE GENERAL NOTES

5744-244CO (cleanout)  
 Construct Shallow Manhole  
 (removal of an existing cleanout  
 shall be incidental)  
 Depth unknown / not found

Remove 85 lf of 6" Pipe  
 Install 85 lf of 8" Pipe

Estimated 5 Service Reconnections (4")  
 Estimated 20 lf Silt Fence
