Install 430 lf of 8" Cured-in-Place Liner:
· 200 lf from MH 5747-062 to MH 5747-046
· 150 lf from MH 5747-046 to MH 5747-045
· 80 lf from MH 5747-045 to MH 5747-044

US Structure: 5747-062 103 N TERRACE ST Date Insp: 3/7/2011 Basin: EC01G
 DS Structure: 5747-046 121 N TERRACE DR Dir Televised: Upstream To Downstream

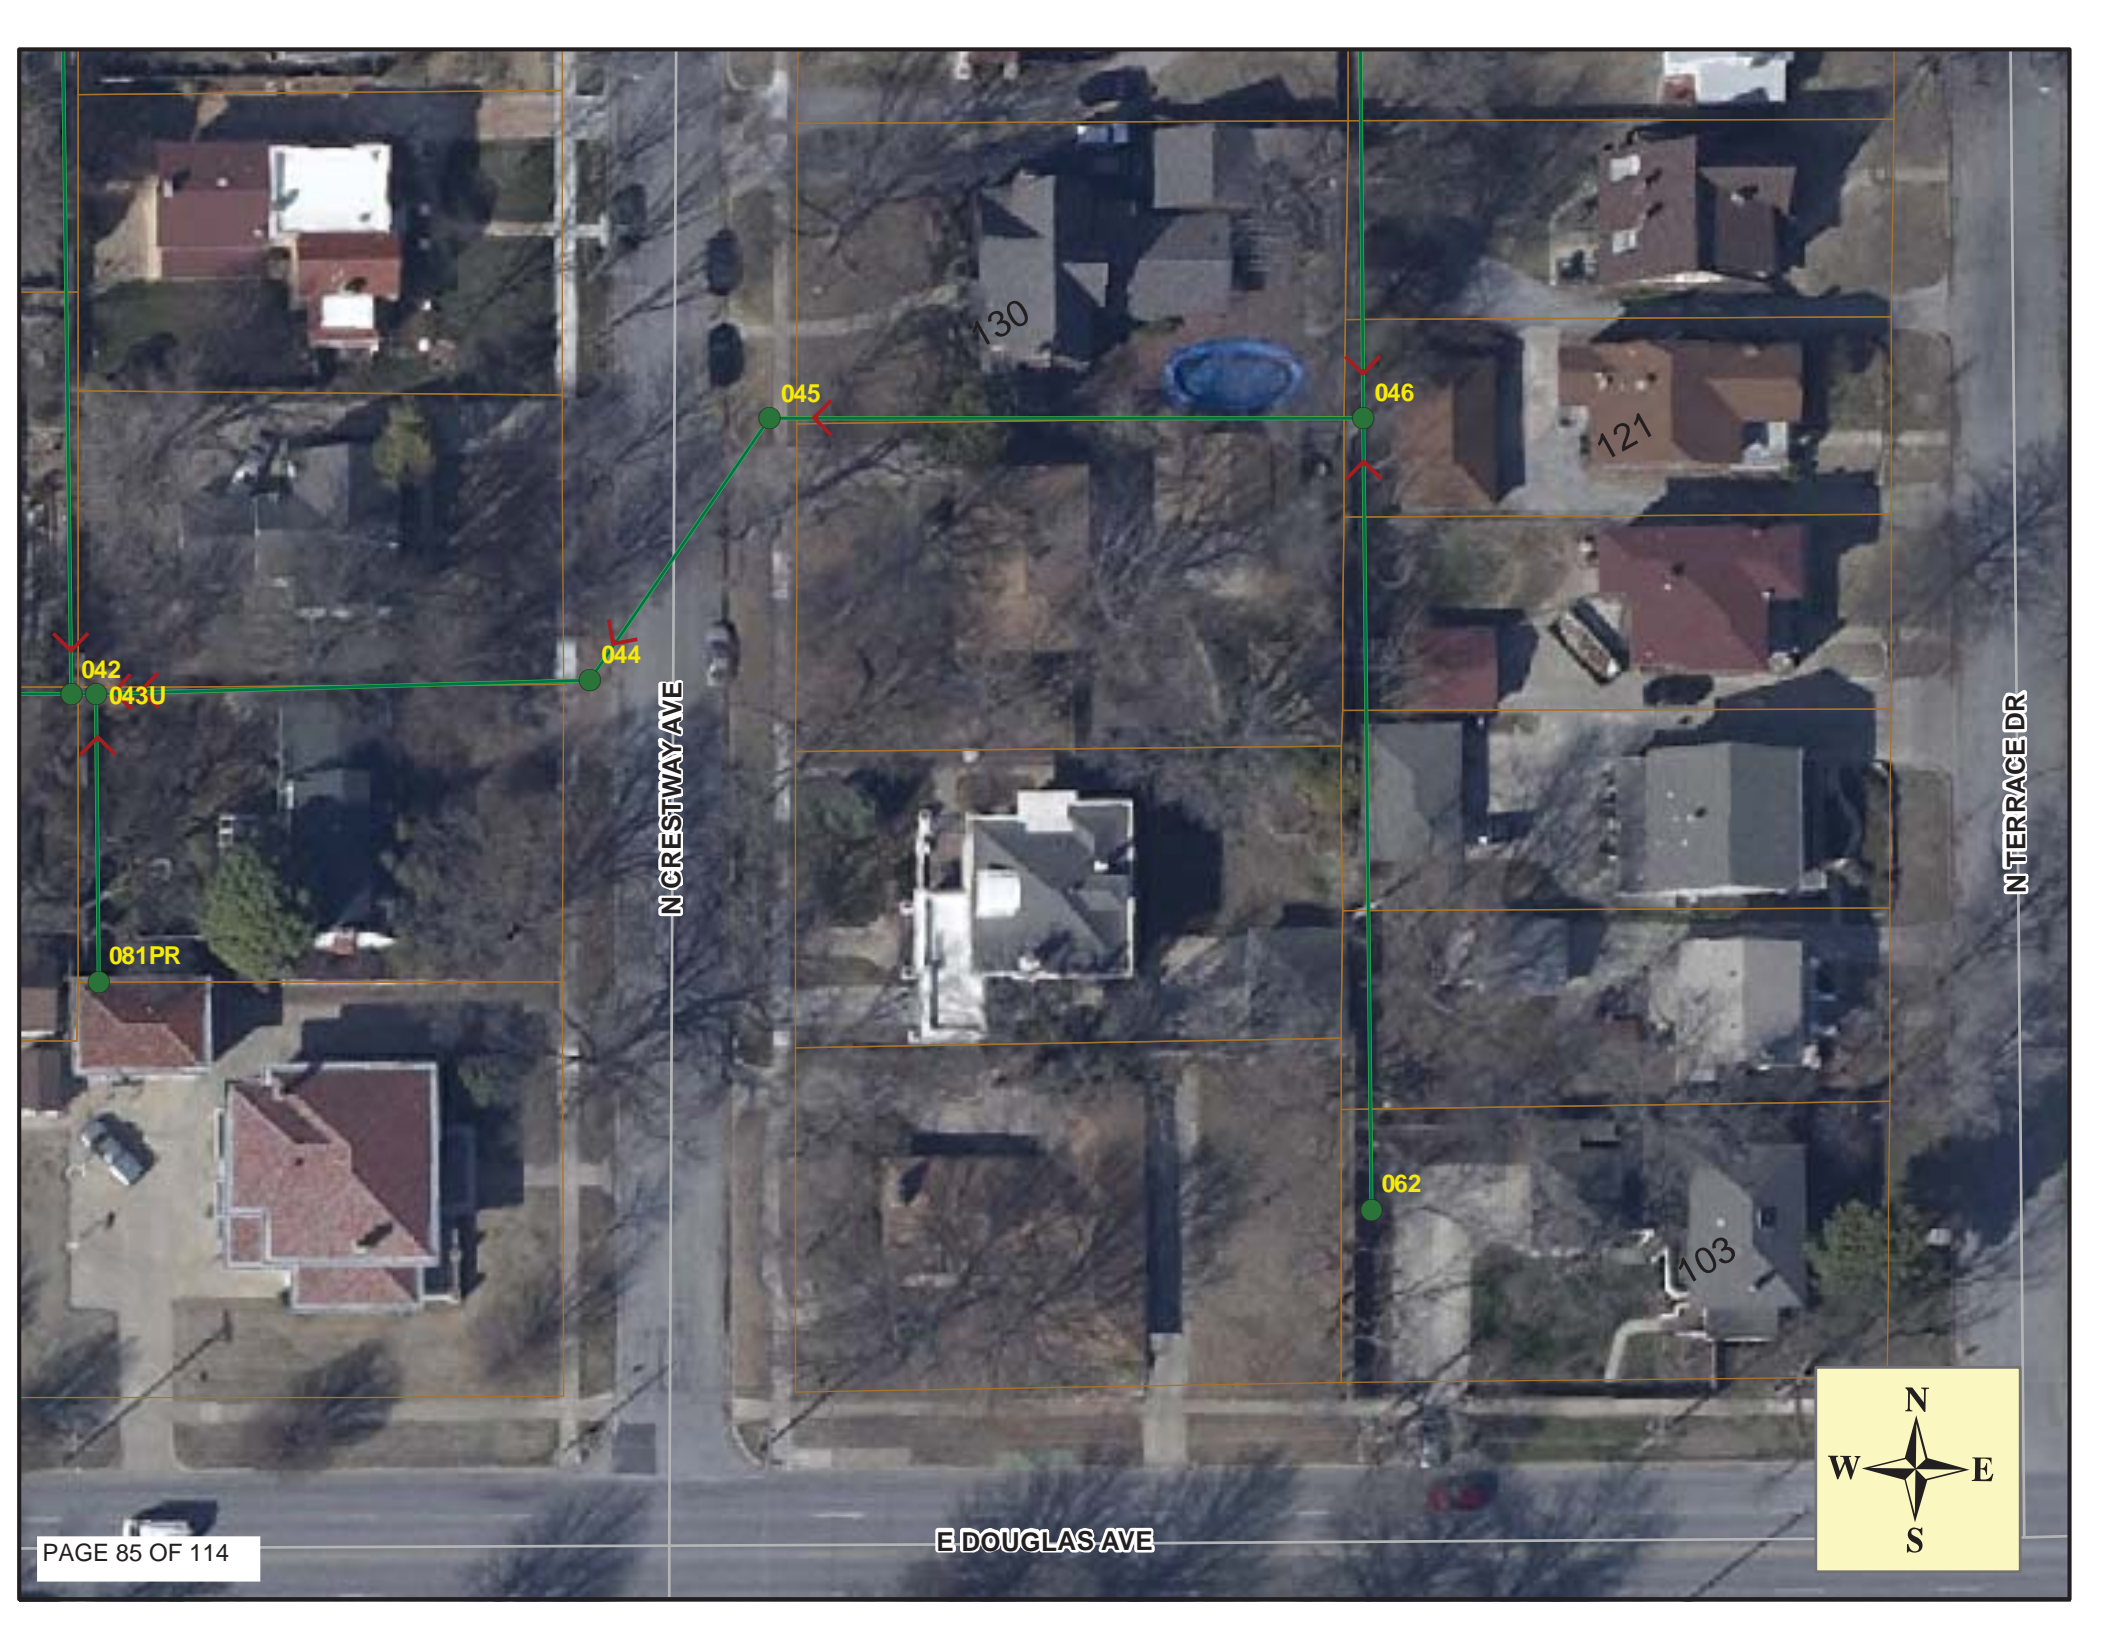
MH 5747-045
130 N. Crestway
Approx depth = 8.2 ft

MH 5747-044
115 N. Crestway
Approx depth = 8.0 ft

MH 5747-042
114 N. Belmont
Approx depth = 11.3 ft

MH 5747-046
121 N. Terrace
Approx depth = 9.0 ft

Underground Union
5747-043U
(no structure)

MH 5747-062
103 N. Terrace
Approx depth = 7.7 ft
