Install 1042 lf of 8" Cured-in-Place Liner

**SITE 7**

City of Wichita  
Sewer Maintenance Division  
715 W. Harry  
Wichita, KS 67213  
(316) 268-4024

# Television Inspection Master Report

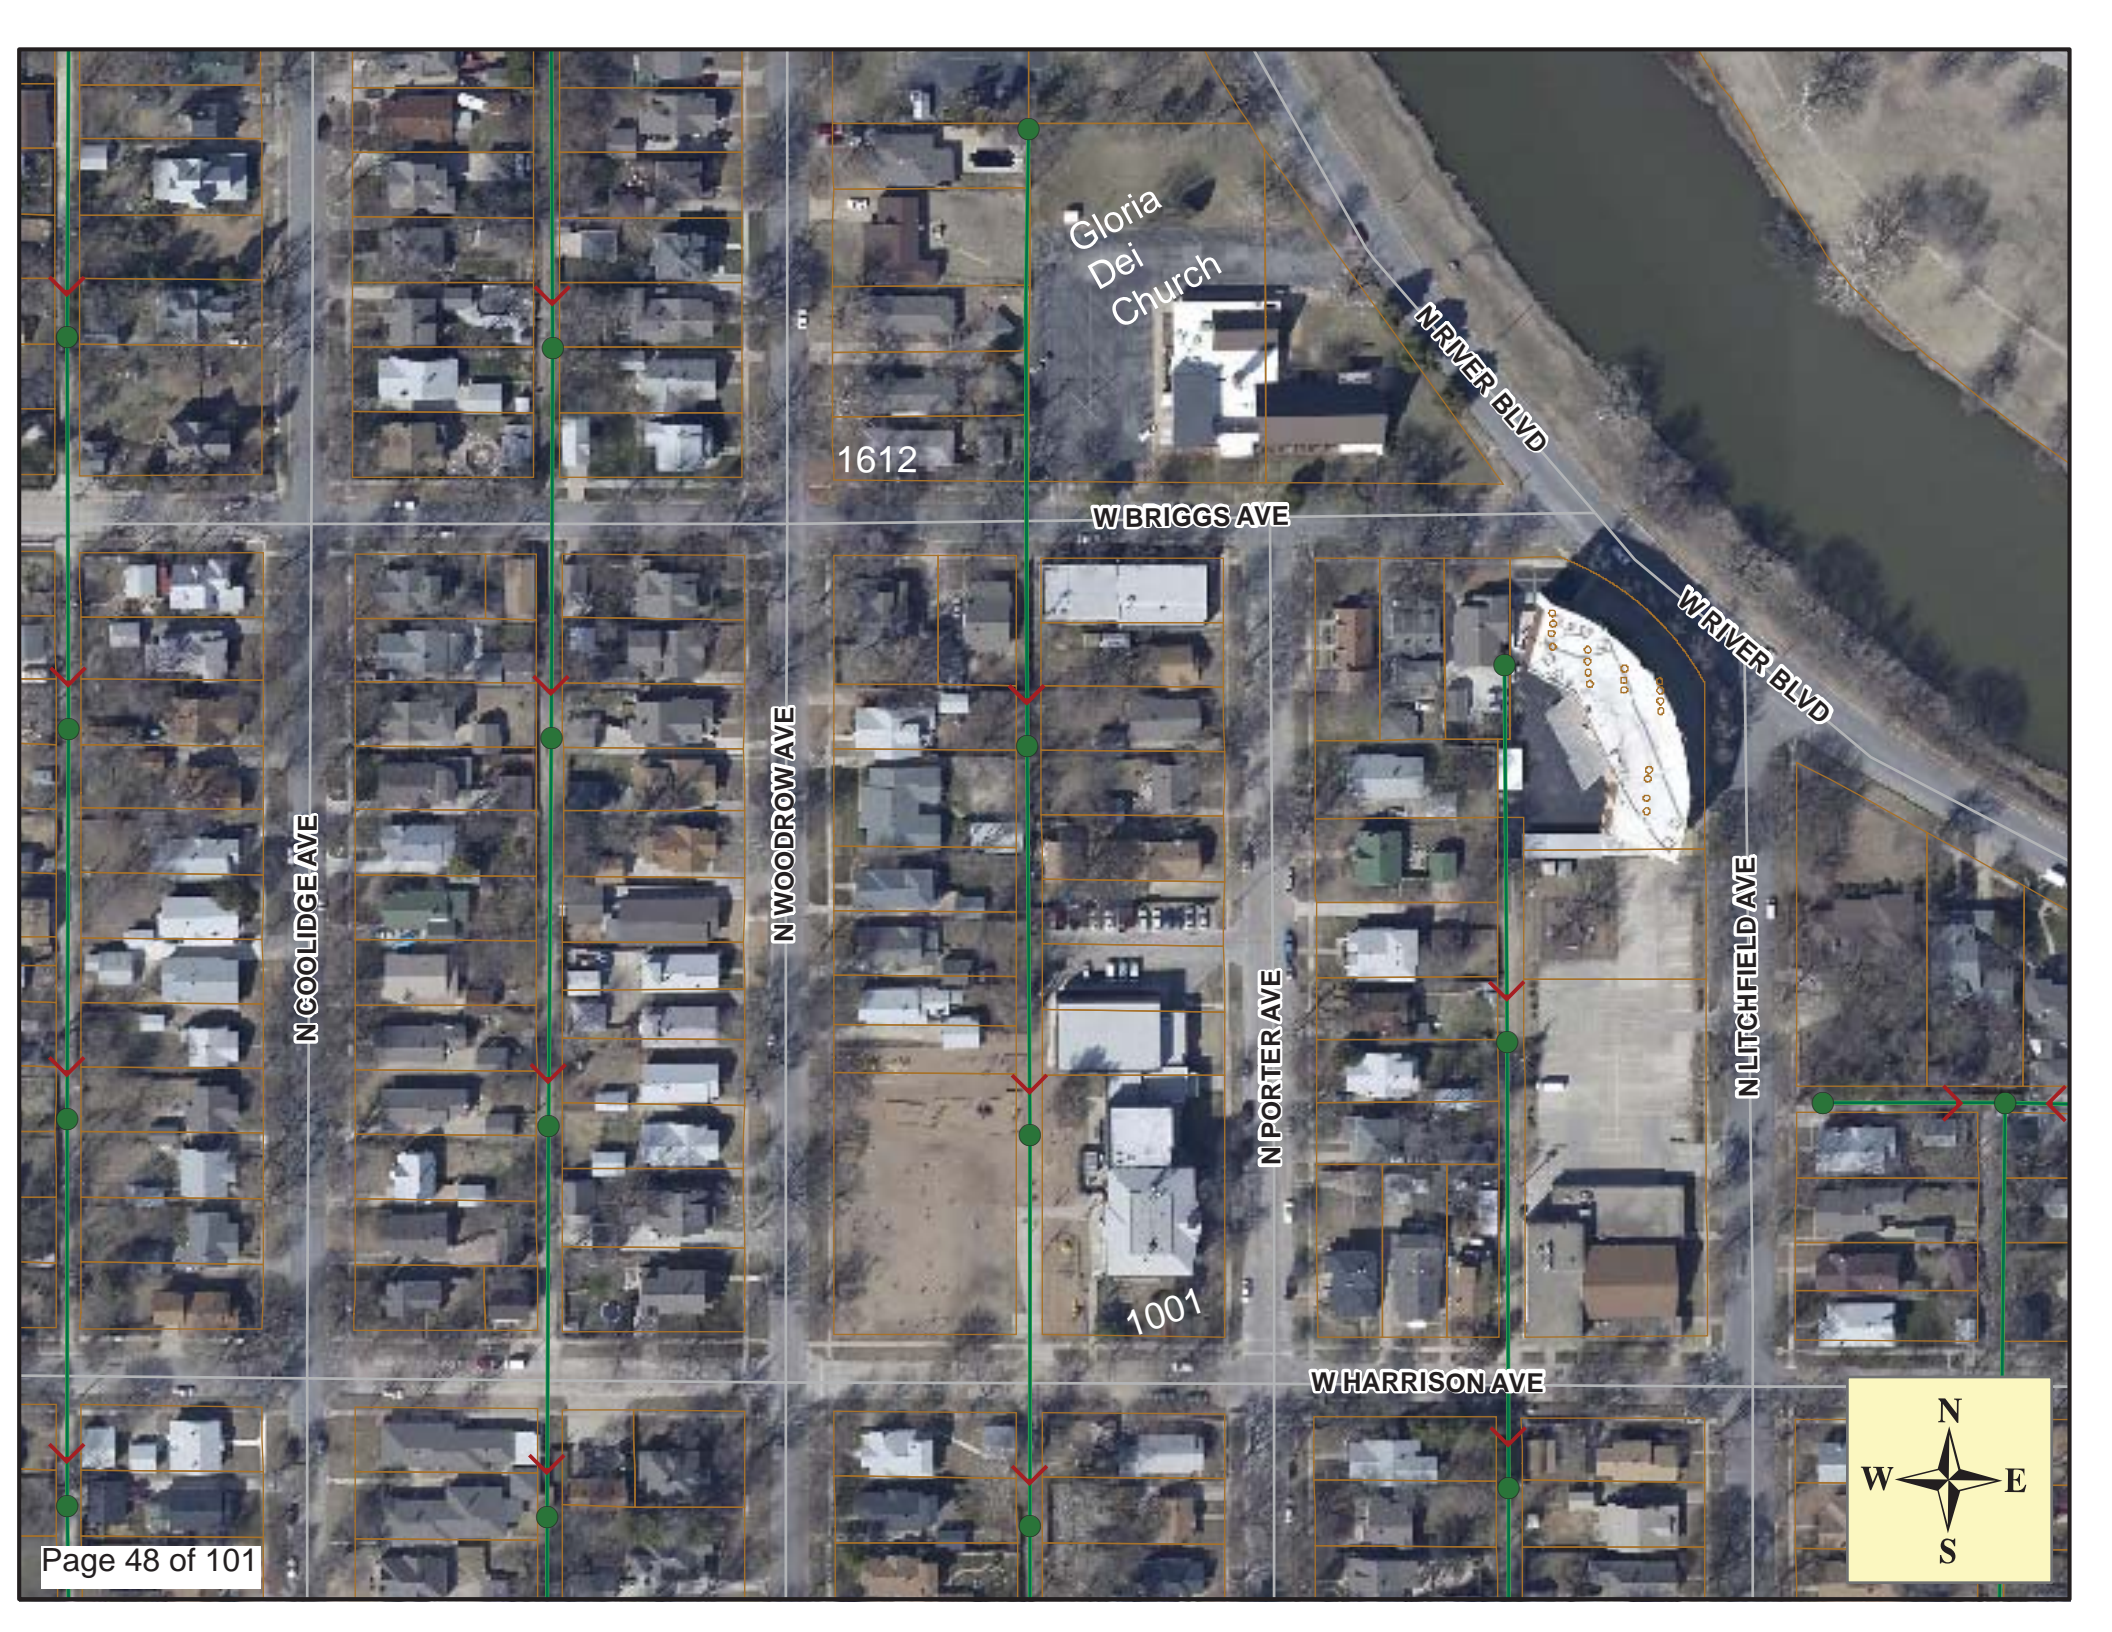
MH 5348-176  
Approx. MH depth = 7.5 ft

MH 5348-172  
Approx. MH depth = 6.8 ft

MH 5348-169  
Depth not measured

MH 5348-166  
Approx. MH depth = 7.0 ft
