Install 887 lf of 8" Cured-in-Place Liner
from MH 5744-390 to MH 5744-381

SITE 12

Video Inspection Master Report

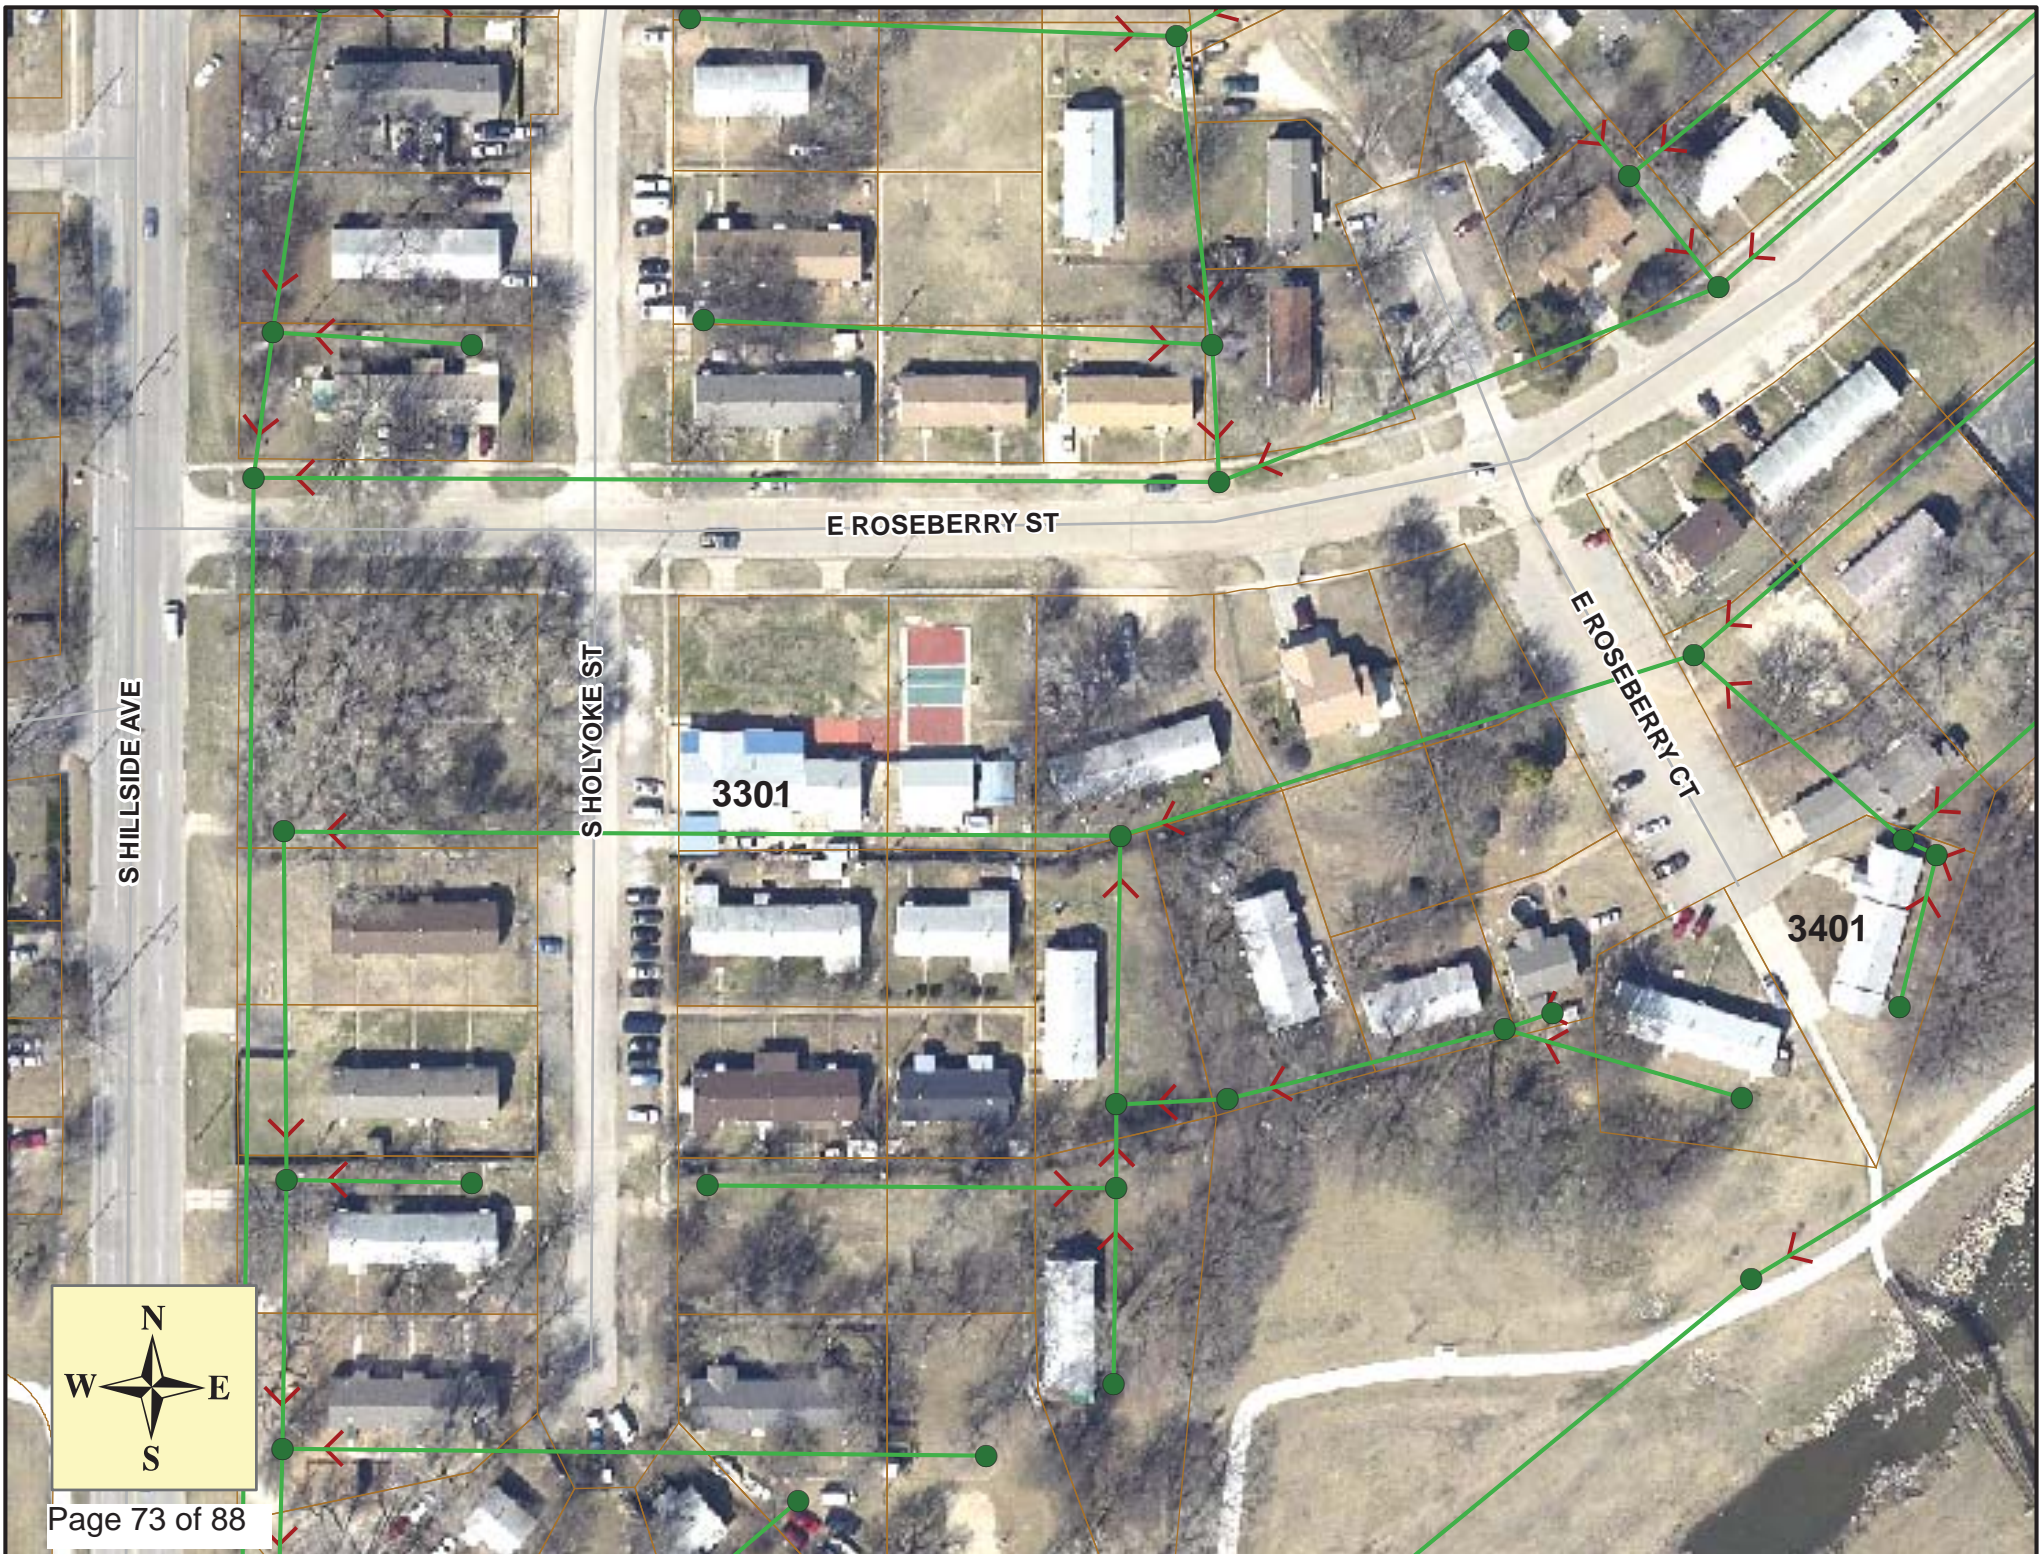
MH 5744-381
Approx MH depth = 9.7 ft

MH 5744-382
Approx MH depth = 10.2 ft

MH 5744-383
Approx MH depth = 10.7 ft

MH 5744-390
3401 Roseberry Ct (church)
Approx MH depth = 10.0 ft

A point repair will be made by Sewer Maintenance to allow for the installation of cured-in-place liner. - Dec 2012 - LML
