**SITE 3**

# Video Inspection Master Report

**SITE 4**

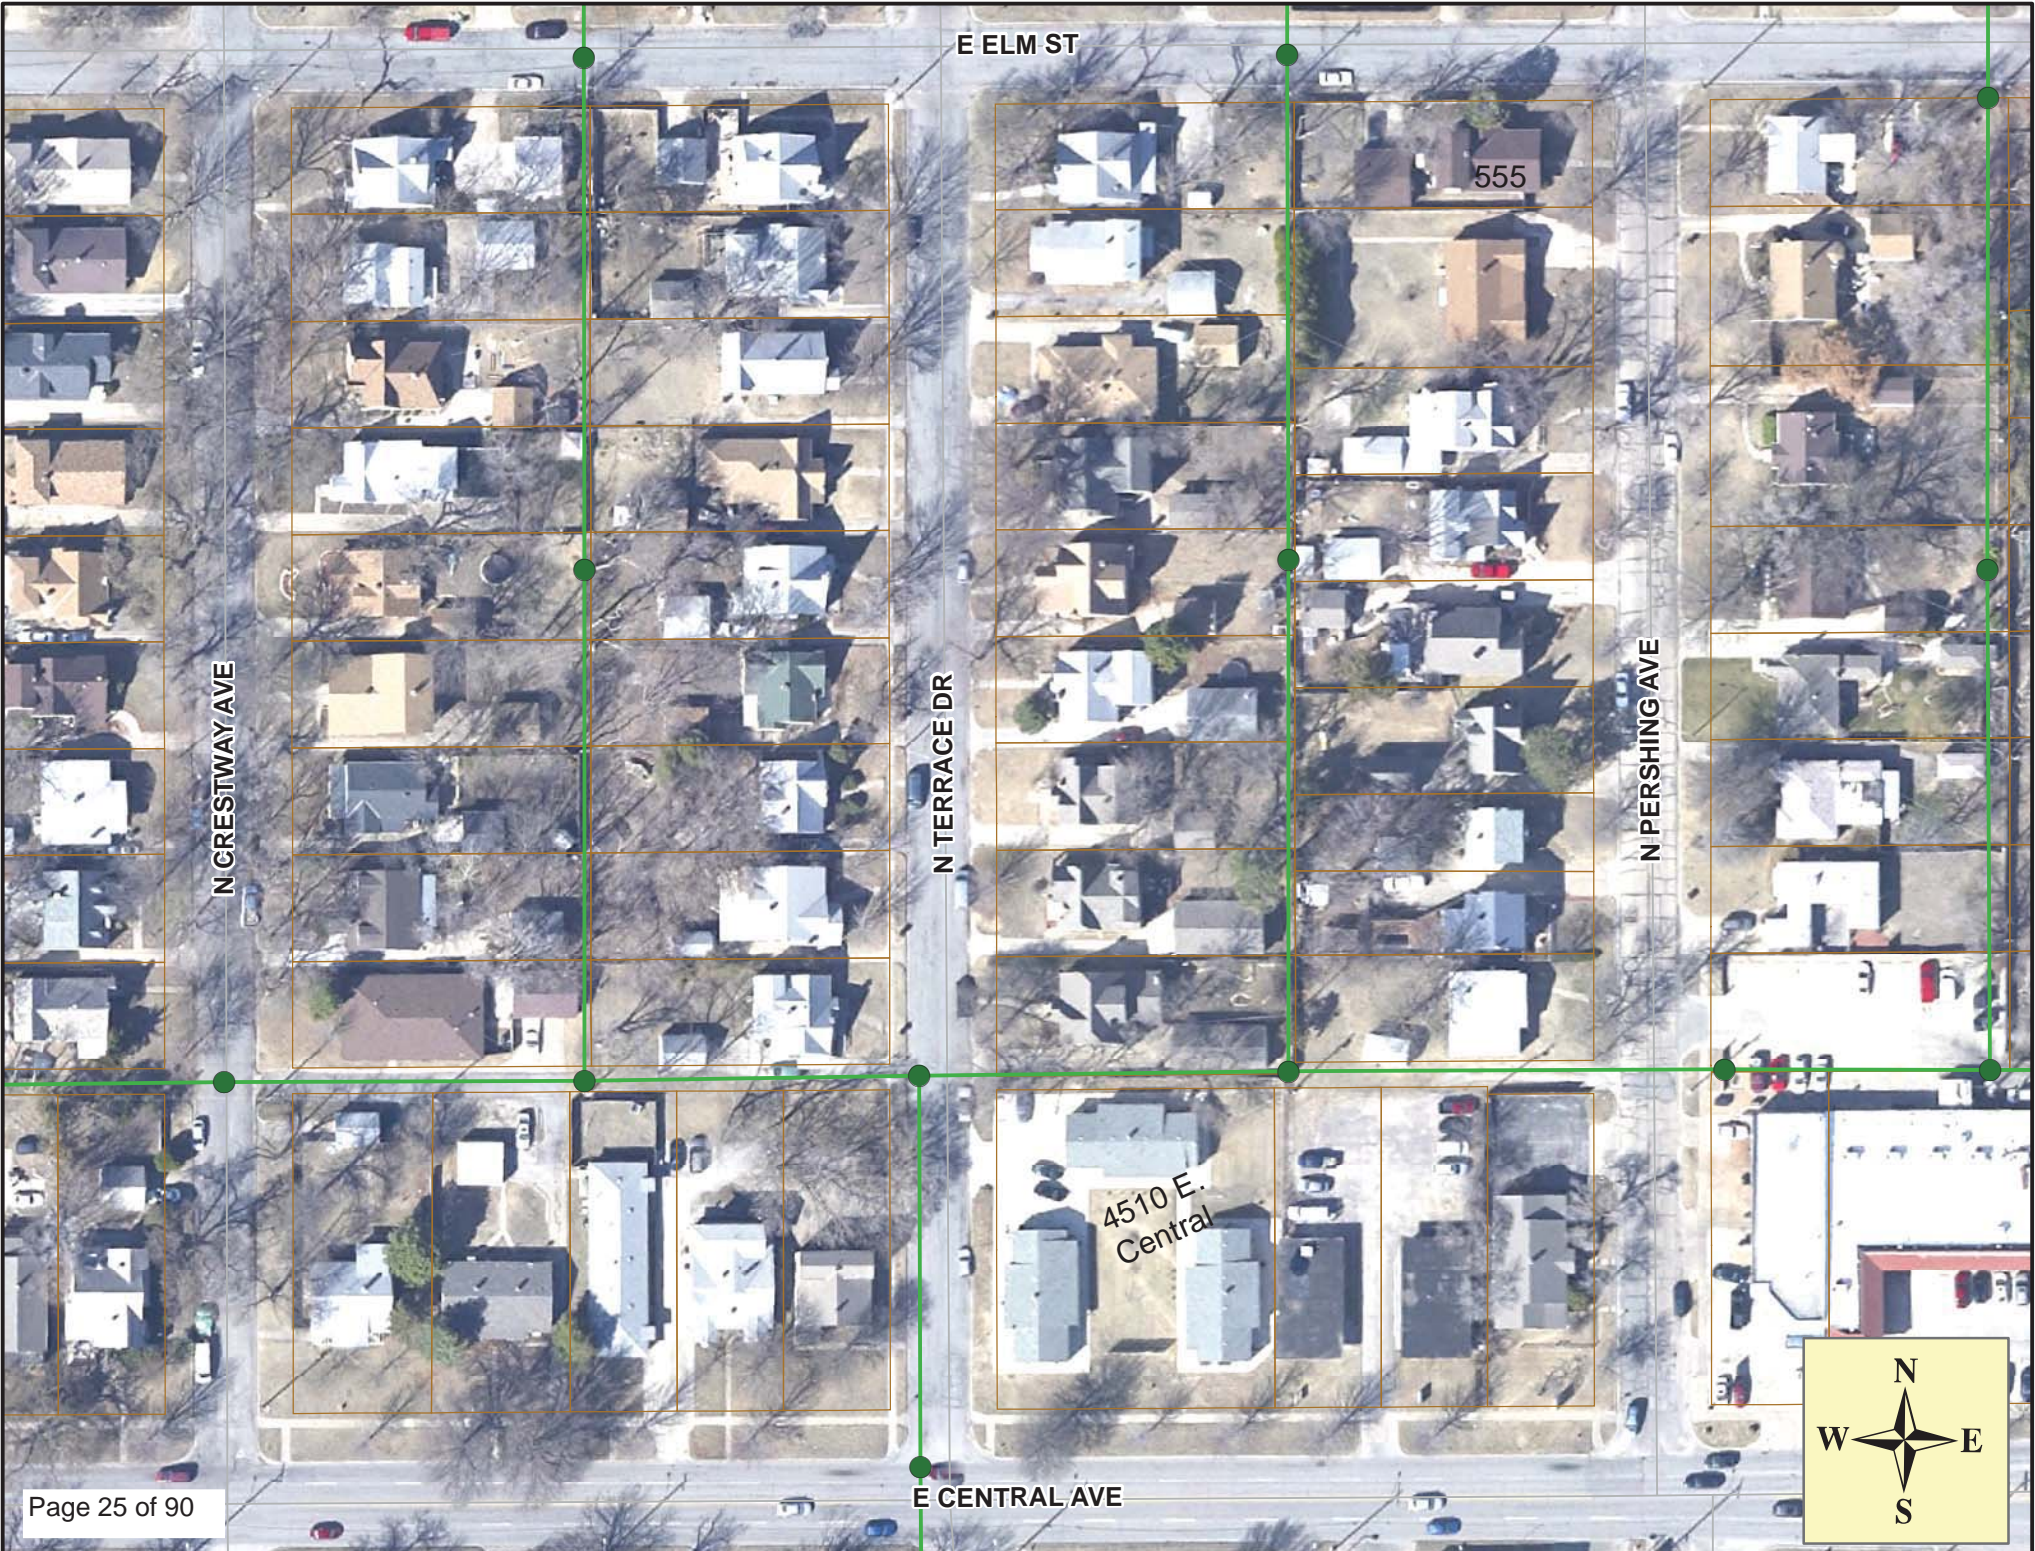
18		144.5		Sealed Off Wye / seal broken / roots entering	5	0.000	0	0	0.000	
19		146.4	525 N PERSHING	Break-In Conn / roots	3	(tap is rough & jagged clay)				
20		168.5	524 N TERRACE	Wye Service	1	0.000	0	0	0.000	
21		171.0		Sealed Off Wye	1	0.000	0	0	0.000	
22		194.8		Sealed Off Wye	1	0.000	0	0	0.000	
23		197.4		Sealed Off Wye	1	0.000	0	0	0.000	
24		221.0	518 N TERRACE	Wye Service / roots	3	0.000	2	0	0.000	
25		223.8		Sealed Off Wye	1	0.000	0	0	0.000	
26		149.4		Sag begins	1	0.000	1	0	0.000	
27		157.0	(water was barely over the camera lens)	Sag ends	1	0.000	1	0	0.000	
29		190.7		Sag begins	1	0.000	1	0	0.000	
30		201.1	(water was barely over the camera lens)	Sag ends	4	0.000	10	0	0.000	
31		201.1		Sag begins	4	0.000	10	0	0.000	
33		209.4	(water was barely over the camera lens)	Sag ends	1	0.000	1	0	0.000	
34		242.9		DS Manhole 5748-352	1	(small inside drop at manhole)

Obs. #	VTR Counter	Distance	Location	Description	Rating	Obsrvd (gpm)	Ratings			Remain (gpm)
							Est. (gpm)	Struct	Clean	
1		0.0		5748-354 DS Manhole	TV AGAINST THE FLOW					
2		16.4		Roots	3	0.008	5	8	0.008	
3		18.4	510 NORTH CRESTWAY	Wye Service	4	(service has heavy roots that hang into main)				
4		21.2		Sealed Off Wye	1	0.000	0	0	0.000	
5		31.5		Crack-Horizontal	2	0.002	2	0	0.002	
6		44.1		Sealed Off Wye	1	0.000	0	0	0.000	
7		46.8		Sealed Off Wye	1	0.000	0	0	0.000	
8		49.9		Crack-Radial	3	0.004	5	0	0.004	
9		51.2		Crack-Horizontal	3	0.004	5	0	0.004	
10		63.1		Roots	3	0.008	5	8	0.008	
11		64.5	522 NORTH CRESTWAY	Break-In Conn	3	(roots inside)				
12		64.5		Hole in side of pipe / Broken Pipe	3	0.010	60	0	0.010	
13		67.5		Sealed Off Wye	1	0.000	0	0	0.000	
14		70.3		Sealed Off Wye	1	0.000	0	0	0.000	
15		94.0	522 NORTH CRESTWAY	Break-In Conn	1	(PVC service inside of old VCP tap)				
16		96.3	529 NORTH TERRACE	Break-In Conn	4	(roots inside)

17		119.5		Sealed Off Wye	1	0.000	0	0	0.000	
18		122.0		Sealed Off Wye	1	0.000	0	0	0.000	
19		125.0		Crack-Horizontal	4	0.008	10	0	0.008	
20		127.6	531 NORTH TERRACE	Break-In Conn	1	(tap in very poor condition)				
21		142.4		Broken Pipe	3	0.010	60	0	0.010	
22		145.5	528 NORTH CRESTWAY	Break-In Conn	1	(poor condition)				
23		147.3		Sealed Off Wye	1	0.000	0	0	0.000	
24		170.8		Sealed Off Wye	1	0.000	0	0	0.000	
25		173.0	537 NORTH TERRACE	Break-In Conn	4	(poor condition)				
26		184.3	532-34 NORTH CRESTWAY	Break-In Conn	4	(poor condition)				
27		196.6		Sealed Off Wye	1	0.000	0	0	0.000	
28		199.4	537 NORTH TERRACE	PVC Break-In Conn	1	0.001	0	0	0.001	
29		222.0		Sealed Off Wye	1	0.000	0	0	0.000	
30		224.8		Sealed Off Wye	1	0.000	0	0	0.000	
31		240.7		5748-370 US Manhole	1	0.000	0	0	0.000

Roots at joints not called out on the log. Taps are in poor condition. Line has a maintenance history. -LML
