Install 341 lf of 8" Cured-in-Place Liner  
from MH 5445-271 to MH 5445-186

**SITE 3**

# Video Inspection Master Report

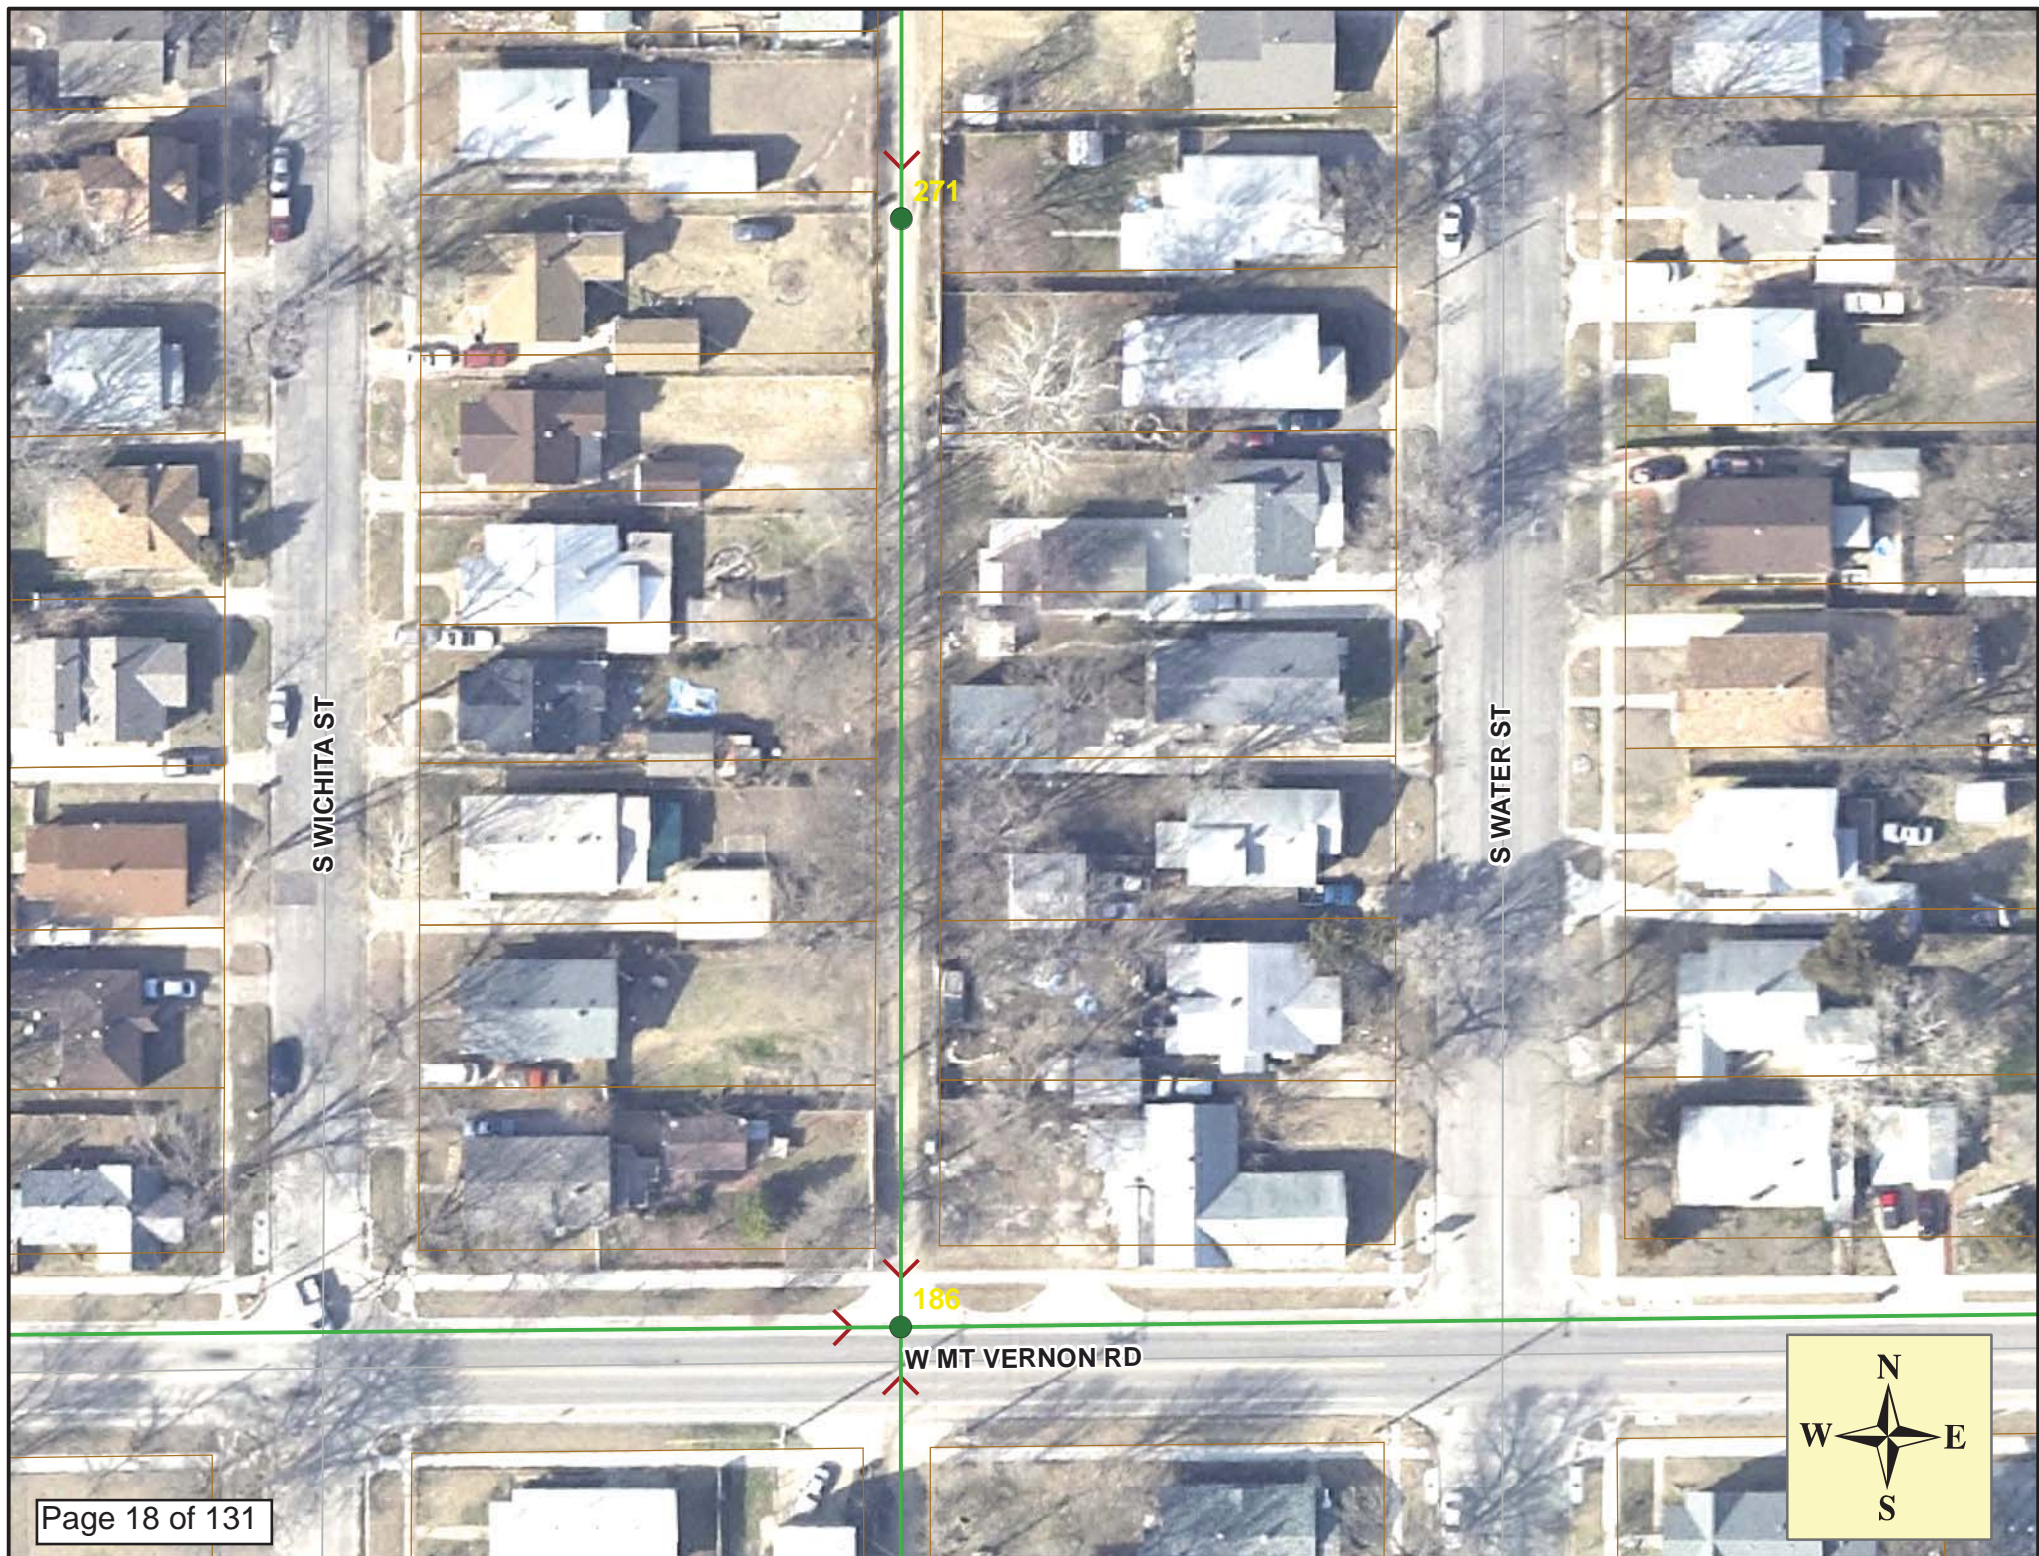
MH 5445-271  
Approx MH depth = 7.7 ft

MH 5445-186  
Approx MH depth = 6.7 ft
