Install 770 lf of 8" Cured-in-Place Liner from MH 5646-117 to MH 5646-112

SITE 5

Video Inspection Master Report

SITE 6

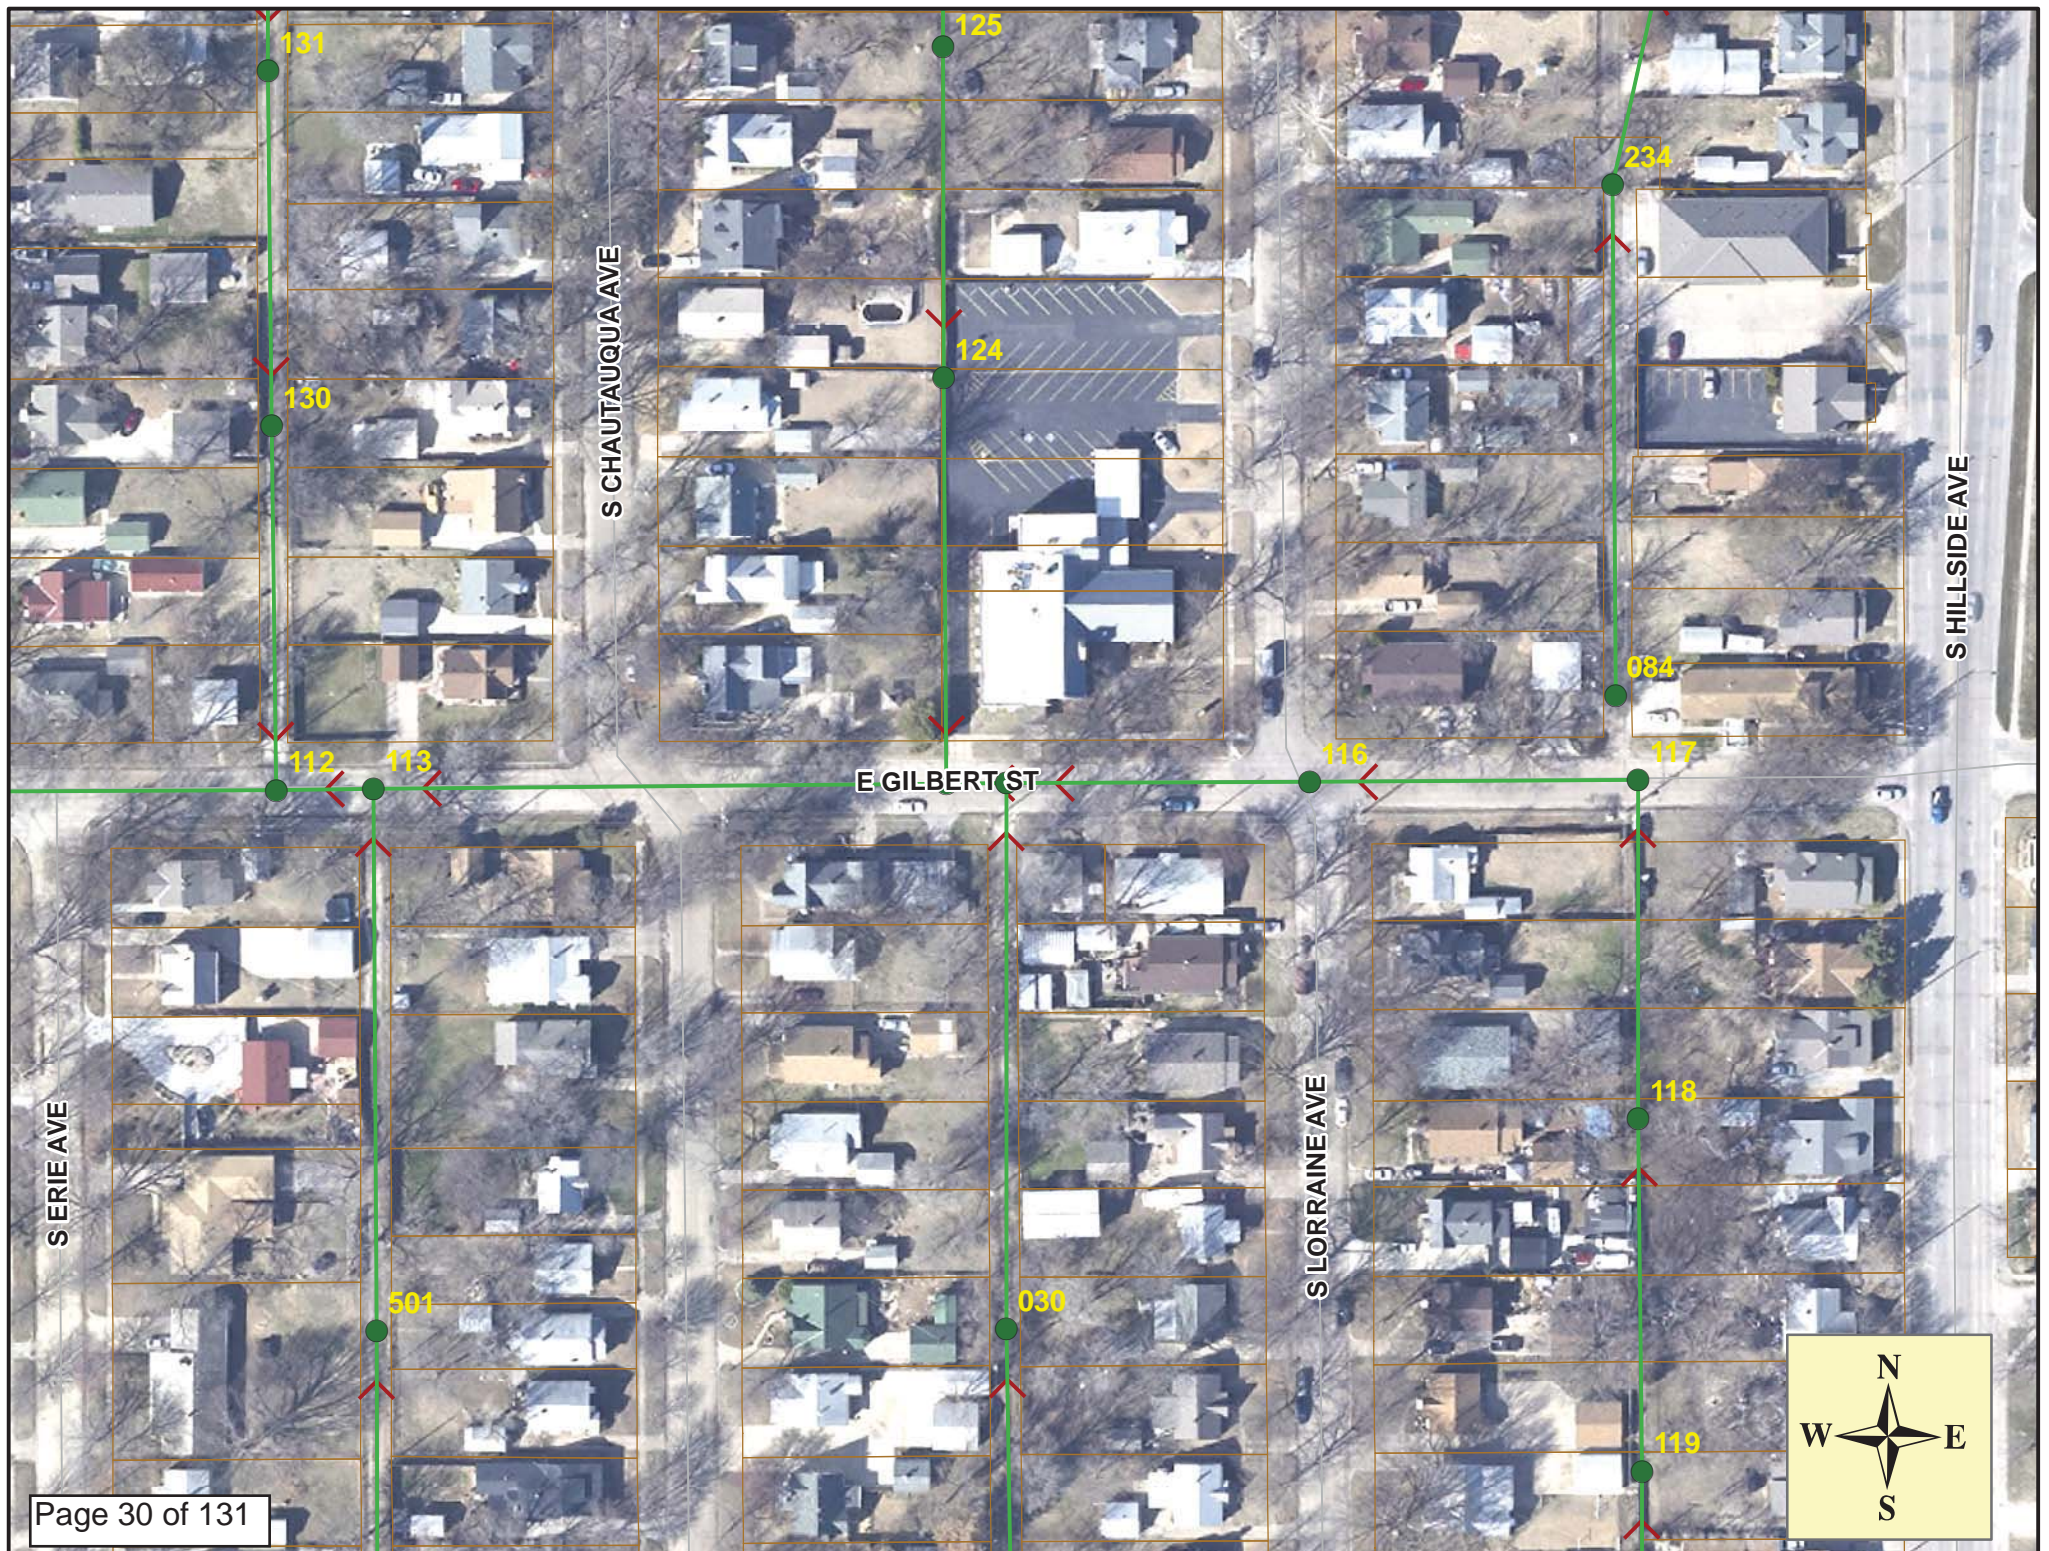
MH 5646-112
Approx depth = 6.7 ft

MH 5646-113
Approx depth = 6.5 ft

MH 5646-114
Approx depth = 6.4 ft

MH 5646-115
Approx depth = 6.5 ft

MH 5646-117
Approx depth = 7.3 ft

SEE TV LOG

MH 5646-116
Abandon Manhole (in pavement) (line through the manhole and abandon the manhole over the liner, per City Spec)
Approx depth = 6.7 ft
