Install 615 lf of 8" Cured-in-Place Liner from MH 5646-135 to MH 5646-111

SITE 7

Video Inspection Master Report

SITE 8

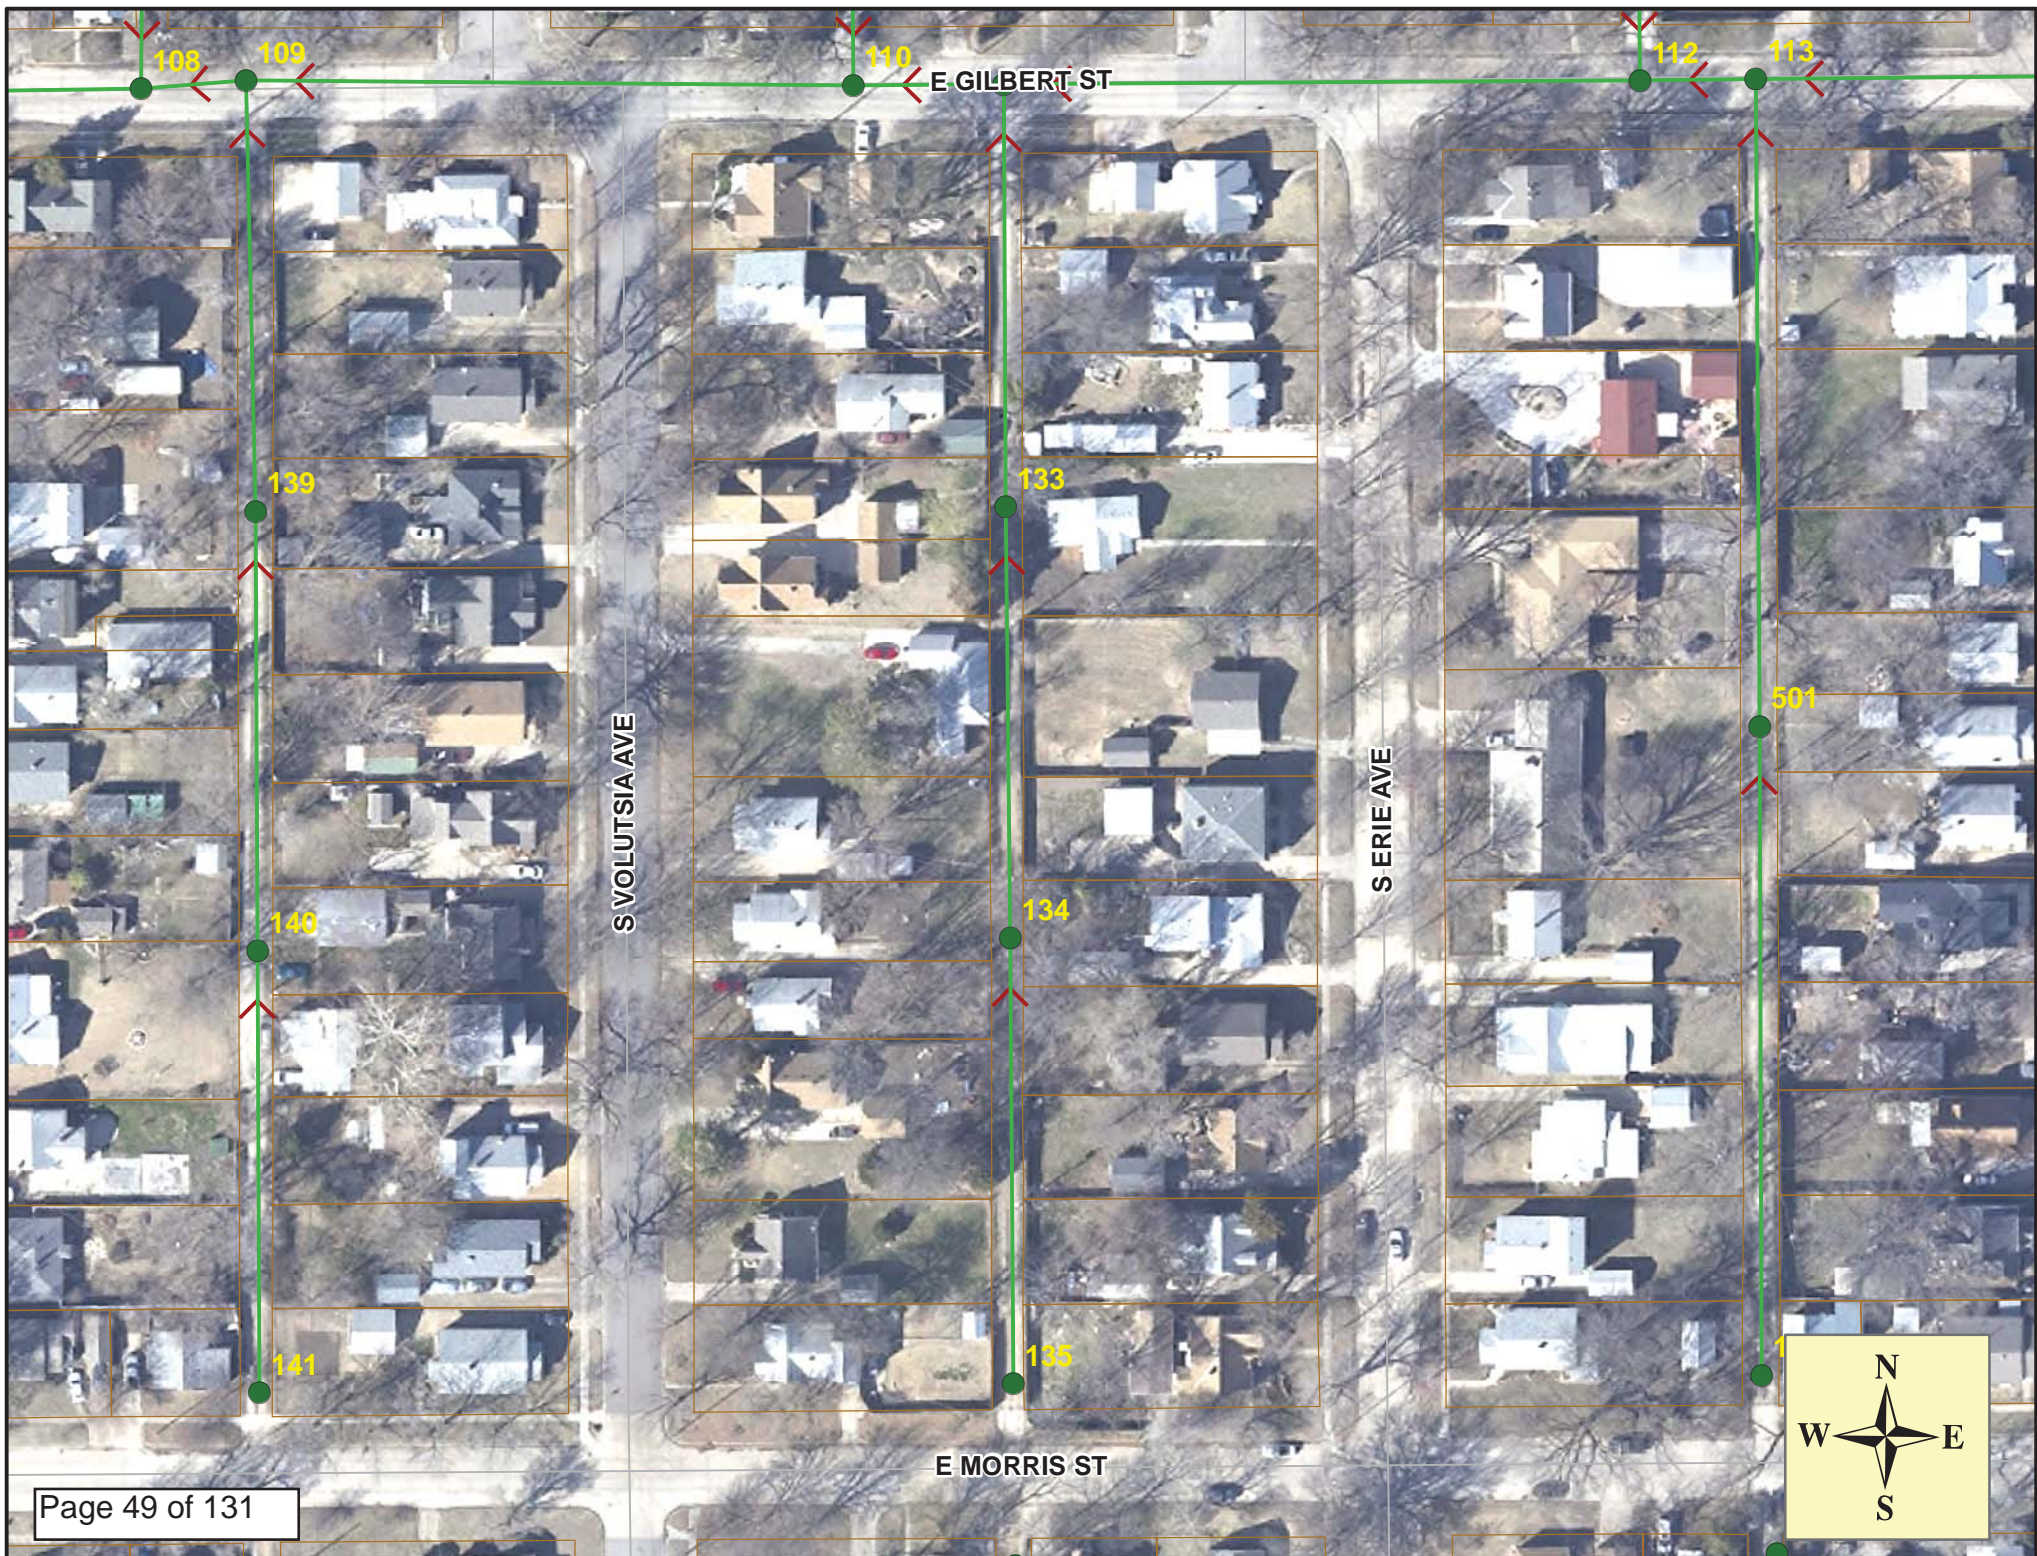
MH 5646-111
Approx depth = 7.0 ft

MH 5646-133
Approx depth = 7.4 ft

MH 5646-134
Approx depth = 7.0 ft

MH 5646-135
Approx depth = 6.2 ft

Obs. #	VTR Counter	Distance	Location	Description	Rating	Obsrvd (gpm)	Ratings			
							Est. (gpm)	Struct	Clean	Remain (gpm)
1		0.0	5646-135	US Manhole	1	0.000	0	0	0.000	
2		8.5		Crack-Radial	4	0.008	10	0	0.008	
3		19.6	756 S VOLUTSIA / PVC	Break-In Conn	1	0.001	0	0	0.001	
4		23.0		Sealed Off Wye	1	0.000	0	0	0.000	
5		45.9	756 S VOLUTSIA	Wye Service (dry) - LML	1	COULD BE ABANDONED / NEEDS VERIFIED				
6		47.4	755 S ERIE	Break-In Conn	1	0.001	0	0	0.001	
7		54.1		Crack-Radial	3	0.004	5	0	0.004	
8		59.4		Crack-Radial	3	0.004	5	0	0.004	
9		62.0		Crack-Radial	2	0.002	2	0	0.002	
10		71.4	748 S VOLUTISA	Wye Service (dry) - LML	1	COULD BE ABANDONED / NEEDS VERIFIED				
11		72.0		Crack-Radial	4	0.008	10	0	0.008	
12		73.4		Sealed Off Wye	1	0.000	0	0	0.000	
13		76.9	748 S VOLUTSIA	Break-In Conn (looks active)	3	0.004	2	0	0.004	
14		77.2	745 S ERIE	Break-In Conn	3	0.004	2	0	0.004	
15		82.3		Crack-Radial	2	0.002	2	0	0.002

16		84.9		Crack-Radial	2	0.002	2	0	0.002	
17		87.2		Crack-Radial	3	0.004	5	0	0.004	
18		89.9		Crack-Radial	2	0.002	2	0	0.002	
19		96.4		Sealed Off Wye	1	0.000	0	0	0.000	
20		97.5		Crack-Radial	2	0.002	2	0	0.002	
22		99.1	737 S ERIE	Wye Service	5	0.000	400	0	0.000	
			(fixed by Sewer Maintenance, main 6' deep, WO 2012-005554)							
23		100.0		Crack-Radial	2	0.002	2	0	0.002	
24		109.9		Crack-Radial	4	0.008	10	0	0.008	
25		112.4		Crack-Radial	3	0.004	5	0	0.004	
26		117.6		Crack-Radial	3	0.004	5	0	0.004	
27		121.8		Sealed Off Wye	1	0.000	0	0	0.000	
28		124.4		Sealed Off Wye	1	0.000	0	0	0.000	
29		127.6		Crack-Radial	4	0.008	10	0	0.008	
30		130.3		Crack-Radial	2	0.002	2	0	0.002	
31		135.4		Crack-Radial	3	0.004	5	0	0.004	
32		143.0		Crack-Radial	2	0.002	2	0	0.002

33	147.3		Sealed Off Wye	1	0.000	0	0	0.000
34	149.8		Sealed Off Wye	1	0.000	0	0	0.000
35	153.3		Crack-Radial	3	0.004	5	0	0.004
36	160.3	736 S VOLUTSIA	Break-In Conn	5	0.010	400	0	0.010
		(fixed by Sewer Maintenance, main 6.5' deep, WO 2012-005623)						
37	163.4		Crack-Radial	1	0.001	1	0	0.001
38	165.7		Crack-Radial	2	0.002	2	0	0.002
39	170.8		Crack-Radial	2	0.002	2	0	0.002
40	172.6	732 S VOLUTIS	Wye Service / roots	1	0.000	0	0	0.000
41	175.2		Sealed Off Wye	1	0.000	0	0	0.000
42	186.3	735 S ERIE	Break-In Conn	4	0.008	60	0	0.008
		(fixed by Sewer Maintenance, WO 2012-005617)						
43	198.0		Sealed Off Wye	1	0.000	0	0	0.000
44	200.4		Sealed Off Wye	1	0.000	0	0	0.000
45	201.4		Crack-Radial	3	0.004	5	0	0.004
46	206.4		Crack-Radial	3	0.004	5	0	0.004
47	209.3	5646-134	DS Manhole	1	0.000	0	0	0.000

Obs. #	VTR Counter	Distance	Location	Description	Rating	Obsrvd (gpm)	Ratings			Remain (gpm)
							Est. (gpm)	Struct	Clean	
1		0.0	5646-134	US Manhole	1		0.000	0	0	0.000
2		4.8		Crack-Radial	4		0.008	10	0	0.008
3		6.1	Sealed off	Break-In Conn	1		0.001	0	0	0.001
4		13.2	730 S VOLUTSIA (fixed by Sewer Maintenance, WO 2012-005555)	Wye Service	5		0.000	400	0	0.000
5		16.1	731 S ERIE	Break-In Conn	1		0.001	0	0	0.001
6		17.7		Broken Pipe	4	OK to line - LML				
7		22.8		Crack-Radial	3		0.004	5	0	0.004
8		35.4		Crack-Radial	3		0.004	5	0	0.004
9		39.9		Sealed Off Wye	1		0.000	0	0	0.000
10		42.3		Sealed Off Wye	1		0.000	0	0	0.000
11		43.3		Crack-Radial	2		0.002	2	0	0.002
12		55.9		Crack-Radial	2		0.002	2	0	0.002
13		58.5		Crack-Radial	2		0.002	2	0	0.002
14		64.1	728 S VOLUTSIA	Break-In Conn	1		0.001	0	0	0.001
15		67.1		Sealed Off Wye	1		0.000	0	0	0.000
16		68.7	725 S ERIE	Break-In Conn	1		0.001	0	0	0.001
17		73.6		Crack-Radial	3		0.004	5	0	0.004

18		91.0		Sealed Off Wye	1		0.000	0	0	0.000
19		93.3		Sealed Off Wye	1		0.000	0	0	0.000
20		94.1		Crack-Radial	2		0.002	2	0	0.002
21		107.0		Crack-Radial	3		0.004	5	0	0.004
22		109.7		Crack-Radial	5		0.010	18	0	0.010
23		116.4		Sealed Off Wye	1		0.000	0	0	0.000
24		119.0		Sealed Off Wye	1		0.000	0	0	0.000
25		124.9		Crack-Radial	2		0.002	2	0	0.002
26		134.0	726 S VOLUTSIA / PVC	Break-In Conn	1		0.001	0	0	0.001
27		141.8		Sealed Off Wye	1		0.000	0	0	0.000
28		142.6	Offset Joint (fixed by Sewer Maintenance)	Mat. Chngs to PVC	1		0.000	0	0	0.000
29		143.7	721 S ERIE	PVC Break-In Conn	4		0.008	60	0	0.008
30		145.7		Mat. Chngs to VCP	1		0.000	0	0	0.000
31		148.0		Crack-Radial	2		0.002	2	0	0.002
32		150.9	726 S VOLUTSIA	Break-In Conn	1		0.001	0	0	0.001
33		155.5		Crack-Radial	2		0.002	2	0	0.002

34	160.4		Crack-Radial	3	0.004	5	0	0.004
35	163.3		Crack-Radial	3	0.004	5	0	0.004
36	167.4	714 S VOLUTSIA	Wye Service	2	0.000	0	0	0.000
37	169.9		Sealed Off Wye	1	0.000	0	0	0.000
38	170.9		Crack-Radial	2	0.002	2	0	0.002
39	175.9		Crack-Radial	5	0.010	18	0	0.010
40	178.4		Crack-Radial	3	0.004	5	0	0.004
41	181.0		Crack-Radial	3	0.004	5	0	0.004
42	192.9		Sealed Off Wye	1	0.000	0	0	0.000
43	195.4	717 S ERIE	Wye Service	3	0.000	2	0	0.000
44	196.9	712 S VOLUTSIA (fixed by Sewer Maintenance, WO 2012-005619)	Break-In Conn	5	0.010	400	0	0.010
45	198.6		Crack-Radial	3	0.004	5	0	0.004
46	205.5	5646-133	DS Manhole	1	0.000	0	0	0.000

Obs. #	VTR Counter	Distance	Location	Description	Rating	Obsrvd (gpm)	Ratings			Remain (gpm)
							Est. (gpm)	Struct	Clean	
1		0.0		US Manhole	1	0.000	0	0	0.000	
2		6.7		Broken Pipe / invert / ok to line over it -LML	4	0.030	78	0	0.030	
3		10.9		Sealed Off Wye	1	0.000	0	0	0.000	
4		13.5		Sealed Off Wye	1	0.000	0	0	0.000	
5		14.3		Crack-Radial	3	0.004	5	0	0.004	
6		19.4		Crack-Radial	3	0.004	5	0	0.004	
7		21.8		Crack-Radial	3	0.004	5	0	0.004	
8		29.4		Crack-Radial	3	0.004	5	0	0.004	
9		31.8		Crack-Radial	5	0.010	18	0	0.010	
10		36.0		Sealed Off Wye	1	0.000	0	0	0.000	
11		38.7		Sealed Off Wye	1	0.000	0	0	0.000	
12		39.6		Crack-Radial	3	0.004	5	0	0.004	
13		49.4		Crack-Radial	3	0.004	5	0	0.004	
14		60.6	710 S VOLUTIS	Break-In Conn	3	0.004	2	0	0.004	
15		64.2	711 S ERIE	Wye Service	1	0.000	0	0	0.000	
16		64.8		Crack-Radial	4	0.008	10	0	0.008	
17		69.9		Crack-Radial	3	0.004	5	0	0.004	
18		77.4		Crack-Radial	1	0.001	1	0	0.001

19		82.5		Crack-Radial	5	0.010	18	0	0.010	
20		86.8		Sealed Off Wye	1	0.000	0	0	0.000	
21		89.4		Sealed Off Wye	1	0.000	0	0	0.000	
22		95.2		Crack-Radial	3	0.004	5	0	0.004	
23		107.8		Crack-Radial	2	0.002	2	0	0.002	
24		112.1		Sealed Off Wye	1	0.000	0	0	0.000	
25		114.1	707 S ERIE	Wye Service / roots	5	0.000	400	0	0.000	
26		118.4	708 S VOLUTSIA	Break-In Conn	3	0.004	2	0	0.004	
27		123.1		Crack-Radial	3	0.004	5	0	0.004	
28		125.7		Crack-Radial	3	0.004	5	0	0.004	
29		130.9		Crack-Radial	2	0.002	2	0	0.002	
30		135.6		Crack-Radial	2	0.002	2	0	0.002	
31		137.0	702 S VOLUTISA	Break-In Conn	3	0.004	2	0	0.004	
32		139.1	701 S ERIE	Break-In Conn	1	0.001	0	0	0.001

33	140.9	Crack-Radial	4	0.008	10	0	0.008
34	153.7	Crack-Radial	3	0.004	5	0	0.004
35	156.4	Crack-Radial	3	0.004	5	0	0.004
36	162.6	Sealed Off Wye	1	0.000	0	0	0.000
37	165.6	Sealed Off Wye	1	0.000	0	0	0.000
38	166.3	Crack-Radial	4	0.008	10	0	0.008
39	168.8	Crack-Radial	3	0.004	5	0	0.004
40	176.3	Crack-Radial	2	0.002	2	0	0.002
41	181.3	Crack-Radial	3	0.004	5	0	0.004
42	188.7	Crack-Radial	3	0.004	5	0	0.004
43	191.6	Crack-Radial	3	0.004	5	0	0.004
44	193.8	Crack-Radial	3	0.004	5	0	0.004
45	196.7	Crack-Radial	4	0.008	10	0	0.008
46	199.6	5646-111 DS Manhole	1	0.000	0	0	0.000

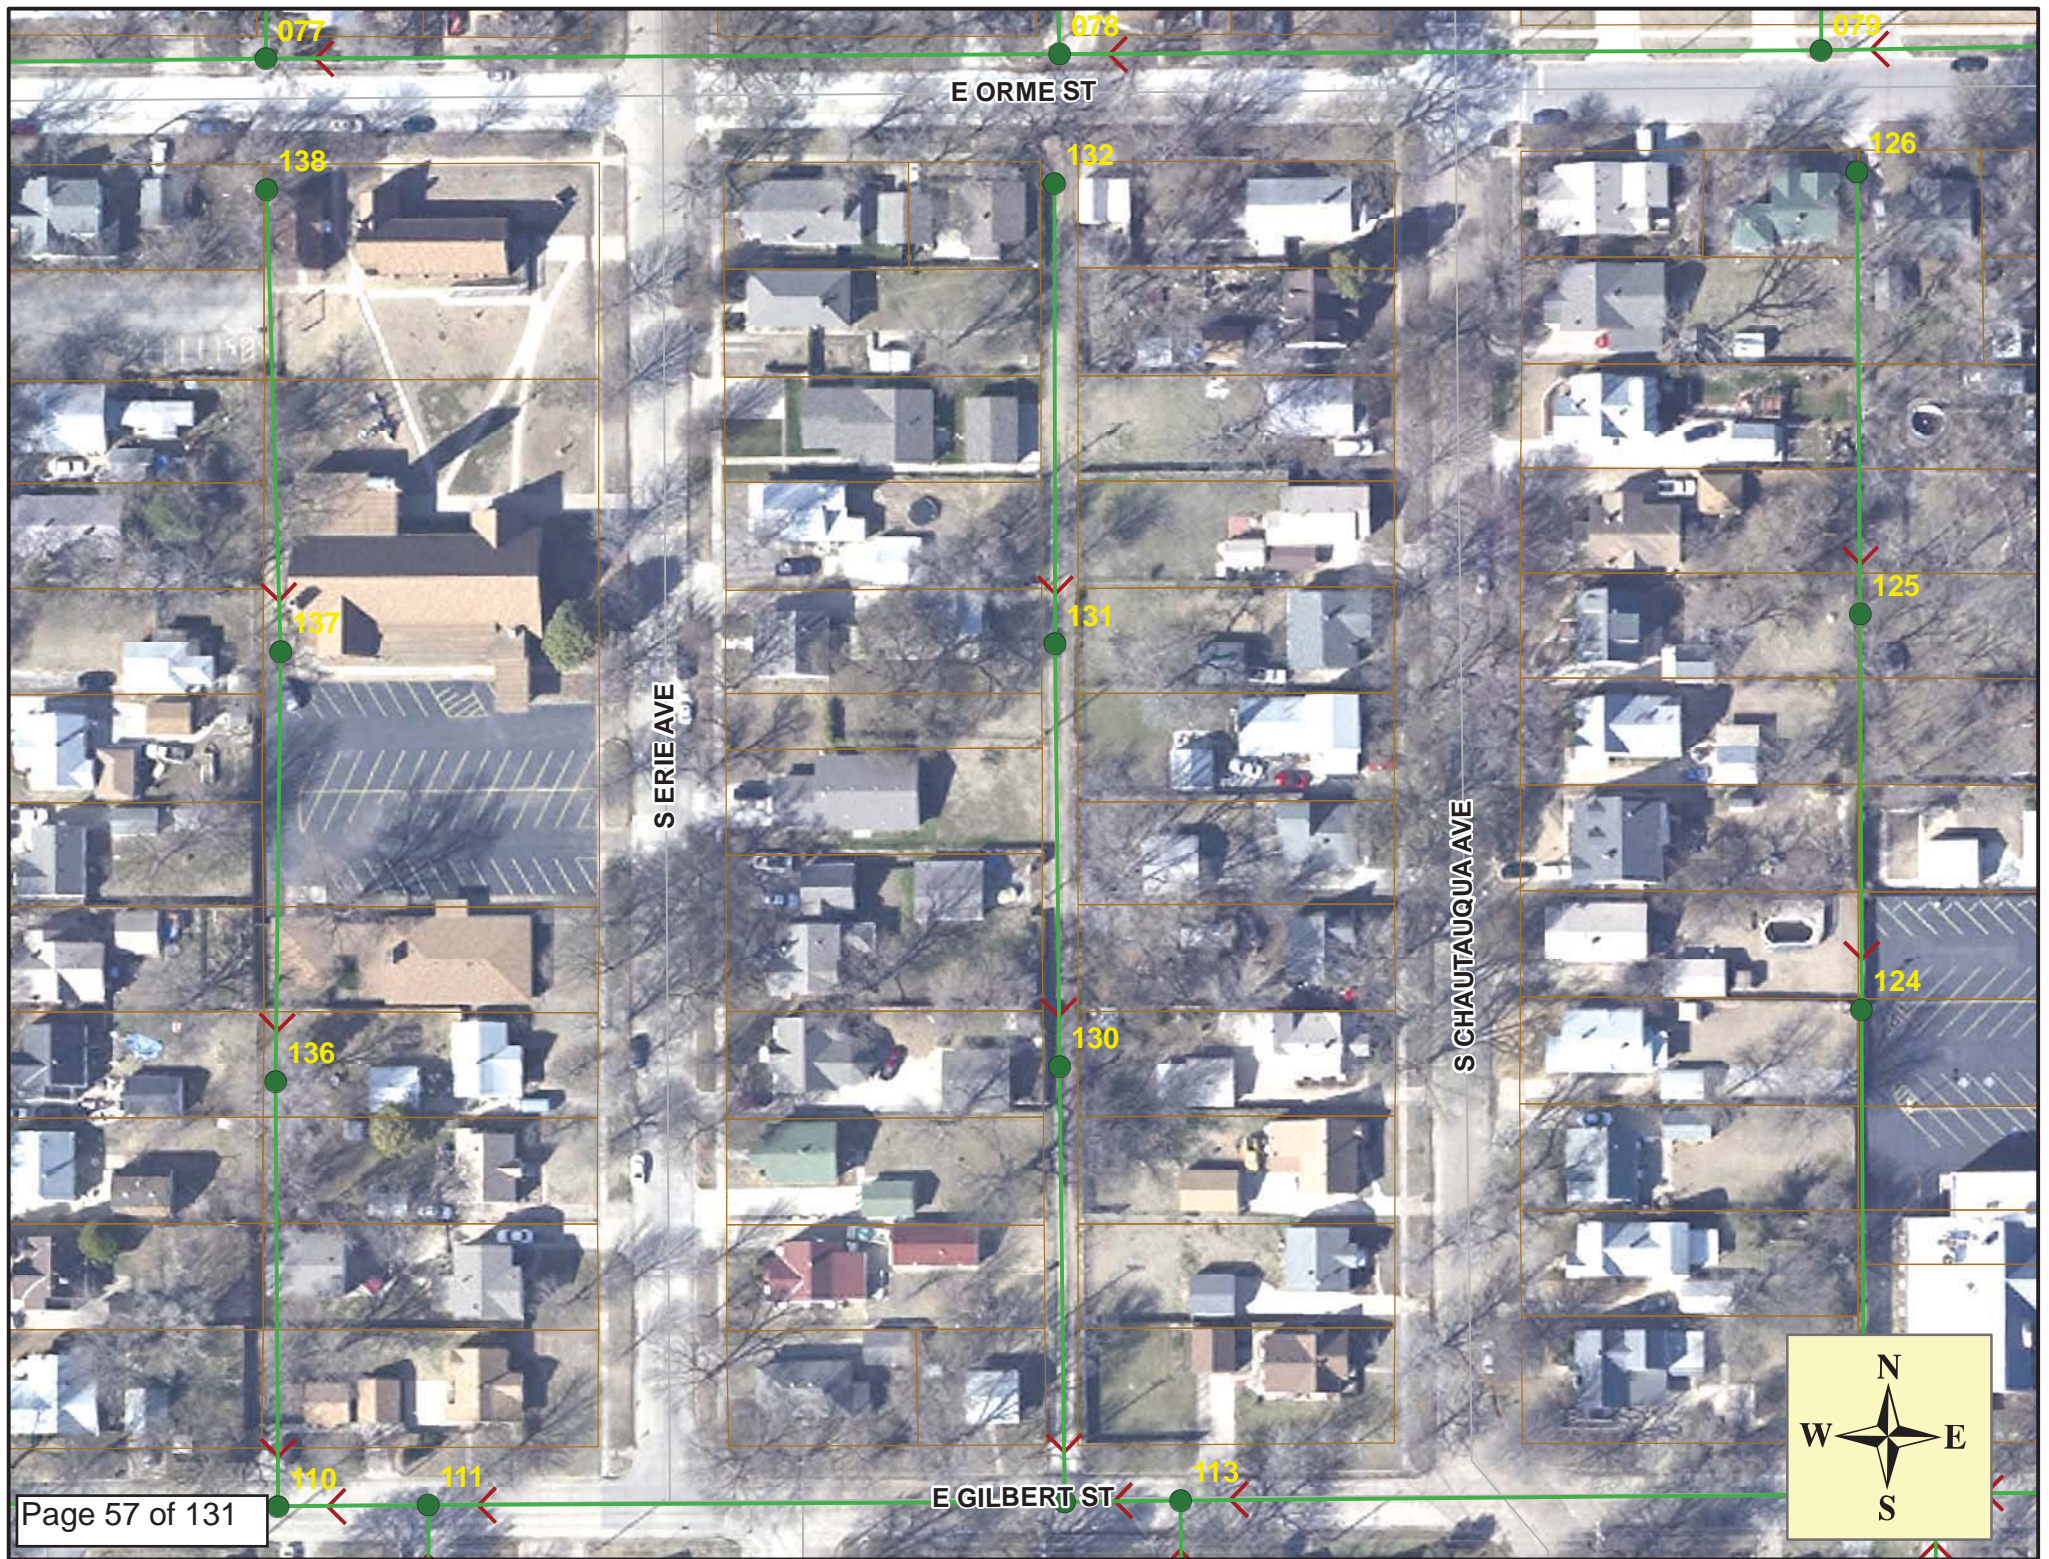
Obs. #	VTR Counter	Distance	Location	Description	Rating	Obsrvd (gpm)	Ratings			Remain (gpm)	
							Est. (gpm)	Struct	Clean		
1		0.0	5646-132	US Manhole	1						
2		6.9		Crack-Radial	4	0.008	10	0	0.008		
3		8.1	601 S CHAUTAUQUA	Break-In Conn	2	0.002	0	0	0.002		
				(connection repaired by Sewer Maintenance since this televising) (8 ft deep)							
4		11.1		Sealed Off Wye	1	0.000	0	0	0.000		
5		16.9	2915 E ORME	Break-In Conn	4	0.008	60	0	0.008		
6		28.7		Sealed Off Wye	1	0.000	0	0	0.000		
7		31.2		Sealed Off Wye	1	0.000	0	0	0.000		
8		42.9	602 S ERIE	Break-In Conn	1	0.001	0	0	0.001		
9		44.7		Crack-Radial	2	0.002	2	0	0.002		
10		53.0	605 S CHAUTAUQUA	Wye Service	1	0.000	0	0	0.000		
11		55.9	608 S ERIE	Break-In Conn	1	0.001	0	0	0.001		
12		60.1		Crack-Radial	4	0.008	10	0	0.008		
13		65.1		Crack-Radial	5	0.010	18	0	0.010		
14		70.4		Crack-Radial	3	0.004	5	0	0.004		
15		79.6		Sealed Off Wye	1	0.000	0	0	0.000
