Install 836 lf of 8"
Cured-in-Place Liner
from MH 5846-076
to MH 5846-012

SITE 15

Video Inspection Master Report

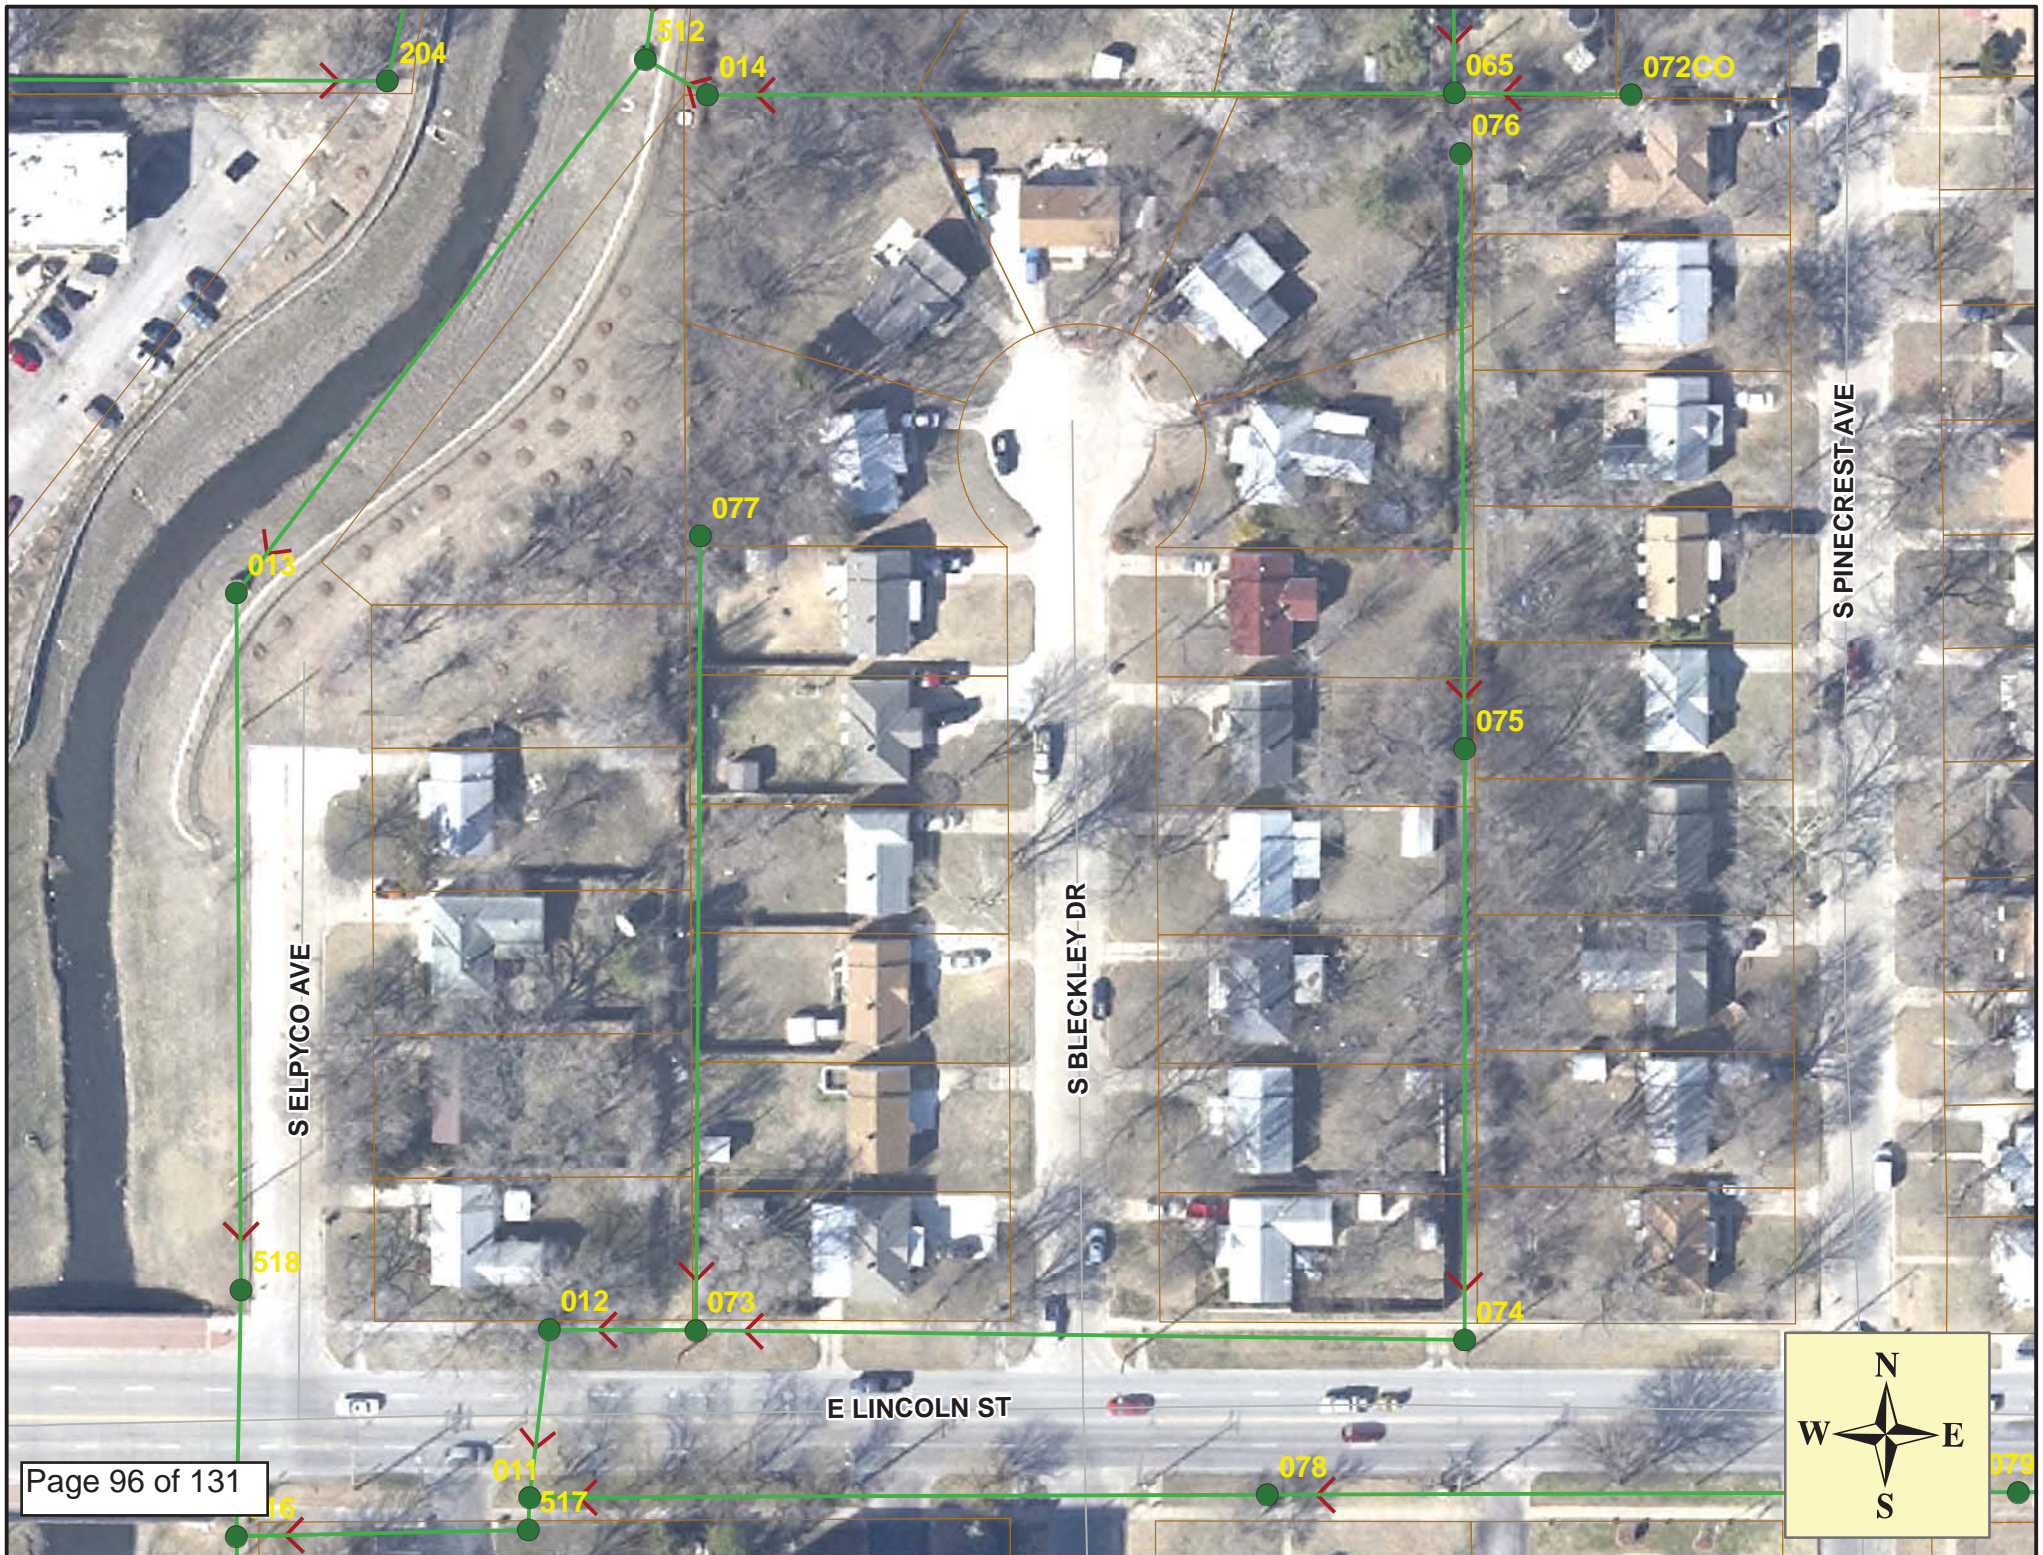
US Structure: 5846-076 815 PINECREST ST Date Insp: 2/27/2012 Basin: E04A
 DS Structure: 5846-075 818 S BLECKLEY DR Dir Televised: Downstream To Upstream

Obs. #	VTR Counter	Distance	Location	Description	Rating	Obsrvd (gpm)	Ratings		Remain (gpm)
							Est. (gpm)	Struct Clean	
1		0.0	TV AGAINST FLOW	5846-075 DS Manhole	2				
2		6.6		Break-In Conn	1				
3	837 S PINE CREST / PVC	9.6		Break-In Conn	1				
4	818 S BLECKLEY DRIVE / PVC	12.8		Roots	2				
5		22.0		Roots	2				
6		43.1		Break-In Conn	2				
7	812 S BLECKLEY DRIVE	54.1		Break-In Conn	1				
8	831 S PINE CREST	61.0		Sealed Wye Service	1				
9		64.5	Ball of roots	Sealed Wye Service	1				
10		111.9		Break-In Conn	2				
11	825 S PINE CREST / roots around PVC service	113.1		Roots	3				
12		115.3		Wye Service	1				
13	808 S BLECKLEY DRIVE	172.6		Break-In Conn	1				
14	819 S PINE CREST / PVC	175.7		Break-In Conn	1				
15	804 S BLECKLEY DRIVE / PVC	226.8		Break-In Conn	1				
16	815 S PINE CREST / PVC	237.7		5846-076 US Manhole	3

Gapped joints & roots at joints not listed on the log. Looks like roots at every joint. -LML

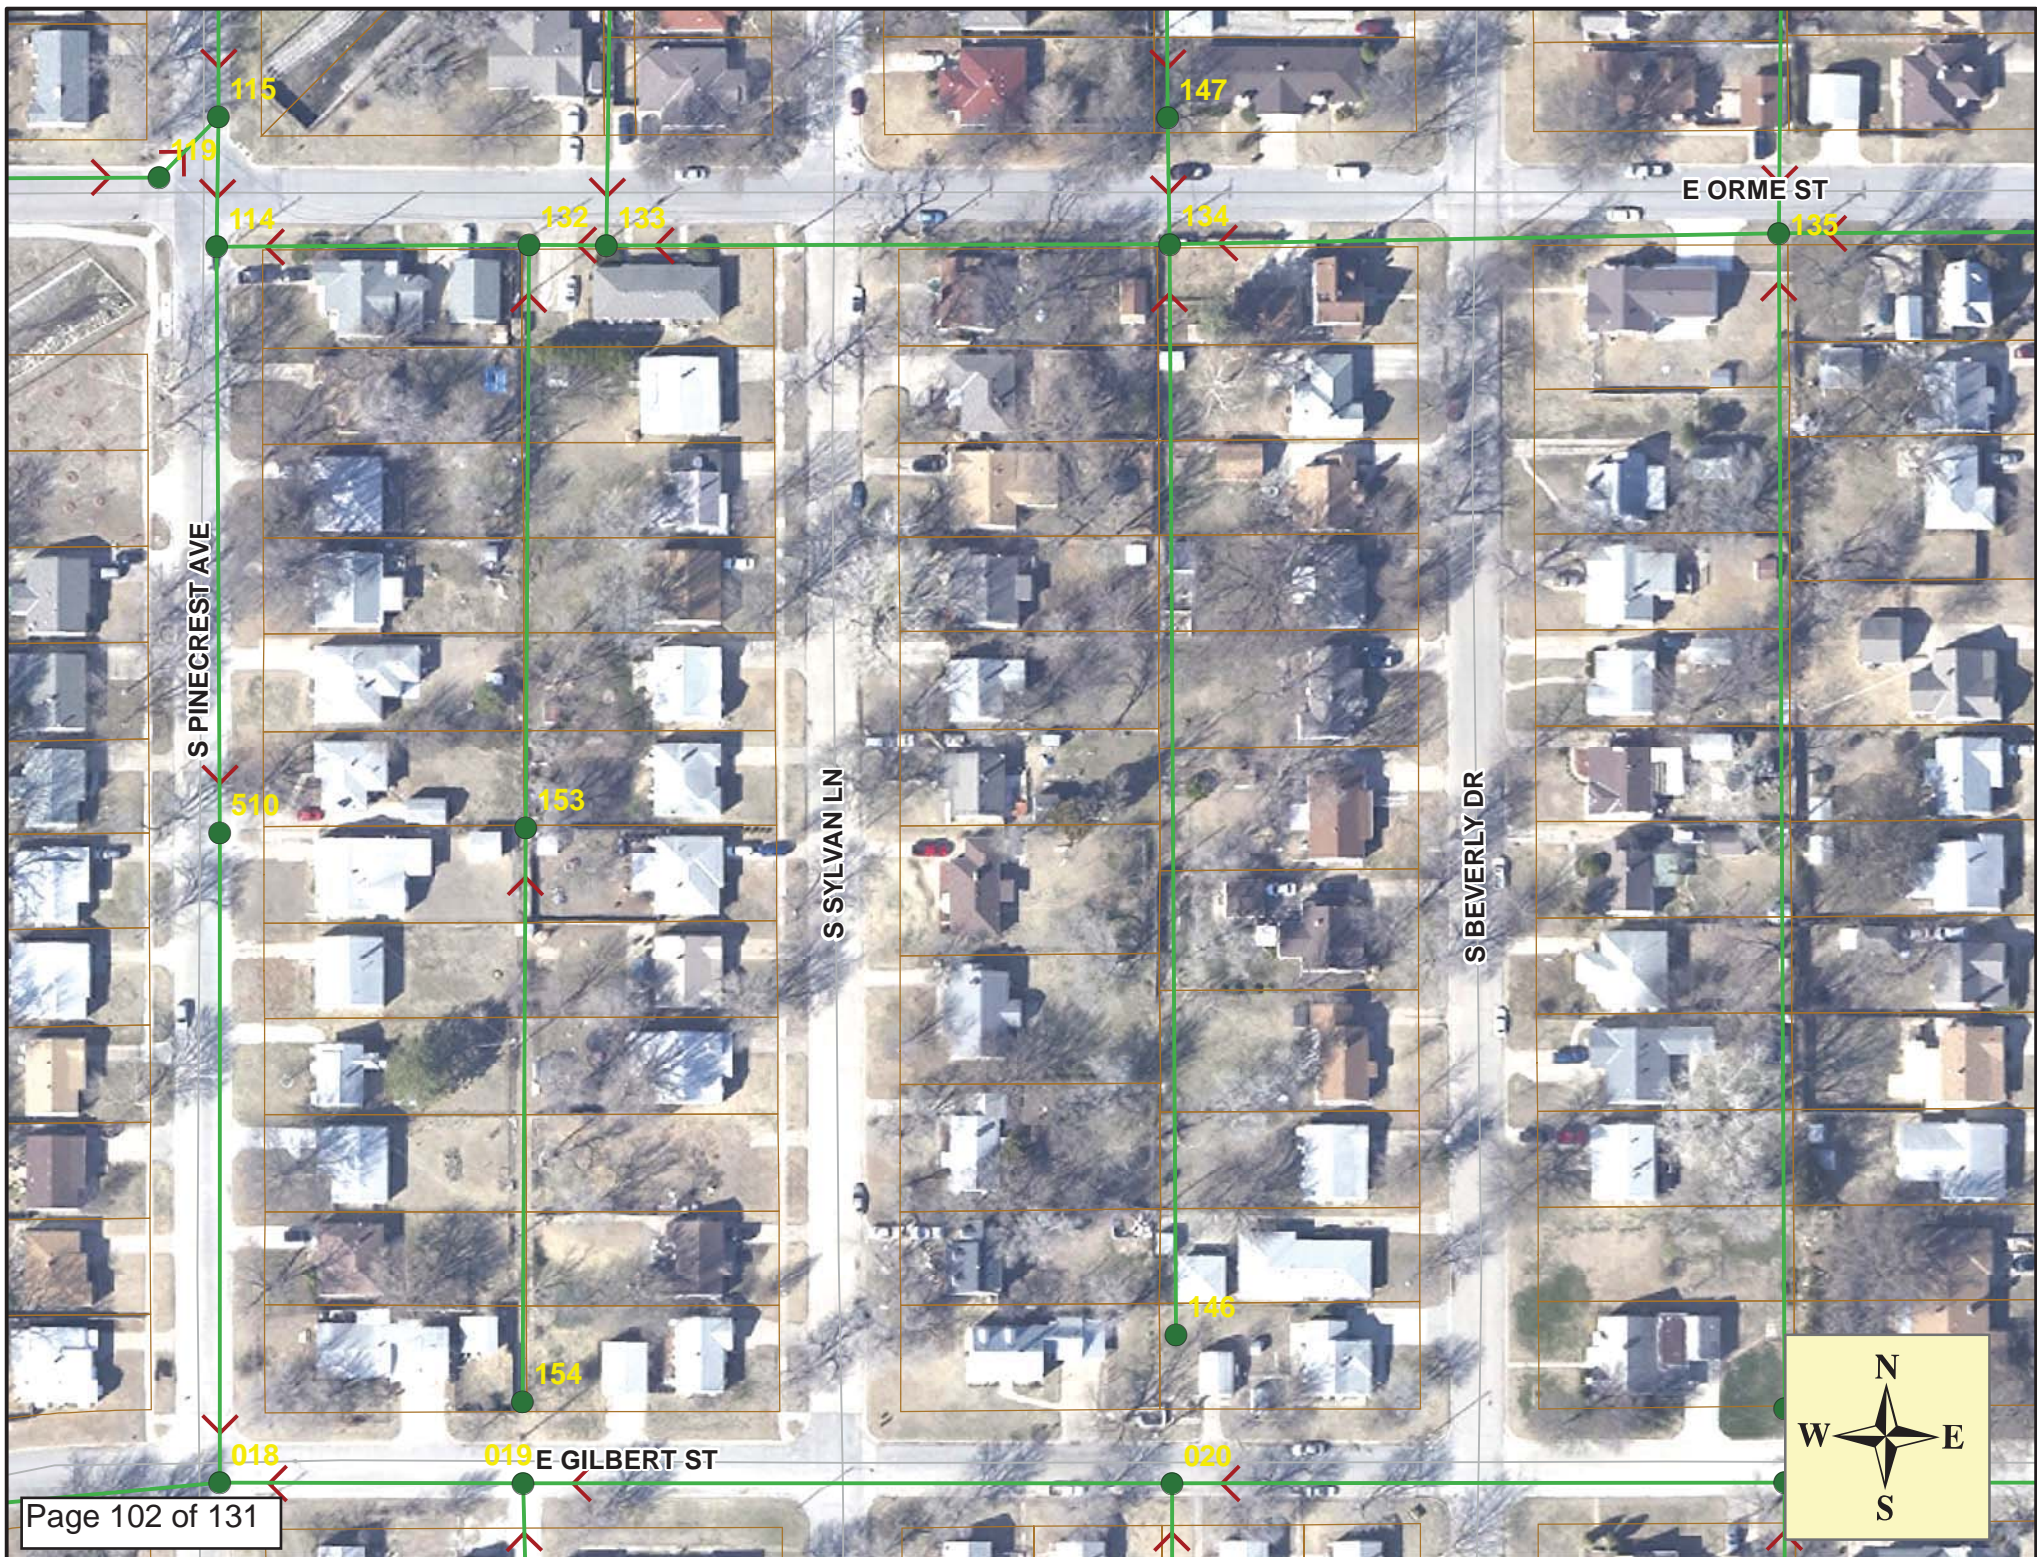
US Structure: 5846-073 837 BLECKLEY DR Date Insp: 2/23/2012 Basin: E04A
 Dir Televised: Upstream To Downstream

DS Structure: 5846-012 858 ELPYCO AV

Comments: LINE HAS LOTS OF OFFSET JOINTS IN BOTTOM OF PIPE, LINE NEEDS REHAB,

Obs. #	VTR Counter	Distance	Location	Description	Rating	Obsrvd (gpm)	Est. (gpm)	Ratings		Remain (gpm)
								Struct	Clean	
1		0.0		US Manhole	1					
2		23.1	Joint	Offset	3					
		50.0	Invert	Outside Drop Hole						
3		51.5	5846-012	DS Manhole	3
