SITE 4

Television Inspection Master Report

US Structure: 5650-313 2720 E 21ST ST Date Insp: 1/5/2010 Basin: EC02D
 DS Structure: 5650-312 2237 N ESTELLE ST Dir Televised: Upstream To Downstream

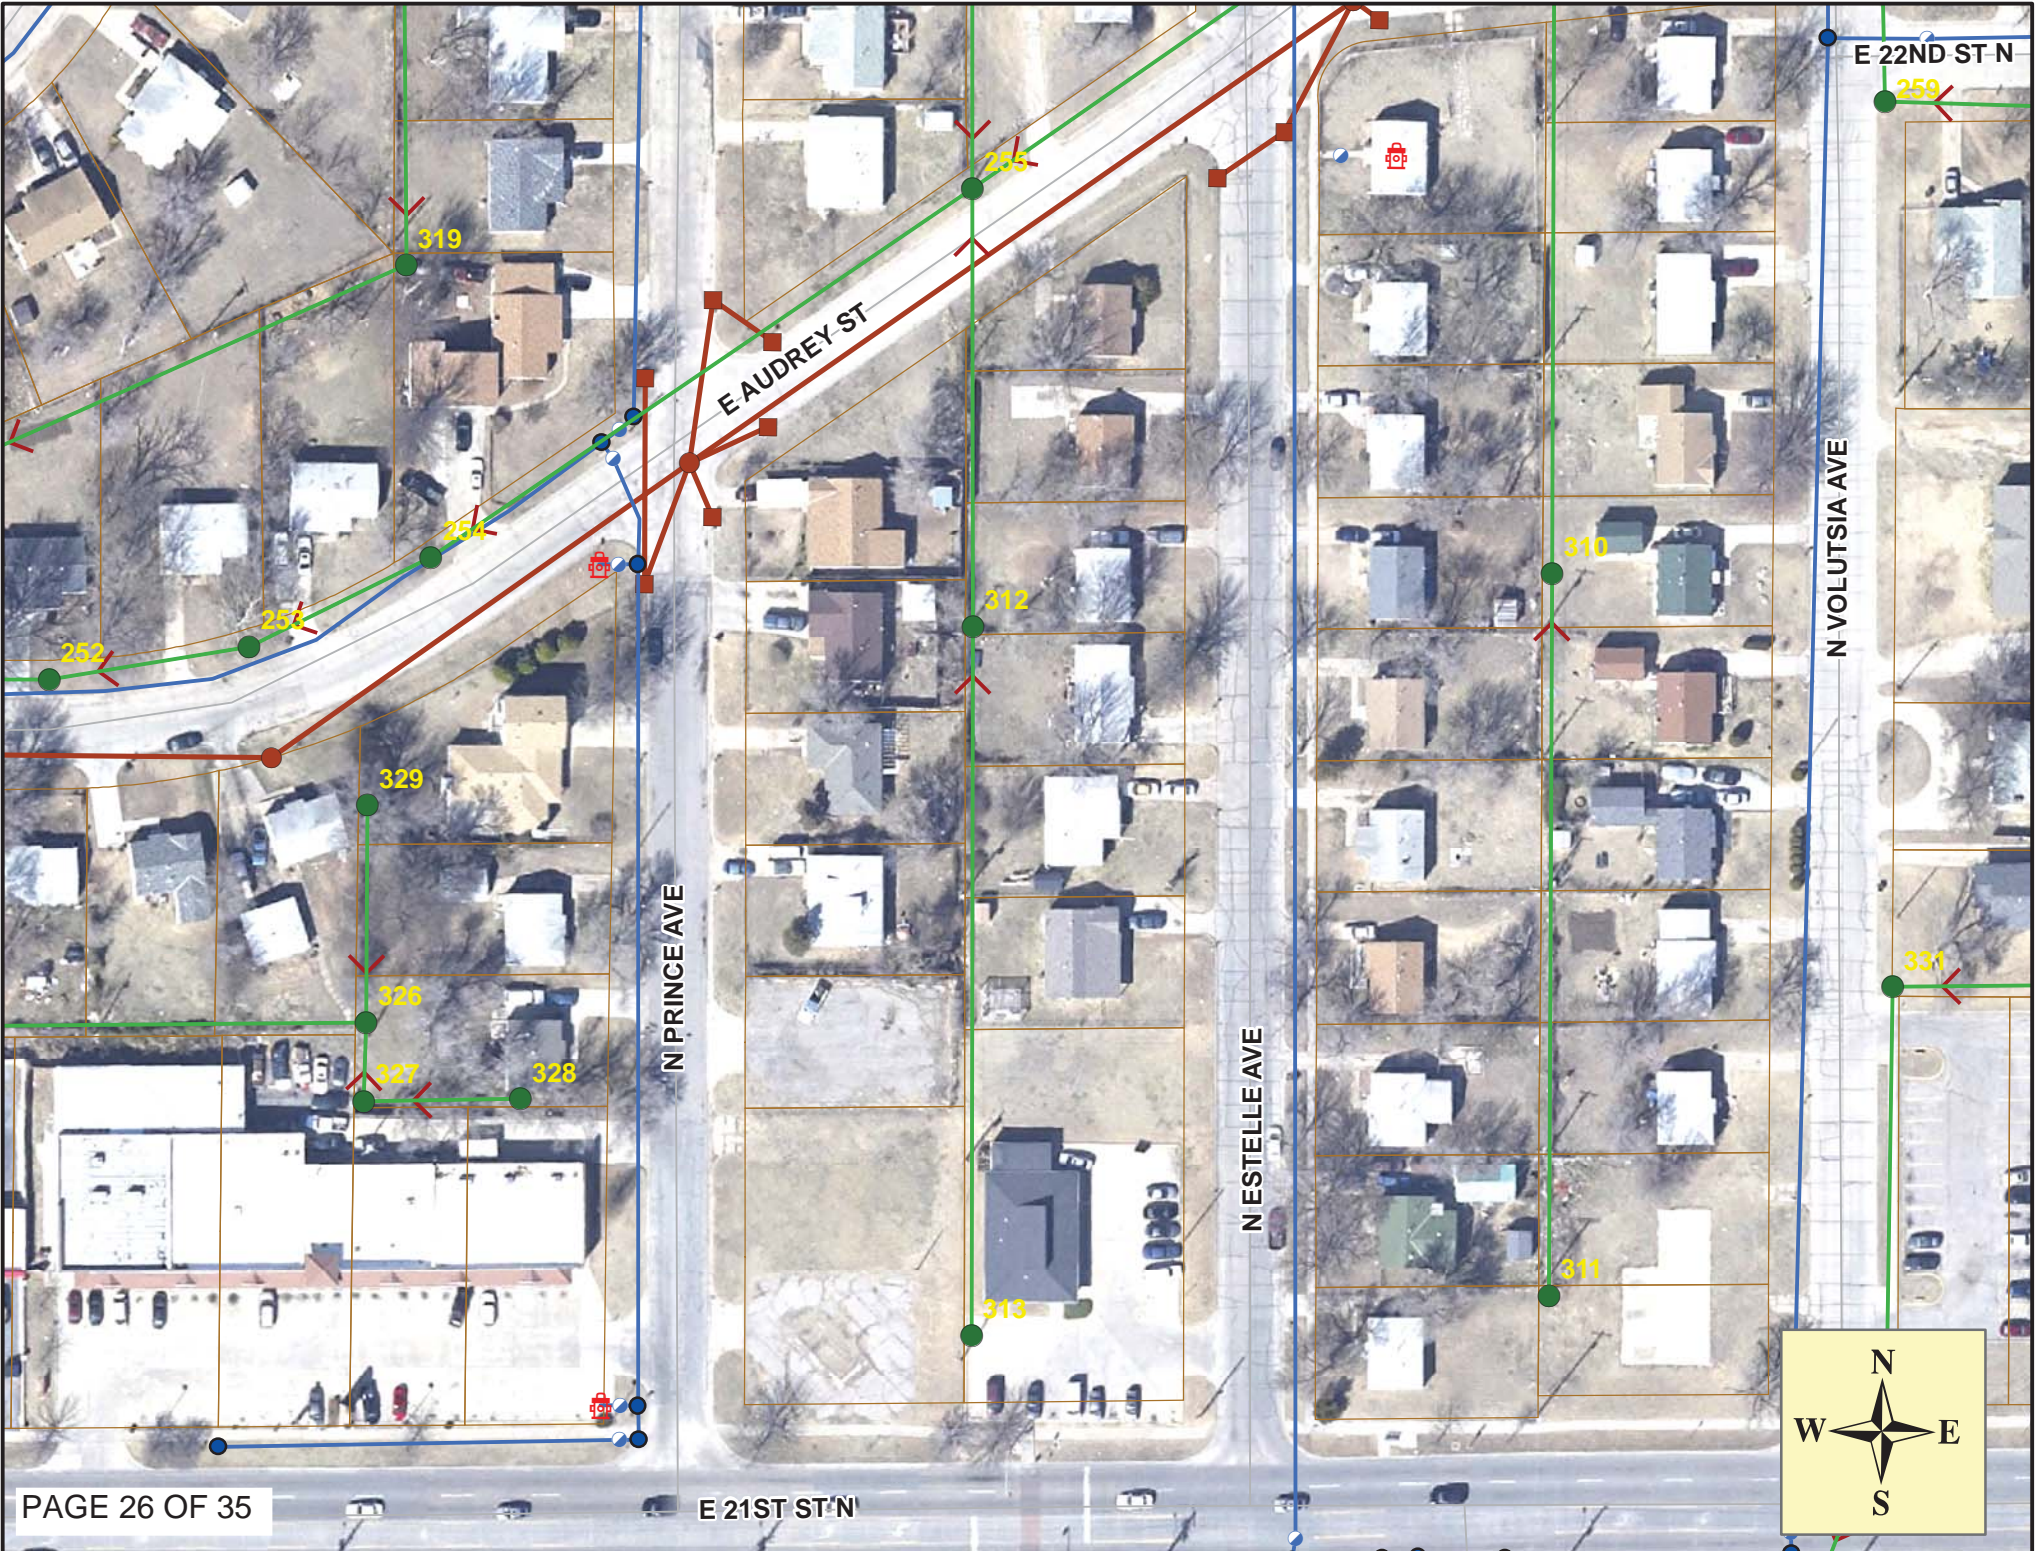
MH 5650-312
 2237 N. Estelle
 Adjust MH to Grade (<6")
 Replace MH Frame & Cover
 Construct Outside Drop
 Est. MH depth = 9.0 ft
 (depth not measured)

MH 5650-255
 Approx MH depth = 7.4 ft

Remove & replace 40 lf of
 Concrete Pavement (incl curb/gutter)
 Install 40 lf of Flowable Fill
 (no water located in Audrey St.)

Remove & replace 9 lf of
 Concrete Parking Lot

MH 5650-313
 2720 E. 21st St. N.
 Approx MH depth = 13.3 ft

Remove 523 lf of 8" Pipe
 Install 523 lf of 8" Pipe

Estimated 10 Service Reconnections (4")
 Estimated 1 Service Reconnection (6")
 Estimated 20 lf Back of Curb Protection
 Estimated 30 sy Erosion Control Mat
 Estimated 1 Construction Entrance
 Estimated 1 Curb Inlet Protection
 Estimated 20 lf Silt Fence
 Easement is 16' wide (8' on each side)
